East Lothian Council

Asset Name: Pinkie St Peters Primary School

Asset / Property Asbestos Management Plan

Property Address:	Pinkie St Peters Primary School, 44 Pinkie Road, Musselburgh, East Lothian EH21 7HA
Plan Issue Date:	8 th February 2024
Emergency Telephone Number (ELC Call Centre):	01875 824311 (Working Hours) 01875 612818 (Out of Hours) See Section 1.6 for Leave or Sickness Absence Day Time Contacts
Site Duty Holder:	Colette Bonnar, Head Teacher, East Lothian Council: Tel: 0131 665 2024: Email: cbonnar@pinkie-st-peters@elcschool.org.uk
Plan Author / Duty Holder:	Grant Fraser, Asbestos Manager, East Lothian Council: Mob: 07736 148929: Tel: 01620 827709 Email: gfraser@eastlothian.gov.uk

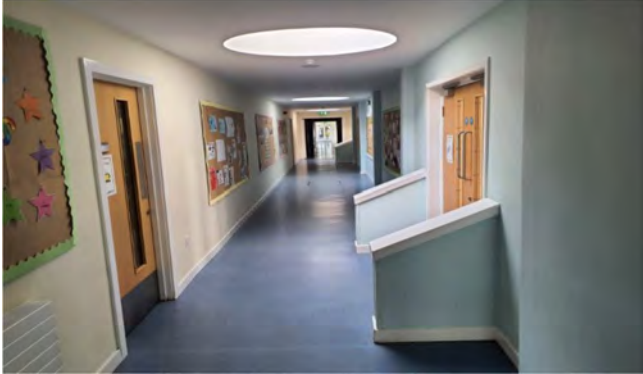
<p>7.1</p>

<p>Photo 1: Concealed bitumen-based flooring adhesive (Chrysotile): Sample No: S0049: Room No: B01/FG/R001A: Circulation Area</p>	<p>7.2</p>

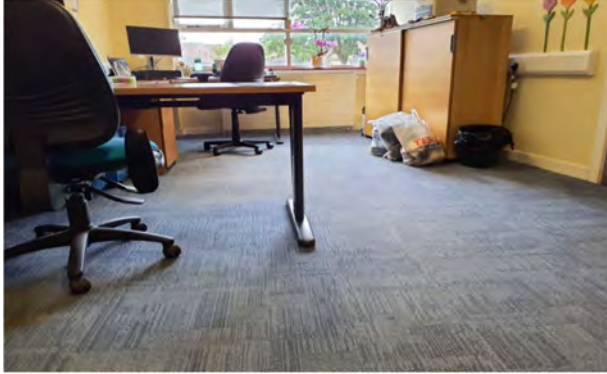
<p>Photo 2: Concealed bitumen-based flooring adhesive (Chrysotile): Sample No: S0049: Room No: B01/FG/R002: Reception Office</p>	<p>7.3</p>

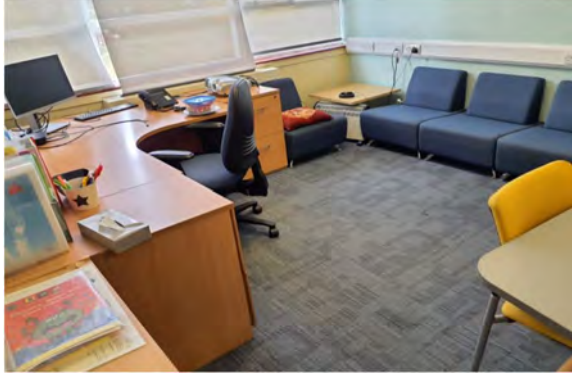
S0049	3	Head Teachers Office B01/FG/R003	Ground	Below visible floor coverings on concrete floor slab	Black coloured asbestos containing floor adhesive	Bitumen	Chrysotile	22.90 SQM	10/07/23 by HSL Ltd	C	Negligible exposure risk for normal use of the area	Inspect again before the end July 2024. Report any damage to ELC Call Centre	Any future planned removal will be NL asbestos works.	Arrange inspection before end July 2024 05/02/24 - GF
S0049	4	Deputy Head Teachers Office B01/FG/R004	Ground	Below visible floor coverings on concrete floor slab	Black coloured asbestos containing floor adhesive	Bitumen	Chrysotile	16.00 SQM	10/07/23 by HSL Ltd	C	Negligible exposure risk for normal use of the area.	Inspect again before the end July 2024. Report any damage to ELC Call Centre	Any future planned removal will be NL asbestos works.	Arrange inspection before end July 2024 05/02/24 - GF
S0049	5	Tutorial Room B01/FG/R006	Ground	Below visible floor coverings on concrete floor slab	Black coloured asbestos containing floor adhesive	Bitumen	Chrysotile	33.20 SQM	10/07/23 by HSL Ltd	C	Negligible exposure risk for normal use of the area	Inspect again before the end July 2024. Report any damage to ELC Call Centre	Any future planned removal will be NL asbestos works.	Arrange inspection before end July 2024 05/02/24 - GF

<p>Photo 3: Concealed bitumen-based flooring adhesive (Chrysotile): Sample No: S0049: Room No: B01/FG/R003: Head Teachers Office</p>
<p>7.4</p>

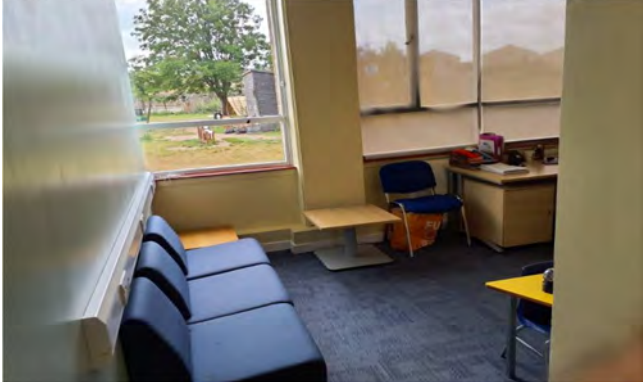
<p>Photo 4: Concealed bitumen-based flooring adhesive (Chrysotile): Sample No: S0049: Room No: B01/FG/R004: Deputy Head Teachers Office</p>	<p>7.5</p>

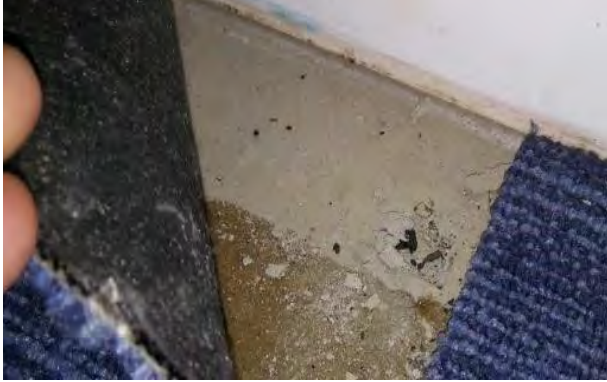
<p>Photo 5: Concealed bitumen-based flooring adhesive (Chrysotile): Sample No: S0048: Room No: B01/FG/R006: Tutorial Room</p>	<p>7.6</p>

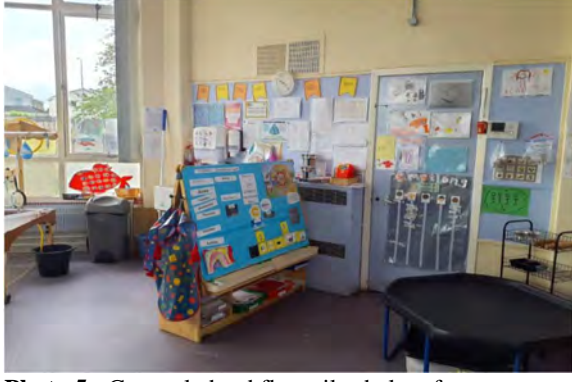
S0048	6	Classroom B01/FG/R007	Ground	Concealed by fan convector heater case on floor	Concealed red coloured asbestos containing vinyl floor tiles.	Thermoplastic	Chrysotile	1.00 SQM	10/07/23 by HSL Ltd	C	Negligible exposure risk for normal use of the area	Inspect again before the end July 2024. Report any damage to ELC Call Centre	Future removal planned summer 2024 - NL asbestos works	Arrange inspection before end July 2024 05/02/24 - GF

<p>Photo 5: Concealed red floor tiles below fan convactor radiator (Chrysotile): Sample No S0048: Room No: B01/FG/R007: Classroom</p>

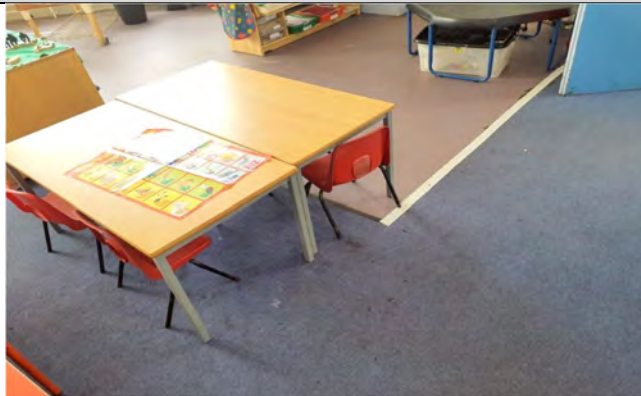
7.07

Photo 7: Concealed bitumen-based flooring adhesive (Chrysotile): Sample No: S0049: Room No: B01/FG/R007: Classroom

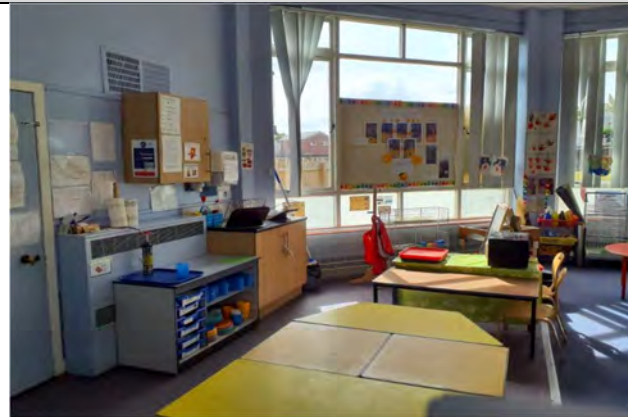
7.08

Photo 8: Concealed red floor tiles below fan convactor radiator (Chrysotile): Sample No S0048: Room No: B01/FG/R008: Classroom

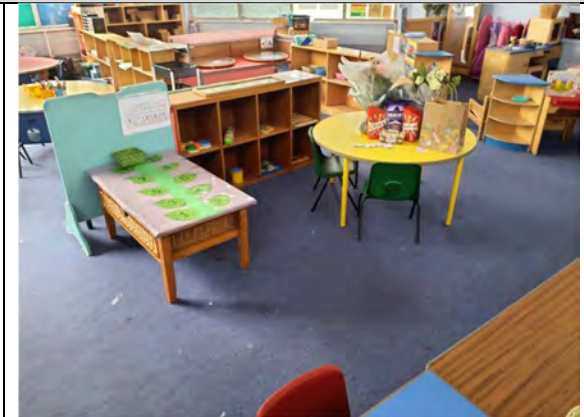
7.09

S0049	9	Classroom B01/FG/R008	Ground	Below visible floor coverings on concrete floor slab	Black coloured asbestos containing floor adhesive	Bitumen	Chrysotile	72.60 SQM	10/07/23 by HSL Ltd	C	Negligible exposure risk for normal use of the area	Inspect again before the end July 2024. Report any damage to ELC Call Centre	Future removal planned summer 2024 - NL asbestos works	Arrange inspection before end July 2024 05/02/24 - GF
S0055	10	Auxiliary Room B01/FG/R009	Ground	Below visible floor coverings on concrete floor slab	Black coloured asbestos containing floor adhesive	Bitumen	Chrysotile	14.70 SQM	10/07/23 by HSL Ltd	C	Negligible exposure risk for normal use of the area.	Inspect again before the end July 2024. Report any damage to ELC Call Centre	Any future planned removal will be NL asbestos works.	Arrange inspection before end July 2024 05/02/24 - GF
S0049	11	Medical Room B01/FG/R010	Ground	Below visible floor coverings on concrete floor slab	Black coloured asbestos containing floor adhesive	Bitumen	Chrysotile	10.70 SQM	10/07/23 by HSL Ltd	C	Negligible exposure risk for normal use of the area	Inspect again before the end July 2024. Report any damage to ELC Call Centre	Any future planned removal will be NL asbestos works	Arrange inspection before end July 2024 05/02/24 - GF

Photo 9: Concealed bitumen-based flooring adhesive (Chrysotile): Sample No: S0049: Room No: B01/FG/R008: Classroom

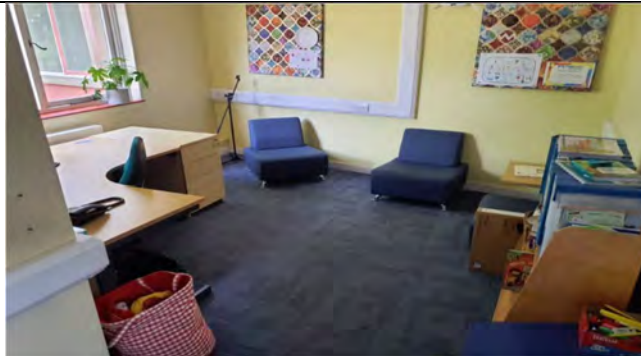
7.10

Photo 9: Concealed bitumen-based flooring adhesive (Chrysotile): Sample No: S0055: Room No: B01/FG/R009: Auxiliary Room

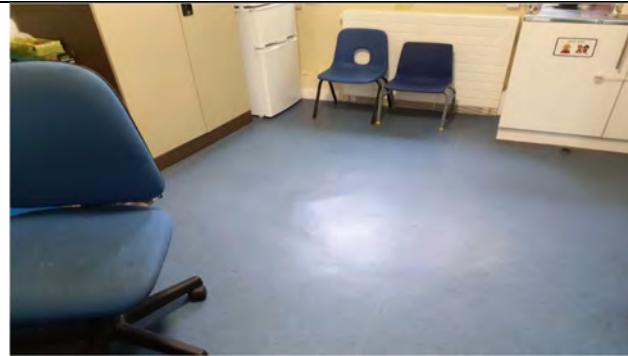
7.11

Photo 11: Concealed bitumen-based flooring adhesive (Chrysotile): Sample No: S0049: Room No: B01/FG/R010: Medical Room

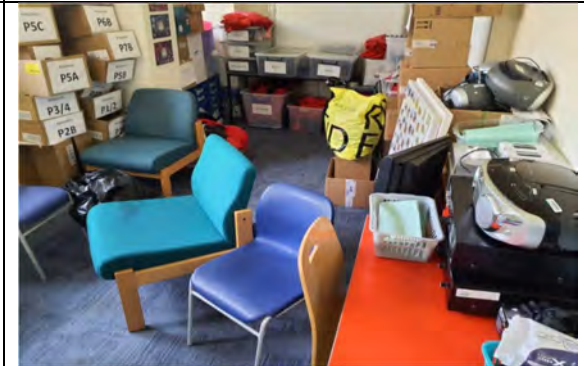
7.12

S0001	12	Learning Support B01/FG/R012	Ground	Below visible floor coverings on concrete floor slab	Black coloured asbestos containing floor adhesive	Bitumen	Chrysotile	17.30 SQM	10/07/23 by HSL Ltd	C	Negligible exposure risk for normal use of the area	Inspect again before the end July 2024. Report any damage to ELC Call Centre	Any future planned removal will be NL asbestos works	Arrange inspection before end July 2024 05/02/24 - GF

Photo 12: Concealed bitumen-based flooring adhesive (Chrysotile): Sample No: S001: Room No: B01/FG/R012: Learning Support

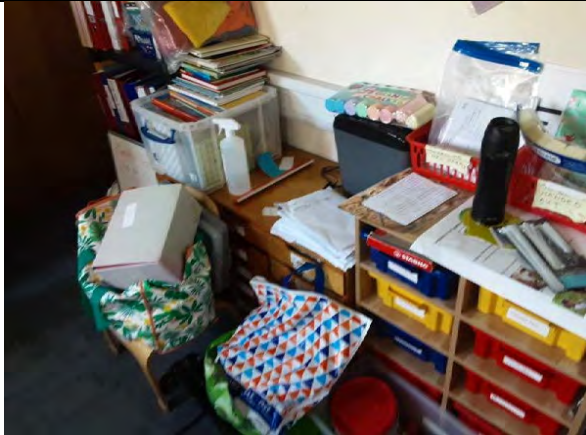
7.13

Photo 13: Concealed bitumen-based flooring adhesive (Chrysotile): Sample No: S001: Room No: B01/FG/R018: Deputy Head Teachers Office

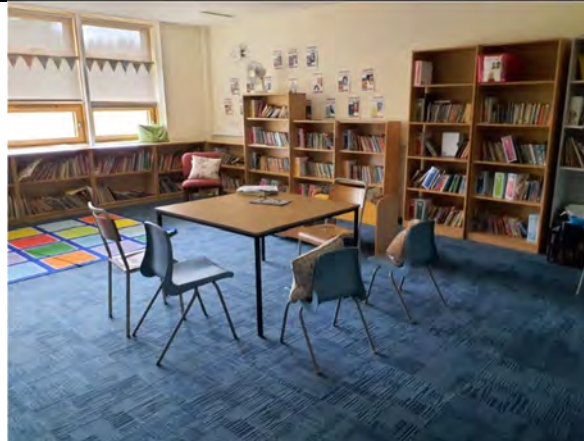
7.14

Photo 14: Concealed bitumen-based flooring adhesive (Chrysotile): Sample No: S010: Room No: B01/FG/R025: Library

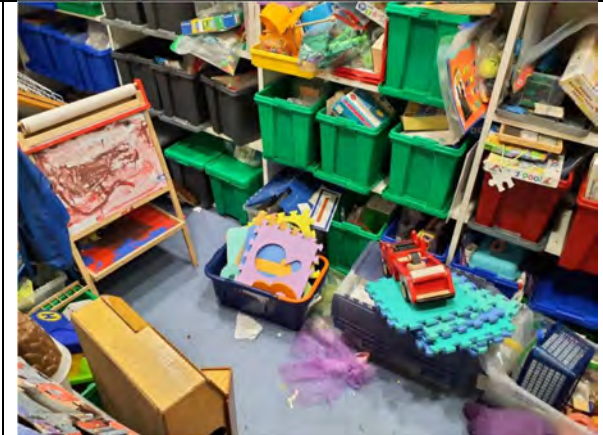
7.15

S0068	15	Storage B01/FG/R029	Ground	Below visible floor coverings on concrete floor slab	Black coloured asbestos containing floor adhesive	Bitumen	Chrysotile	10.00 SQM	10/07/23 by HSL Ltd	C	Negligible exposure risk for normal use of the area.	Inspect again before the end July 2024. Report any damage to ELC Call Centre	Any future planned removal will be NL asbestos works.	Arrange inspection before end July 2024 05/02/24 - GF
S0068	16	Girls Toilets B01/FG/R030	Ground	Below visible floor coverings on concrete floor slab	Black coloured asbestos containing floor adhesive	Bitumen	Chrysotile	11.90 SQM	10/07/23 by HSL Ltd	C	Negligible exposure risk for normal use of the area.	Inspect again before the end July 2024. Report any damage to ELC Call Centre	Any future planned removal will be NL asbestos works.	Arrange inspection before end July 2024 05/02/24 - GF
S0068	17	Boys Toilets B01/FG/R031	Ground	Below visible floor coverings on concrete floor slab	Black coloured asbestos containing floor adhesive	Bitumen	Chrysotile	9.70 SQM	10/07/23 by HSL Ltd	C	Negligible exposure risk for normal use of the area.	Inspect again before the end July 2024. Report any damage to ELC Call Centre	Any future planned removal will be NL asbestos works.	Arrange inspection before end July 2024 05/02/24 - GF

Photo 15: Concealed bitumen-based flooring adhesive (Chrysotile): Sample No: S0068: Room No: B01/FG/R029: Storage

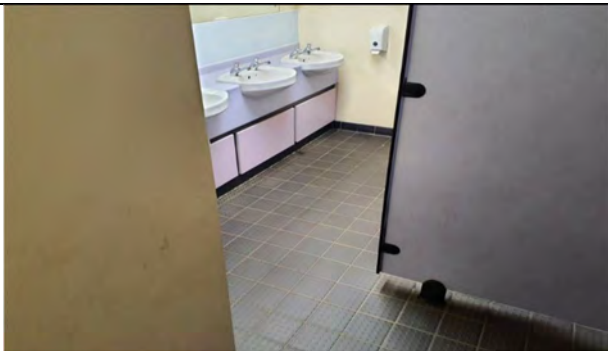
7.16

Photo 16: Concealed bitumen-based flooring adhesive (Chrysotile): Sample No: S0068: Room No: B01/FG/R030: Girls Toilets

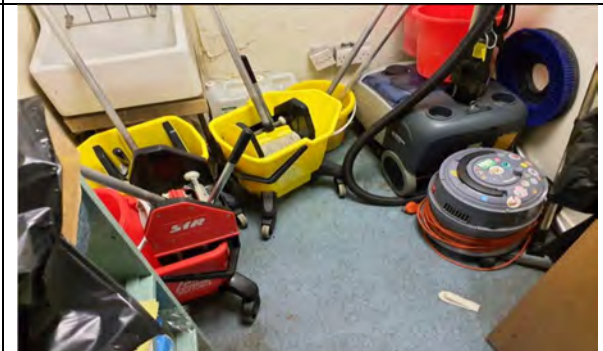
7.18

S0068	18	Cleaners Cupboard B01/FG/R032	Ground	Below visible floor coverings on concrete floor slab	Black coloured asbestos containing floor adhesive	Bitumen	Chrysotile	2.70 SQM	10/07/23 by HSL Ltd	C	Negligible exposure risk for normal use of the area.	Inspect again before the end July 2024. Report any damage to ELC Call Centre	Any future planned removal will be NL asbestos works.	Arrange inspection before end July 2024 05/02/24 - GF

Photo 18: Concealed bitumen-based flooring adhesive (Chrysotile): Sample No: S0068: Room No: B01/FG/R032: Cleaners Cupboard

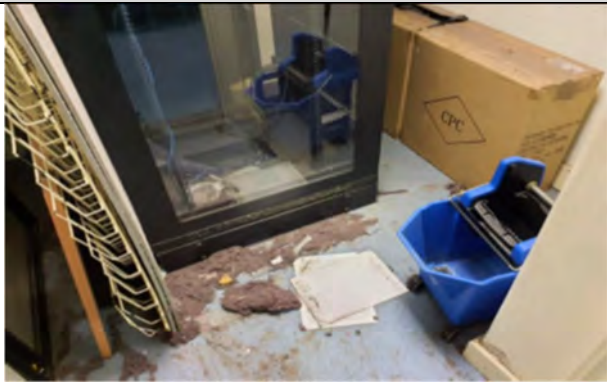
<p>7.19</p>

<p>Photo 19: Concealed bitumen-based flooring adhesive (Chrysotile): Sample No: S0068: Room No: B01/FG/R033: IT Hub</p>	<p>7.20</p>

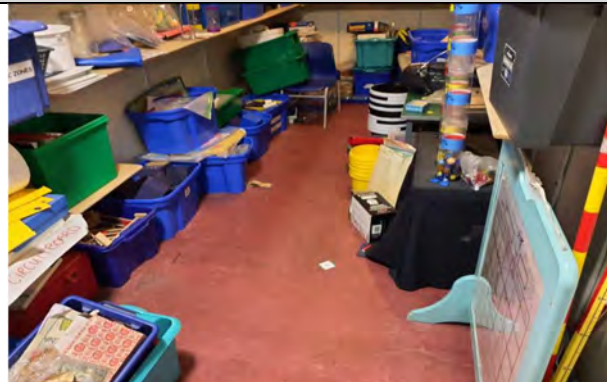
<p>Photo 20: Concealed bitumen-based flooring adhesive (Chrysotile): Sample No: S0068: Room No: B01/FG/R034: Storage</p>	<p>7.21</p>

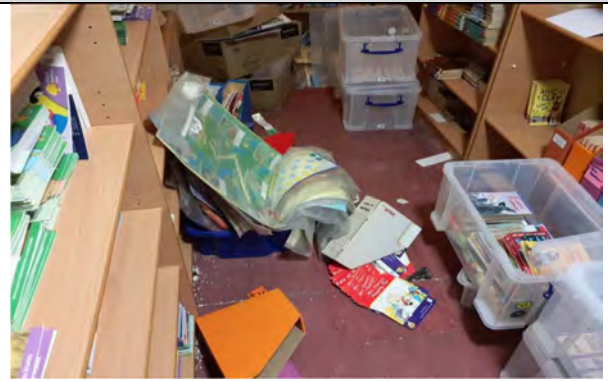
S0068	21	Storage B01/FG/R039	Ground	Below visible floor coverings on concrete floor slab	Black coloured asbestos containing floor adhesive	Bitumen	Chrysotile	8.10 SQM	10/07/23 by HSL Ltd	C	Negligible exposure risk for normal use of the area	Inspect again before the end July 2024. Report any damage to ELC Call Centre	Any future planned removal will be NL asbestos works.	Arrange inspection before end July 2024 05/02/24 - GF
S0131	22	Storage B01/FG/R039	Ground	Wall 3	Black coloured asbestos containing skirting board	Thermo-Plastic	Chrysotile	5.00 L/M	10/07/23 by HSL Ltd	C	Negligible exposure risk for normal use of the area	Inspect again before the end July 2024. Report any damage to ELC Call Centre	Any future planned removal will be NL asbestos works.	Arrange inspection before end July 2024 05/02/24 - GF
S0068	23	Girls Toilets B01/FG/R040	Ground	Below visible floor coverings on concrete floor slab	Black coloured asbestos containing floor adhesive	Bitumen	Chrysotile	40.10 SQM	10/07/23 by HSL Ltd	C	Negligible exposure risk for normal use of the area	Inspect again before the end July 2024. Report any damage to ELC Call Centre	Any future planned removal will be NL asbestos works.	Arrange inspection before end July 2024 05/02/24 - GF

<p>Photo 21: Concealed bitumen-based flooring adhesive (Chrysotile): Sample No: S0068: Room No: B01/FG/R039: Storage</p>
<p>7.22</p>

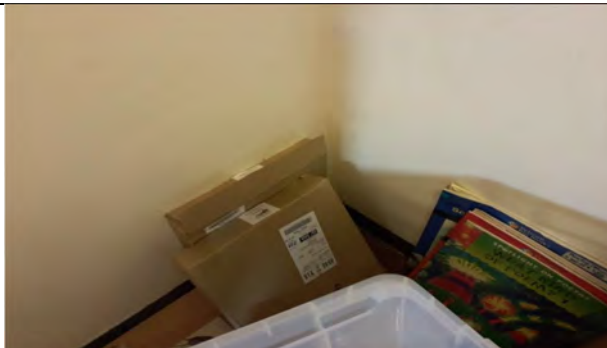
<p>Photo 22: Black coloured asbestos containing thermoplastic skirting board to Wall 3 (Chrysotile): Sample No: S0131: Room No: B01/FG/R039: Storage</p>	<p>7.23</p>

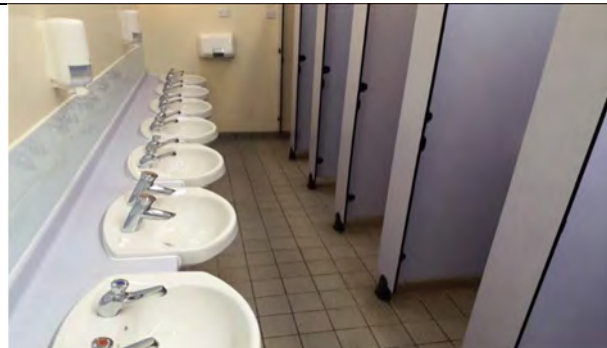
<p>Photo 23: Concealed bitumen-based flooring adhesive (Chrysotile): Sample No: S0068: Room No: B01/FG/R040: Girls Toilets</p>	<p>7.24</p>

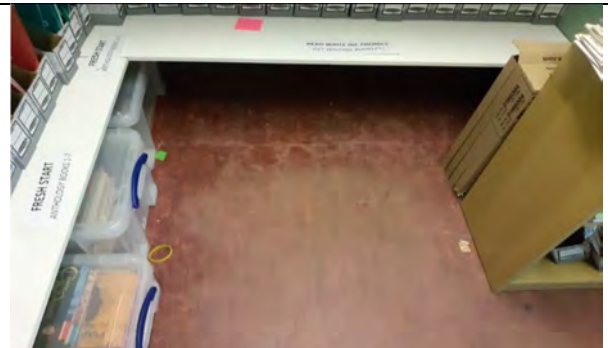
S0068	24	Storage B01/FG/R041	Ground	Below visible floor coverings on concrete floor slab	Black coloured asbestos containing floor adhesive	Bitumen	Chrysotile	7.20 SQM	10/07/23 by HSL Ltd	C	Negligible exposure risk for normal use of the area	Inspect again before the end July 2024. Report any damage to ELC Call Centre	Any future planned removal will be NL asbestos works.	Arrange inspection before end July 2024 05/02/24 - GF

<p>Photo 24: Concealed bitumen-based flooring adhesive (Chrysotile): Sample No: S0068: Room No: B01/FG/R041: Storage</p>

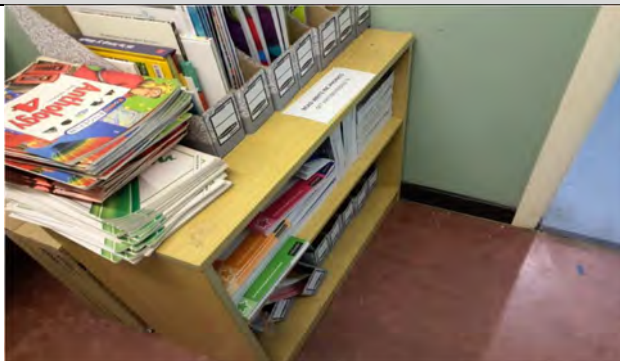
<p>7.25</p>

<p>Photo 25: Black coloured asbestos containing thermoplastic skirting board to Walls 2 & 3 (Chrysotile): Sample No: S0131: Room No: B01/FG/R041: Storage</p>	<p>7.26</p>

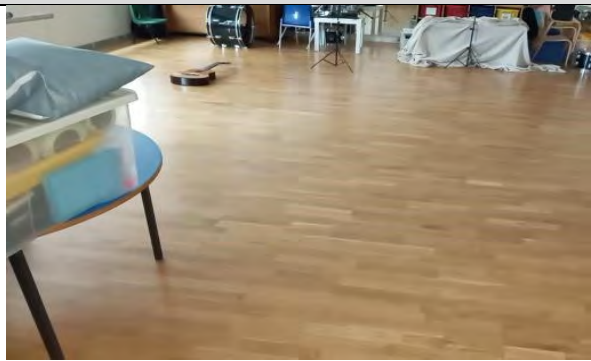
<p>Photo 26: Concealed bitumen-based flooring adhesive (Chrysotile): Sample No: S0068: Room No: B01/FG/R042: Movement & Dance</p>	<p>7.27</p>

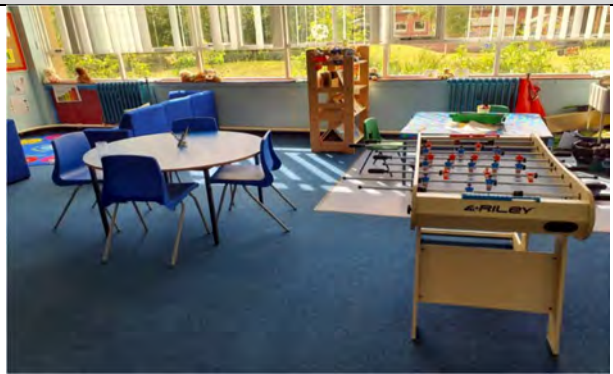
S0068	27	Classroom B01/FG/R044	Ground	Below visible floor coverings on concrete floor slab	Black coloured asbestos containing floor adhesive	Bitumen	Chrysotile	50.80 SQM	10/07/23 by HSL Ltd	C	Negligible exposure risk for normal use of the area	Inspect again before the end July 2024. Report any damage to ELC Call Centre	Any future planned removal will be NL asbestos works.	Arrange inspection before end July 2024 05/02/24 - GF
S0068	28	Classroom B01/FG/R045	Ground	Below visible floor coverings on concrete floor slab	Black coloured asbestos containing floor adhesive	Bitumen	Chrysotile	50.70 SQM	10/07/23 by HSL Ltd	C	Negligible exposure risk for normal use of the area	Inspect again before the end July 2024. Report any damage to ELC Call Centre	Any future planned removal will be NL asbestos works.	Arrange inspection before end July 2024 05/02/24 - GF
S0068	29	Classroom B01/FG/R046	Ground	Below visible floor coverings on concrete floor slab	Black coloured asbestos containing floor adhesive	Bitumen	Chrysotile	51.20 SQM	10/07/23 by HSL Ltd	C	Negligible exposure risk for normal use of the area	Inspect again before the end July 2024. Report any damage to ELC Call Centre	Any future planned removal will be NL asbestos works.	Arrange inspection before end July 2024 05/02/24 - GF

<p>Photo 27: Concealed bitumen-based flooring adhesive (Chrysotile): Sample No: S0068: Room No: B01/FG/R044: Classroom</p>
<p>7.28</p>

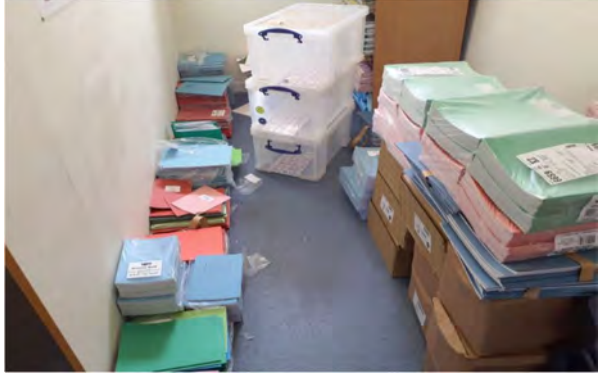
<p>7.31</p>

<p>Photo 31: Concealed bitumen-based flooring adhesive (Chrysotile): Sample No: S0136: Room No: B01/FG/R058: Storage</p>	<p>7.32</p>

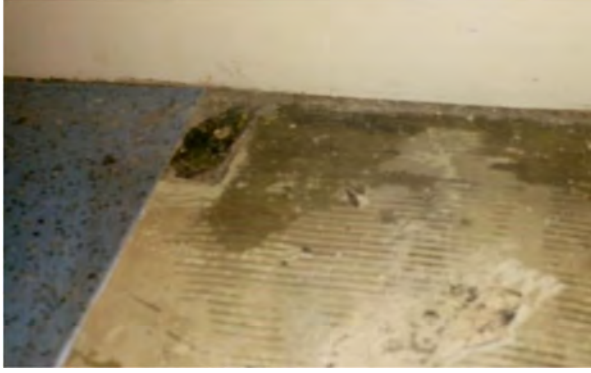
<p>Photo 32: Concealed bitumen-based flooring adhesive (Chrysotile): Sample No: S0135: Room No: B01/FG/R059: Janitors Office</p>	<p>7.33</p>

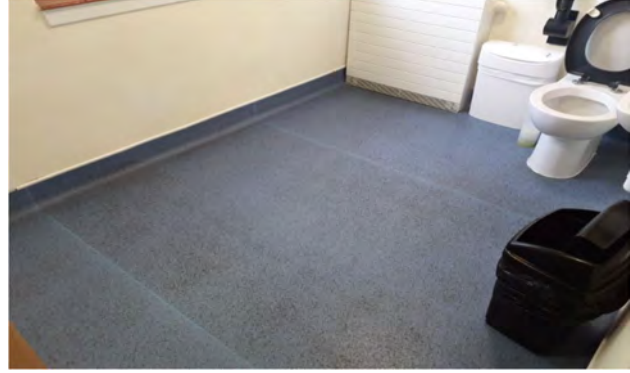
S0049	33	Toilet B01/FG/R060	Ground	Below visible floor coverings and screed to concrete floor slab	Black coloured asbestos containing floor adhesive	Bitumen	Chrysotile	6.50 SQM	10/07/23 by HSL Ltd	C	Negligible exposure risk for normal use of the area	Inspect again before the end July 2024. Report any damage to ELC Call Centre	Any future planned removal will be NL asbestos works.	Arrange inspection before end July 2024 05/02/24 - GF
S0049	34	Toilet B01/FG/R061	Ground	Below visible floor coverings and screed to concrete floor slab	Black coloured asbestos containing floor adhesive	Bitumen	Chrysotile	6.50 SQM	10/07/23 by HSL Ltd	C	Negligible exposure risk for normal use of the area	Inspect again before the end July 2024. Report any damage to ELC Call Centre	Any future planned removal will be NL asbestos works.	Arrange inspection before end July 2024 05/02/24 - GF
S0049	35	Toilet B01/FG/R062	Ground	Below visible floor coverings and screed to concrete floor slab	Black coloured asbestos containing floor adhesive	Bitumen	Chrysotile	6.50 SQM	10/07/23 by HSL Ltd	C	Negligible exposure risk for normal use of the area	Inspect again before the end July 2024. Report any damage to ELC Call Centre	Any future planned removal will be NL asbestos works.	Arrange inspection before end July 2024 05/02/24 - GF

<p>Photo 33: Concealed bitumen-based flooring adhesive (Chrysotile): Sample No: S0049: Room No: B01/FG/R060: Toilet</p>
<p>7.34</p>

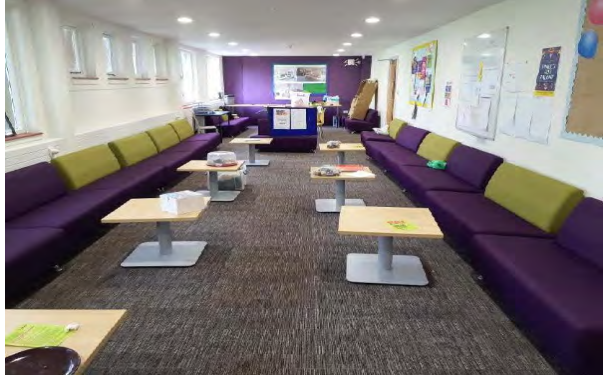
<p>7.37</p>

<p>Photo 37: Concealed bitumen-based flooring adhesive below the carpet (Chrysotile): Sample No: S138: Room No: B01/FG/R063: Staff Base</p>	<p>7.38</p>

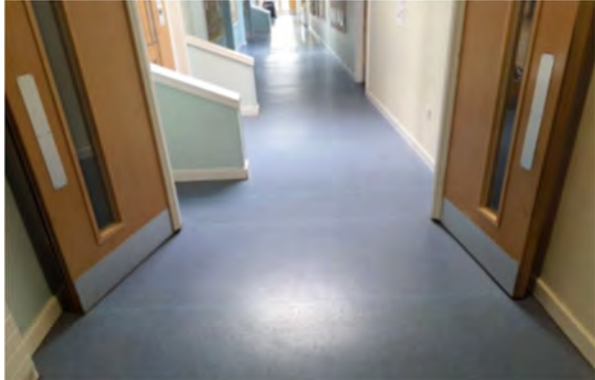
<p>Photo 38: Concealed bitumen-based flooring adhesive (Chrysotile): Sample No: S0049: Room No: B01/FG/R064: Circulation Area</p>	<p>7.39</p>

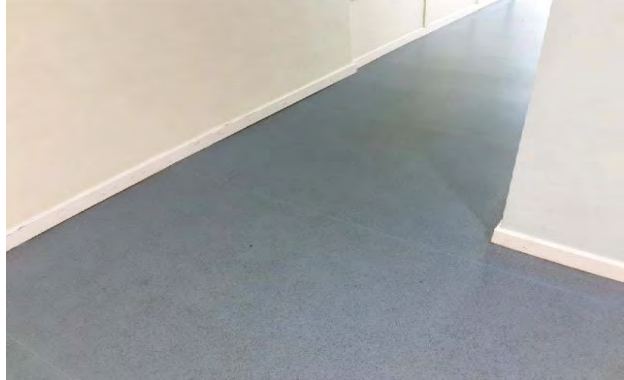
S0049	39	Circulation Area B01/FG/R064 A	Ground	Below visible floor coverings and screed to concrete floor slab	Black coloured asbestos containing floor adhesive	Bitumen	Chrysotile	60.00 SQM	10/07/23 by HSL Ltd	C	Negligible exposure risk for normal use of the area	Inspect again before the end July 2024. Report any damage to ELC Call Centre	Any future planned removal will be NL asbestos works.	Arrange inspection before end July 2024 05/02/24 - GF
S0049	40	Circulation Area B01/FG/R065	Ground	Below visible floor coverings and screed to concrete floor slab	Black coloured asbestos containing floor adhesive	Bitumen	Chrysotile	40.00 SQM	10/07/23 by HSL Ltd	C	Negligible exposure risk for normal use of the area	Inspect again before the end July 2024. Report any damage to ELC Call Centre	Any future planned removal will be NL asbestos works.	Arrange inspection before end July 2024 05/02/24 - GF
S0049	41	Circulation Area B01/FG/R065 A	Ground	Below visible floor coverings and screed to concrete floor slab	Black coloured asbestos containing floor adhesive	Bitumen	Chrysotile	56.80 SQM	10/07/23 by HSL Ltd	C	Negligible exposure risk for normal use of the area	Inspect again before the end July 2024. Report any damage to ELC Call Centre	Any future planned removal will be NL asbestos works.	Arrange inspection before end July 2024 05/02/24 - GF

<p>Photo 39: Concealed bitumen-based flooring adhesive (Chrysotile): Sample No: S0049: Room No: B01/FG/R064A: Circulation Area</p>
<p>7.40</p>

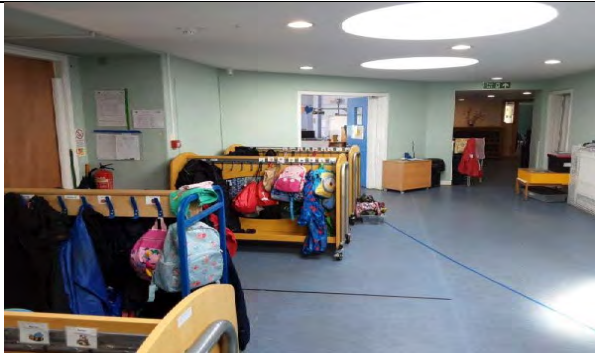
<p>Photo 41: Concealed bitumen-based flooring adhesive (Chrysotile): Sample No: S0049: Room No: B01/FG/R065A: Circulation Area</p>	<p>7.42</p>

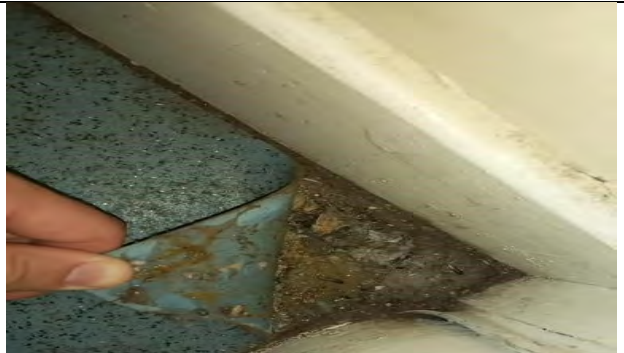
S0068	42	Circulation Area B01/FG/R066 B	Ground	Below visible floor coverings and screed to concrete floor slab	Black coloured asbestos containing floor adhesive	Bitumen	Chrysotile	26.10 SQM	10/07/23 by HSL Ltd	C	Negligible exposure risk for normal use of the area	Inspect again before the end July 2024. Report any damage to ELC Call Centre	Any future planned removal will be NL asbestos works.	Arrange inspection before end July 2024 05/02/24 - GF

<p>Photo 42: Concealed bitumen-based flooring adhesive (Chrysotile): Sample No: S0068: Room No: B01/FG/R066B: Circulation Area</p>

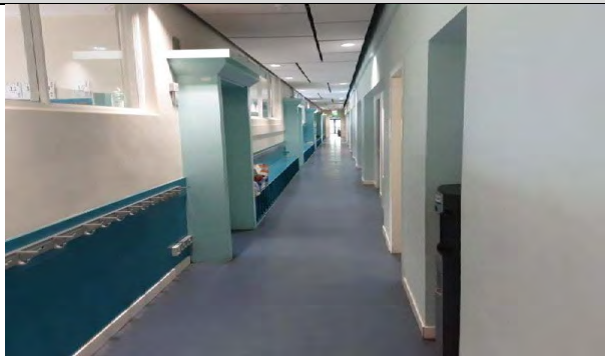
<p>7.43</p>

<p>Photo 43: Concealed bitumen-based flooring adhesive (Chrysotile): Sample No: S0068: Room No: B01/FG/R067: Circulation Area</p>	<p>7.44</p>

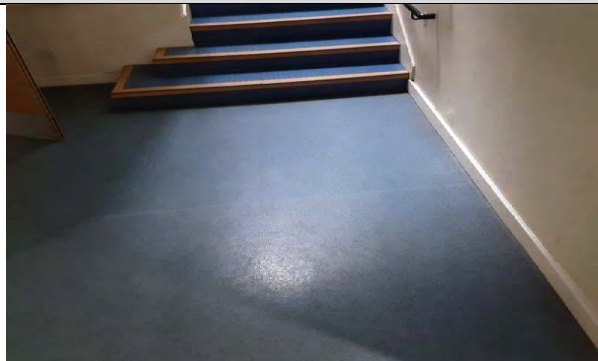
<p>Photo 43: Concealed bitumen-based flooring adhesive (Chrysotile): Sample No: S0068: Room No: B01/FG/R068: Circulation Area</p>	<p>7.45</p>

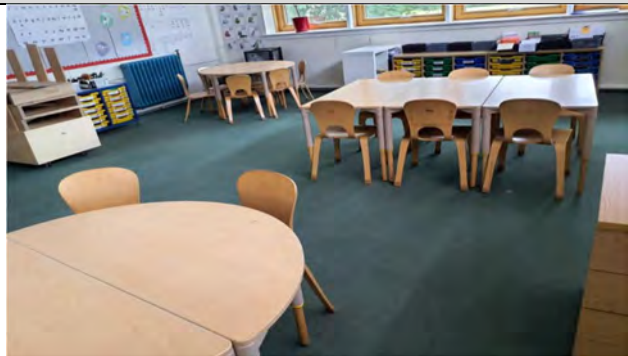
<p>Photo 45: Concealed bitumen-based flooring adhesive (Chrysotile): Sample No: S003: Room No: B01/F1/R005: Classroom</p>
<p>7.46</p>

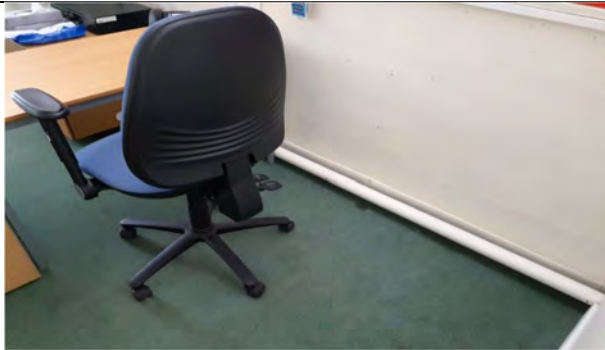
<p>Photo 46: Asbestos containing vinyl skirting boards (Chrysotile): Sample No S0078: Room No: B01/F1/R005: Classroom</p>	<p>7.47</p>

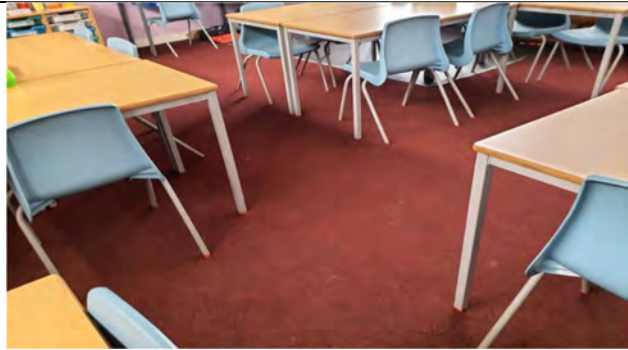
<p>Photo 48: Concealed bitumen-based flooring adhesive (Chrysotile): Sample No: S003: Room No: B01/F1/R011: Classroom</p>

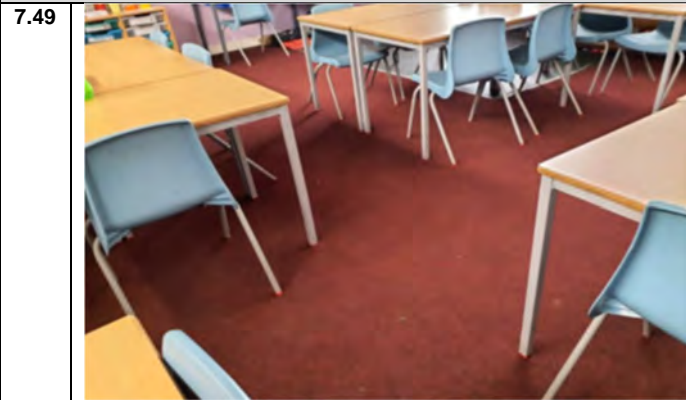
7.49

Photo 49: Concealed red coloured vinyl floor tiles (Chrysotile): Sample No: S0079: Room No: B01/F1/R011: Classroom

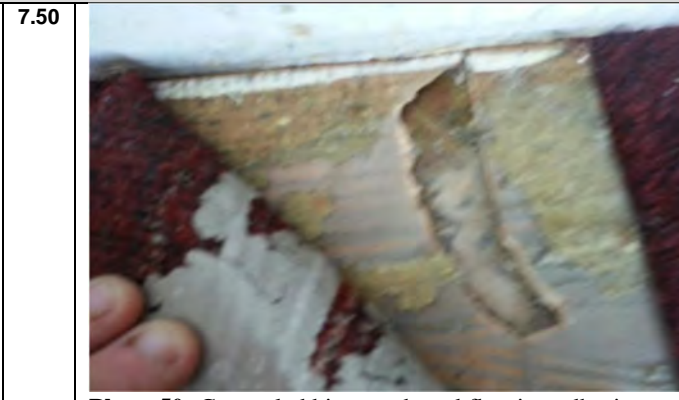
7.50

Photo 50: Concealed bitumen-based flooring adhesive (Chrysotile): Sample No: S003: Room No: B01/F1/R012: Classroom

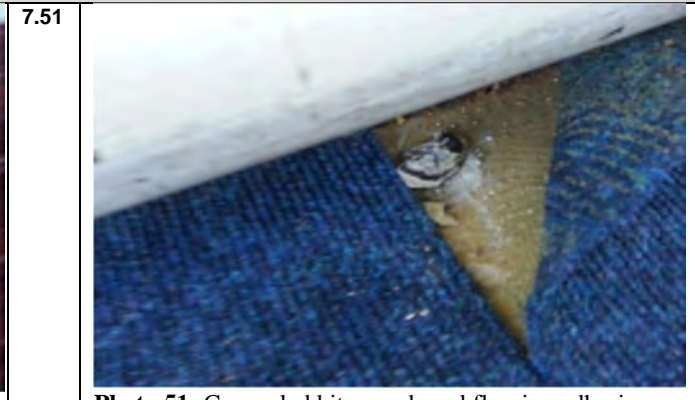
7.51

Photo 51: Concealed bitumen-based flooring adhesive (Chrysotile): Sample No: S004: Room No: B01/F1/R013: Classroom

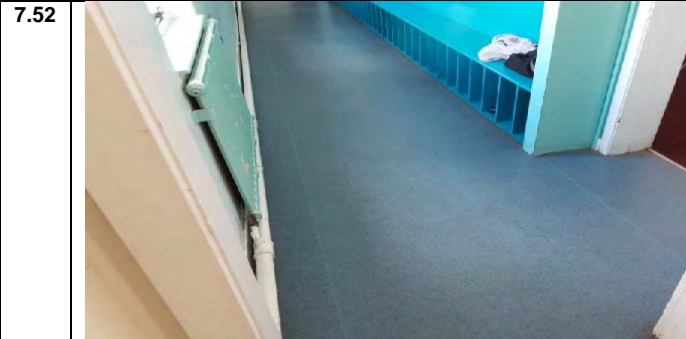
7.52

Photo 52: Concealed red coloured vinyl floor tiles remnants below shoe boxes (Chrysotile): Sample No: S007: Room No: B01/F1/R022: Circulation Areas

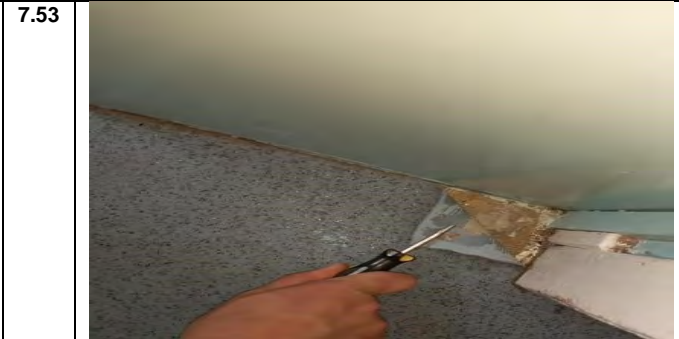
7.53

Photo 53: Concealed bitumen-based flooring adhesive (Chrysotile): Sample No: S008: Room No: B01/F1/R022: Circulation Area

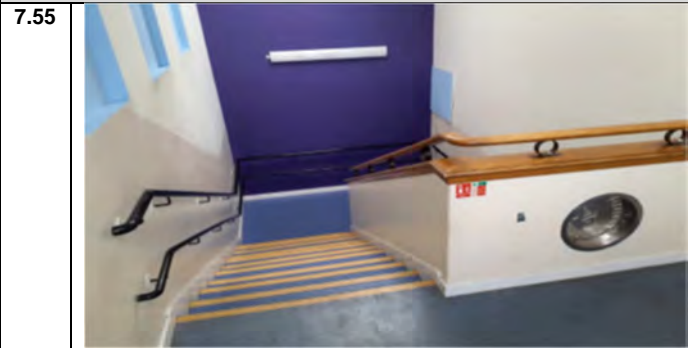
Photo 55: Concealed asbestos containing floor tile adhesive (Chrysotile): Sample No: S008: Room No: B01/FG/R022A: Circulation Area / Staircase Mid Landing

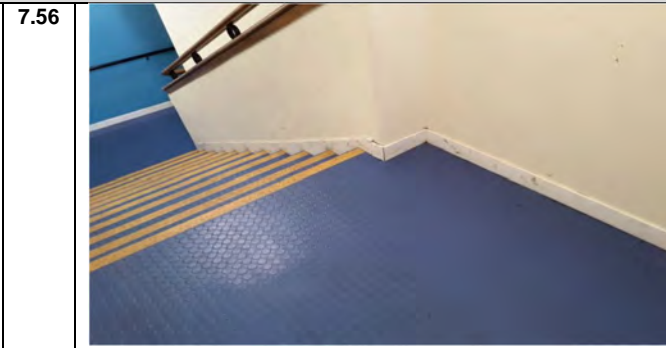
Photo 56: Concealed red coloured asbestos floor tiles (Chrysotile): Sample No: S007: Room No: B01/F1/R022B: Circulation Area / Staircase Mid & Top Landings

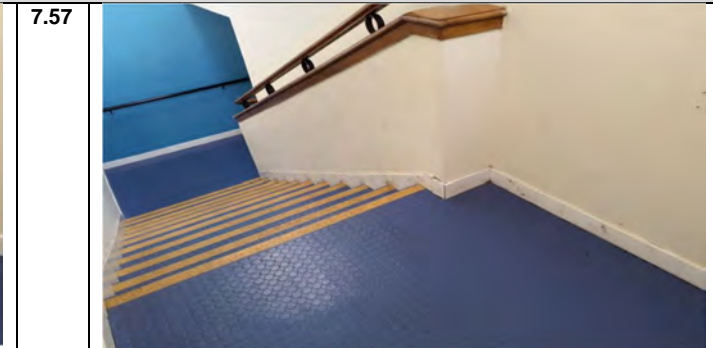
Photo 57: Concealed asbestos containing floor tile adhesive (Chrysotile): Sample No: S008: Room No: B01/F1/R022B: Circulation Area / Staircase Mid Landing

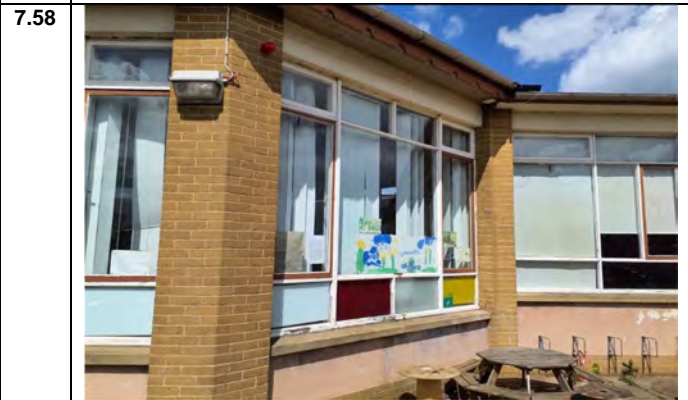
Photo 58: Asbestos containing mastic to windows frame sides (Chrysotile): Sample No: JP000701: External Elevation No: EXT001

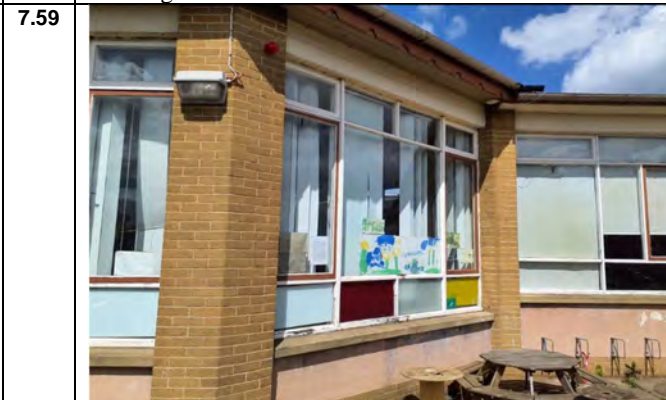
Photo 59: Asbestos containing mastic to windows frame sides (Chrysotile): Sample No: JP000702: External Elevation No: EXT001

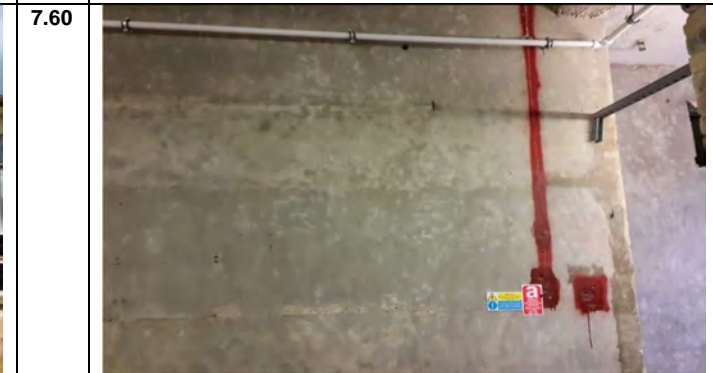
Photo 60: Sealed asbestos thermal insulation debris to Wall 9 (Amosite & Chrysotile): Sample No: IOM30A: Room No: B01/FB/R001: Former Boiler House

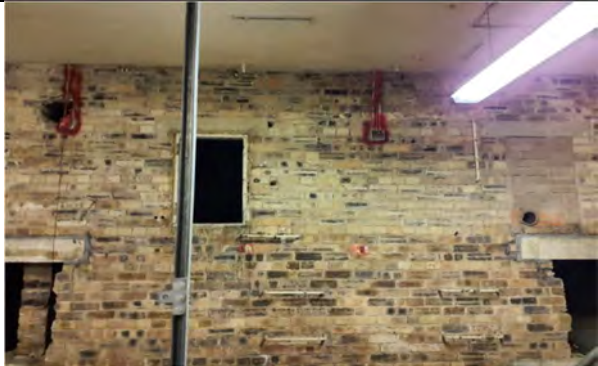
<p>7.61</p>

<p>Photo 61: Sealed asbestos thermal insulation debris to Wall 3 (Amostie & Chrysotile): Sample No: IOM30B: Room No: B01/FB/R001: Former Boiler House</p>	<p>7.62</p>

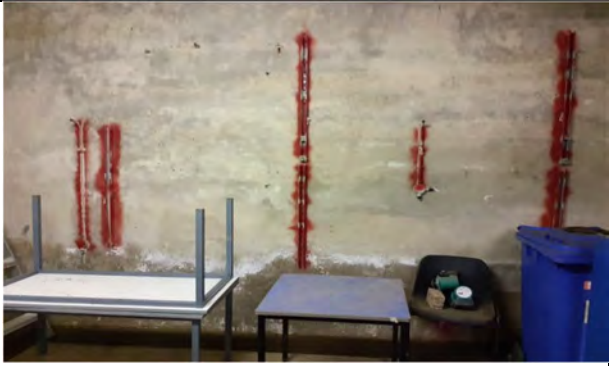
<p>Photo 62: Sealed asbestos thermal insulation debris to Wall 4 (Amostie & Chrysotile): Sample No: IOM30C: Room No: B01/FB/R001: Former Boiler House</p>	<p>7.63</p>

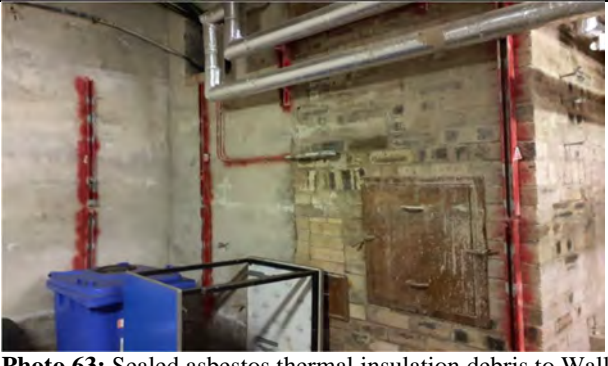
<p>Photo 63: Sealed asbestos thermal insulation debris to Wall 5 (Amostie & Chrysotile): Sample No: IOM30D: Room No: B01/FB/R001: Former Boiler House</p>
<p>7.64</p>

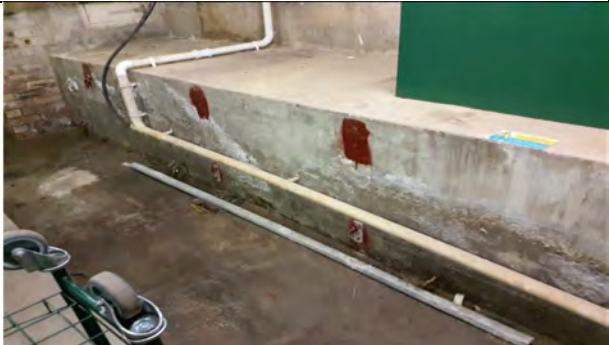
<p>Photo 65: Sealed asbestos thermal insulation debris to Wall 6 at low-level (Amostie & Chrysotile): Sample No: IOM30F: Room No: B01/FB/R001: Former Boiler House</p>	<p>7.66</p>

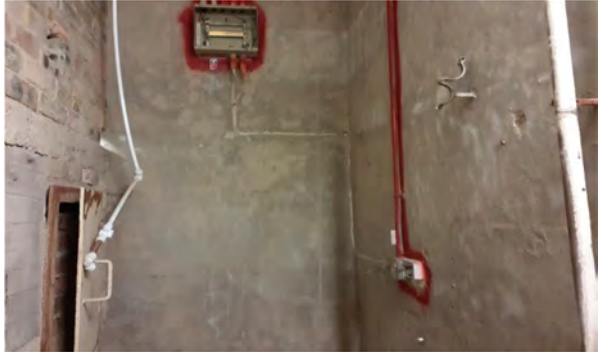
<p>7.67</p>

<p>Photo 67: Sealed asbestos thermal insulation debris to Wall 8 (Amostie & Chrysotile): Sample No: IOM30H: Room No: B01/FB/R001: Former Boiler House</p>	<p>7.68</p>

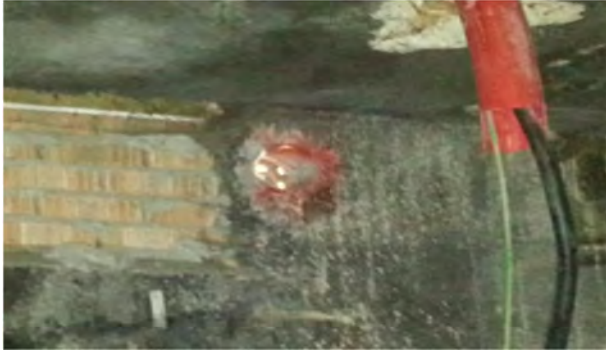
<p>Photo 68: Sealed asbestos cement pipes x 2 No (Crocidolite): Sample No: S0001: Room No: B01/FB/R003: Former Fuel Store</p>	<p>7.69</p>

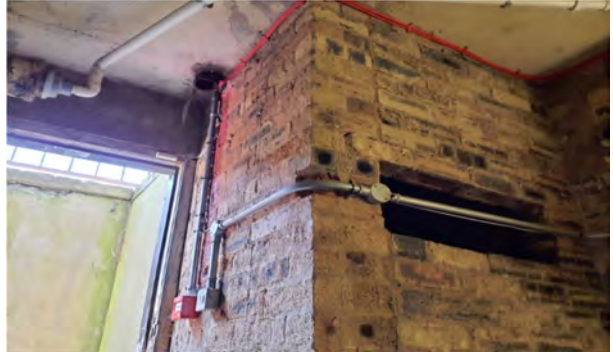
<p>Photo 69: Sealed asbestos thermal insulation debris to Wall 1 (Amostie & Chrysotile): Sample No: IOM30I: Room No: B01/FB/R001: Former Boiler House</p>
<p>7.70</p>

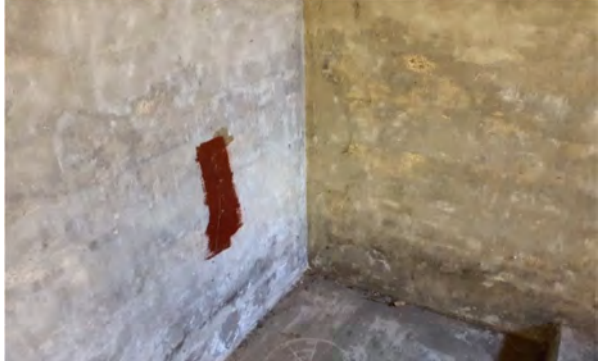
<p>Photo 70: Sealed asbestos thermal insulation debris to Wall 2 (Amostie & Chrysotile): Sample No: IOM30J: Room No: B01/FB/R001: Former Boiler House</p>	<p>7.71</p>

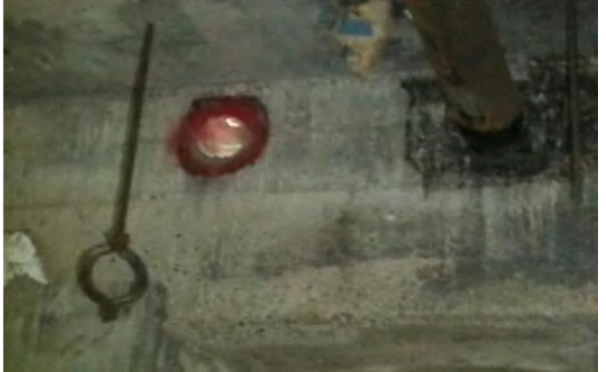
<p>Photo 71: Sealed asbestos cement pipe x 1 No (Crocidolite): Sample No: S0001: Room No: B01/FB/R005: Former Fuel Store</p>
