Asbestos Re-inspection Report Up-date

Pinkie St Peters Primary School, 44 Pinkie Road, Musselburgh, East Lothian, EH21 7HA

Contact:	Grant Fraser	Issue Number:	2
Customer:	East Lothian Council	Survey Dates:	10 July 2023
Project No:	G24-00142	Report Issue Date:	08 February 2024

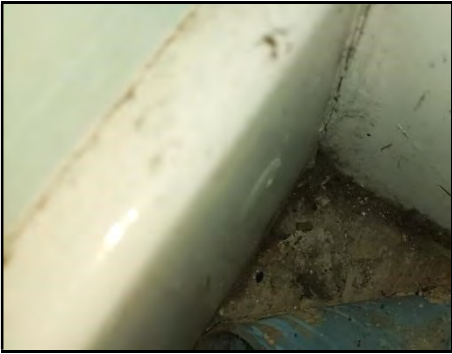
Building ID	Pinkie St Peters Primary School	Item Description	Bitumen adhesive to floor below modern screed
Sample No.	VSSG13-01632 - 0049	Material	Bituminous Products
Floor	Ground Floor	Asbestos Type	Chrysotile
Room No.	R001A	Extent	46m2
Room ID	Circulation Area	Notes: Ceiling void / Above suspended ceiling - Concrete roof, Brick and Plasterboard walls, MMMF tiles in metal grid, Metal cable trays. Other - Timber doors and surrounds, Timber skirtings, Timber window frames, Metal radiators. Condition of ACM remains the same 11.07.2023

HSG 264 Material Assessment Scores				Priority Assessment Scores				Risk Priority Rating:
Product:	1	Condition:	0	Occupant Activity:	1	Likelihood of Disturbance:	2	3
Surface Treatment:	0	Asbestos Type:	1	Potential of Human Exposure:	2	Maintenance Activity:	1	
Material Score:	2	Material Category:	D	Priority Score:	6	Total Score (Overall):	8

Surveyor:	Reece Feenie
		Recommendation:	Manage and Monitor through annual re-inspection

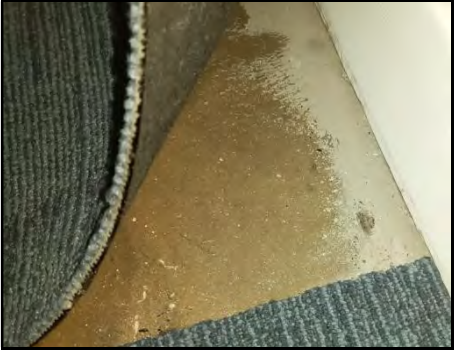
Building ID	Pinkie St Peters Primary School	Item Description	Bitumen adhesive to floor below modern screed
Sample No.	PSG13-01632 - 0049	Material	Bituminous Products
Floor	Ground Floor	Asbestos Type	Chrysotile
Room No.	R003	Extent	22m2
Room ID	Head Teacher	Notes: Ceiling void / Above suspended ceiling - Plasterboard ceiling with foam insulation above, Brick and Plasterboard walls, MMMF tiles in metal grid, MMMF insulated metal pipes, Metal cable trays, Timber window frames. Walls - Plasterboard and timber stud partitions with MMMF insulated cavities. Other - Timber doors and surrounds, Timber skirtings, Timber window frames with Quarry tiles sills, Metal radiator. Boxing's - MMMF insulated metal pipes within timber boxing at radiator on wall 2. Condition of ACM remains the same 11.07.2023

HSG 264 Material Assessment Scores				Priority Assessment Scores				Risk Priority Rating:
Product:	1	Condition:	0	Occupant Activity:	1	Likelihood of Disturbance:	2	3
Surface Treatment:	0	Asbestos Type:	1	Potential of Human Exposure:	3	Maintenance Activity:	1	
Material Score:	2	Material Category:	D	Priority Score:	7	Total Score (Overall):	9

Surveyor:	Reece Feenie
		Recommendation:	Manage and Monitor through annual re-inspection

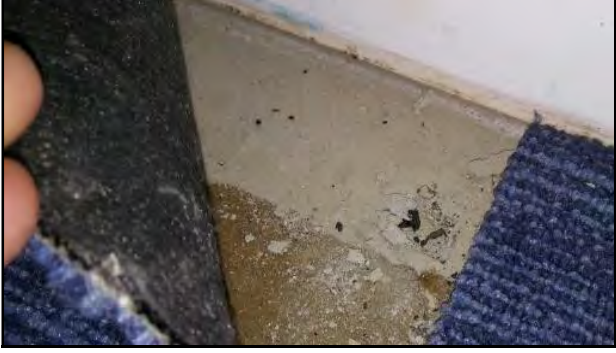
Building ID	Pinkie St Peters Primary School	Item Description	Bitumen adhesive to floor below screed
Sample No.	PSG13-01632 - 0049	Material	Bituminous Products
Floor	Ground Floor	Asbestos Type	Chrysotile
Room No.	R006	Extent	32m2
Room ID	Tutorial Meeting	Notes: Ceiling void / Above suspended ceiling - Plasterboard ceiling with MMMF insulation and concrete above, Brick and Plasterboard walls, MMMF tiles in metal grid, MMMF insulated metal pipes, Metal cable trays, Timber window frames. Other - Timber doors and surrounds, Timber skirtings, Timber window frames with Quarry tiles sills, Metal radiators. Boxing's - MMMF insulated metal pipes within timber boxing at radiators on wall 3. Condition of ACM remains the same 11.07.2023

HSG 264 Material Assessment Scores				Priority Assessment Scores				Risk Priority Rating:
Product:	1	Condition:	0	Occupant Activity:	1	Likelihood of Disturbance:	2	3
Surface Treatment:	0	Asbestos Type:	1	Potential of Human Exposure:	3	Maintenance Activity:	1	
Material Score:	2	Material Category:	D	Priority Score:	7	Total Score (Overall):	9

Surveyor:	Reece Feenie
		Recommendation:	Manage and Monitor through annual re-inspection

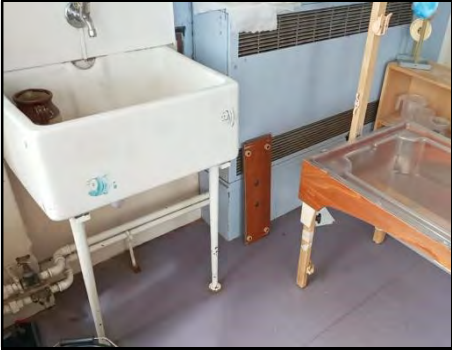
Building ID	Pinkie St Peters Primary School	Item Description	Red vinyl floor tiles below convector heater
Sample No.	PSG13-01632 - 0048	Material	Floor Tiles
Floor	Ground Floor	Asbestos Type	Chrysotile
Room No.	R007	Extent	2lin m
Room ID	Classroom	Notes: Ceiling - Fibreboard ceiling tiles previously sampled and did not contain asbestos. Other - Timber doors and surrounds, Timber skirtings, Timber window frames with Quarry tiles sills, Metal radiators, Un-insulated metal pipes, Ceramic sink, Metal convector heater, Timber ceiling hatch. Condition of ACM remains the same 11.07.2023

Surveyor:	Reece Feenie
		Recommendation:	Manage and Monitor through annual re-inspection

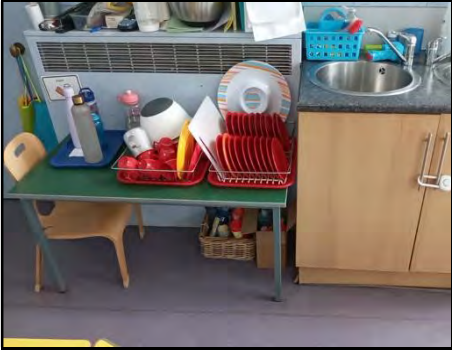
Building ID	Pinkie St Peters Primary School	Item Description	Red vinyl floor tiles below convector heater
Sample No.	PSG13-01632 - 0048	Material	Floor Tiles
Floor	Ground Floor	Asbestos Type	Chrysotile
Room No.	R008	Extent	2lin m
Room ID	Classroom	Notes:	Ceiling - Fibreboard ceiling tiles previously sampled and did not contain asbestos. Other - Timber doors and surrounds, Timber skirtings, Timber window frames with Quarry tiles sills, Metal radiators, Un-insulated metal pipes, Modern metal sinks and heat pads, Metal convector heater, Timber ceiling hatch. Condition of ACM remains the same 11.07.2023

Surveyor:	Reece Feenie
		Recommendation:	Manage and Monitor through annual re-inspection

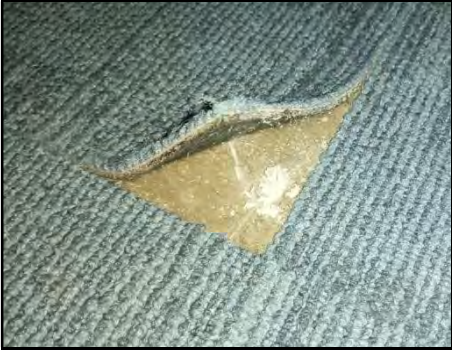
Building ID	Pinkie St Peters Primary School	Item Description	Bitumen adhesive to floor below modern vinyl flooring
Sample No.	VSS001	Material	Bituminous Products
Floor	Ground Floor	Asbestos Type	Chrysotile
Room No.	R012	Extent	16m2
Room ID	Learning Support	Notes: Floor - Carpet on modern vinyl flooring on concrete. Other - Timber door and surrounds, Timber skirtings, Timber window frames, Metal radiator. Condition of ACM remains the same 11.07.2023

Surveyor:	Reece Feenie
		Recommendation:	Manage and Monitor through annual re-inspection

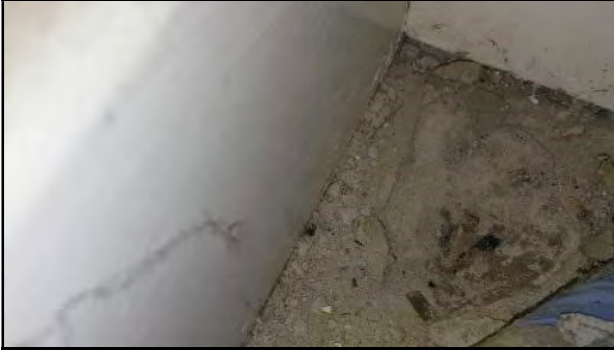
Building ID	Pinkie St Peters Primary School	Item Description	Bitumen adhesive to floor below modern screed
Sample No.	PSG13-01632 - 0068	Material	Bituminous Products
Floor	Ground Floor	Asbestos Type	Chrysotile
Room No.	R029	Extent	10m2
Room ID	General Store	Notes: Ceiling void / Above suspended ceiling - Plasterboard ceiling, Brick & Plaster and Plasterboard walls, MMMF tiles in metal grid, Metal conduits. Other - Timber door and surrounds, Timber skirtings, Un-insulated metal pipe. Condition of ACM remains the same 11.07.2023

Surveyor:	Reece Feenie
		Recommendation:	Manage and Monitor through annual re-inspection

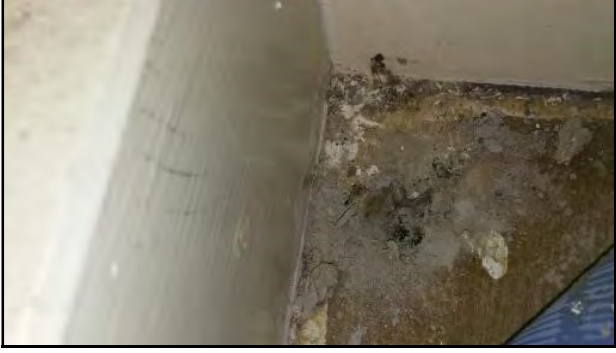
Building ID	Pinkie St Peters Primary School	Item Description	Bitumen adhesive to floor below modern screed
Sample No.	PSG13-01632 - 0068	Material	Bituminous Products
Floor	Ground Floor	Asbestos Type	Chrysotile
Room No.	R032	Extent	5m2
Room ID	Storage	Notes: Ceiling void / Above suspended ceiling - Plasterboard ceiling, Brick & Plaster and Plasterboard walls, MMMF tiles in metal grid, Un-insulated metal pipes, Plastic ducting. Other - Timber door and surrounds, Timber skirtings, Ceramic sink, MMMF insulated copper pipes. Condition of ACM remains the same 11.07.2023

Surveyor:	Reece Feenie
		Recommendation:	Manage and Monitor through annual re-inspection

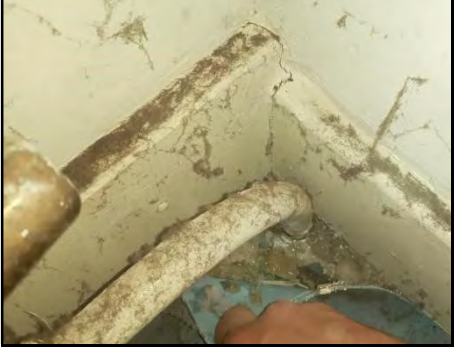
Building ID	Pinkie St Peters Primary School	Item Description	Bitumen adhesive to floor below modern vinyl flooring
Sample No.	PSG13-01632 - 0068	Material	Bituminous Products
Floor	Ground Floor	Asbestos Type	Chrysotile
Room No.	R033	Extent	5m2
Room ID	I.T. Hub	Notes: Ceiling void / Above suspended ceiling - Plasterboard ceiling, Brick & Plaster and Plasterboard walls, MMMF tiles in metal grid, Un-insulated metal pipes, Plastic ducting. Other - Timber door and surrounds, Timber skirtings, Un-insulated metal pipes, Modern metal encased trip switch electrics. Condition of ACM remains the same 11.07.2023

Surveyor:	Reece Feenie
		Recommendation:	Manage and Monitor through annual re-inspection

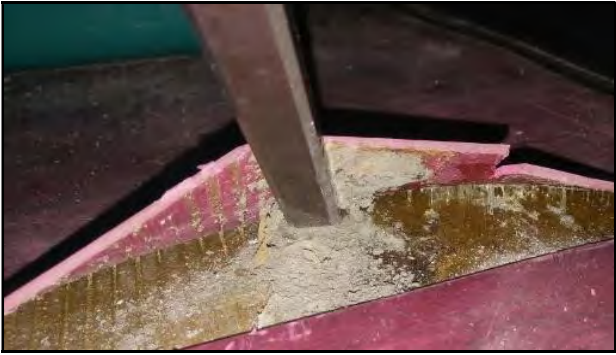
Building ID	Pinkie St Peters Primary School	Item Description	Bitumen adhesive to floor below modern screed
Sample No.	PSG13-01632 - 0068	Material	Bituminous Products
Floor	Ground Floor	Asbestos Type	Chrysotile
Room No.	R034	Extent	14m2
Room ID	Storage	Notes: Other - Timber door and surrounds, Rubber skirtings. Condition of ACM remains the same 11.07.2023

Surveyor:	Reece Feenie
		Recommendation:	Manage and Monitor through annual re-inspection

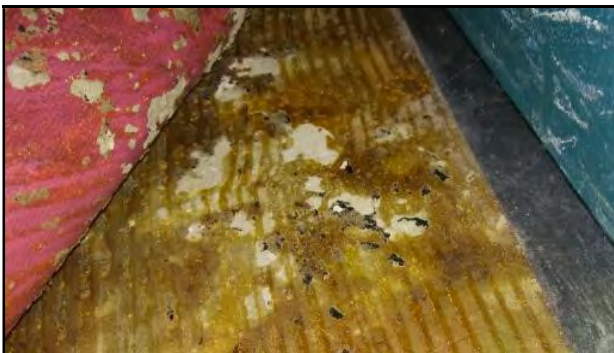
Building ID	Pinkie St Peters Primary School
Sample No.	PSG13-01632 - 0068
Floor	Ground Floor
Room No.	R041
Room ID	Storage

Item Description	Bitumen adhesive to floor below modern vinyl flooring
Material	Bituminous Products
Asbestos Type	Chrysotile
Extent	6m2

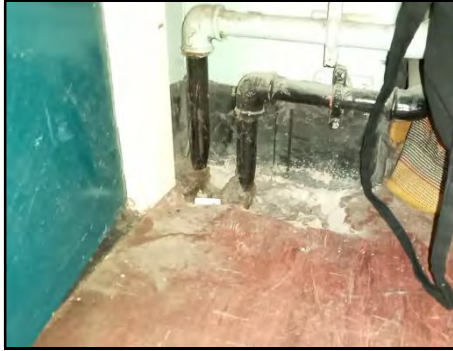
Building ID	Pinkie St Peters Primary School
Sample No.	PSG13-01632 - 0131
Floor	Ground Floor
Room No.	R041
Room ID	Storage

Item Description	Black resin skirtings on walls 2 & 3
Material	Resin Products
Asbestos Type	Chrysotile
Extent	6lin m

Notes:
 Other - Timber door and surrounds, Timber skirtings, Metal radiator, Un-insulated metal pipes.
 Condition of ACM remains the same 11.07.2023

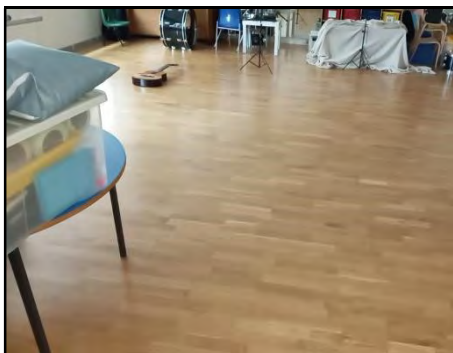
Building ID	Pinkie St Peters Primary School
Sample No.	PSG13-01632 - 0068
Floor	Ground Floor
Room No.	R042
Room ID	Movement and Dance

Item Description	Bitumen adhesive to floor
Material	Bituminous Products
Asbestos Type	Chrysotile
Extent	104m2

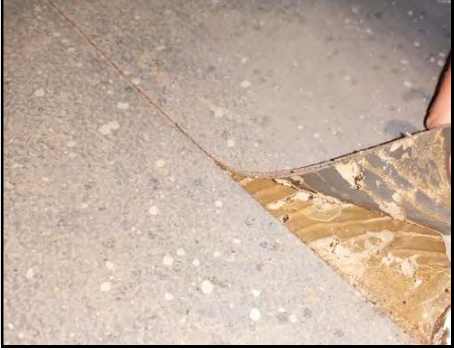
Building ID	Pinkie St Peters Primary School	Item Description	Bitumen adhesive to floor below carpet and modern vinyl flooring
Sample No.	PSG13-01632 - 0068	Material	Bituminous Products
Floor	Ground Floor	Asbestos Type	Chrysotile
Room No.	R044	Extent	48m2
Room ID	Classroom	Notes: Other - Timber doors and surrounds, Rubber skirtings, Timber window frames, Metal radiators, Un-insulated metal pipes, Ceramic sink. Condition of ACM remains the same 10.07.2023

Surveyor:	Reece Feenie
		Recommendation:	Manage and Monitor through annual re-inspection

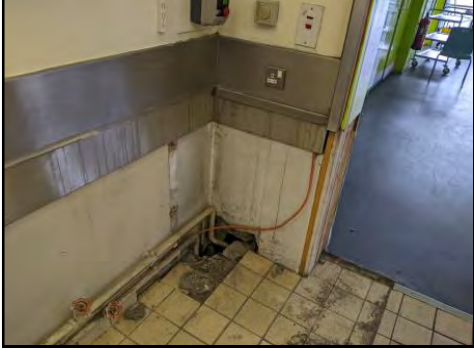
Building ID	Pinkie St Peters Primary School	Item Description	Panel on floor
Sample No.	PS135 - IOM	Material	Insulating Board
Floor	Ground Floor	Asbestos Type	Removed
Room No.	R050	Extent	
Room ID	Kitchen	Notes:	Sampled by customer 18/07/2022

Surveyor:	
		Recommendation:	Removed by Erith 04/08/2022
