Hub South East Scotland

Herdmanflat Landscape Masterplan Ecological Appraisal Report

Project Number 12049

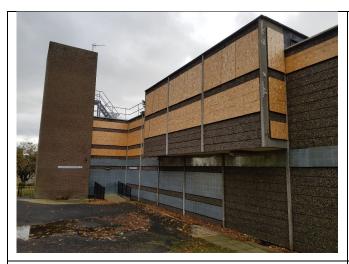
Photograph 11: Garleton Unit (BS 9)

- **4.56** All windows and doors were boarded up with plywood boards. Overall, the condition of the building was good with shallow cracks in the brickwork on the lift tower and a small gap under roof flashing on the eastern corner of the building.
- **4.57** Due to the lack of access no internal inspection was undertaken.
- **4.58** The building was considered to have a low bat roost potential. This building remains present on Site.

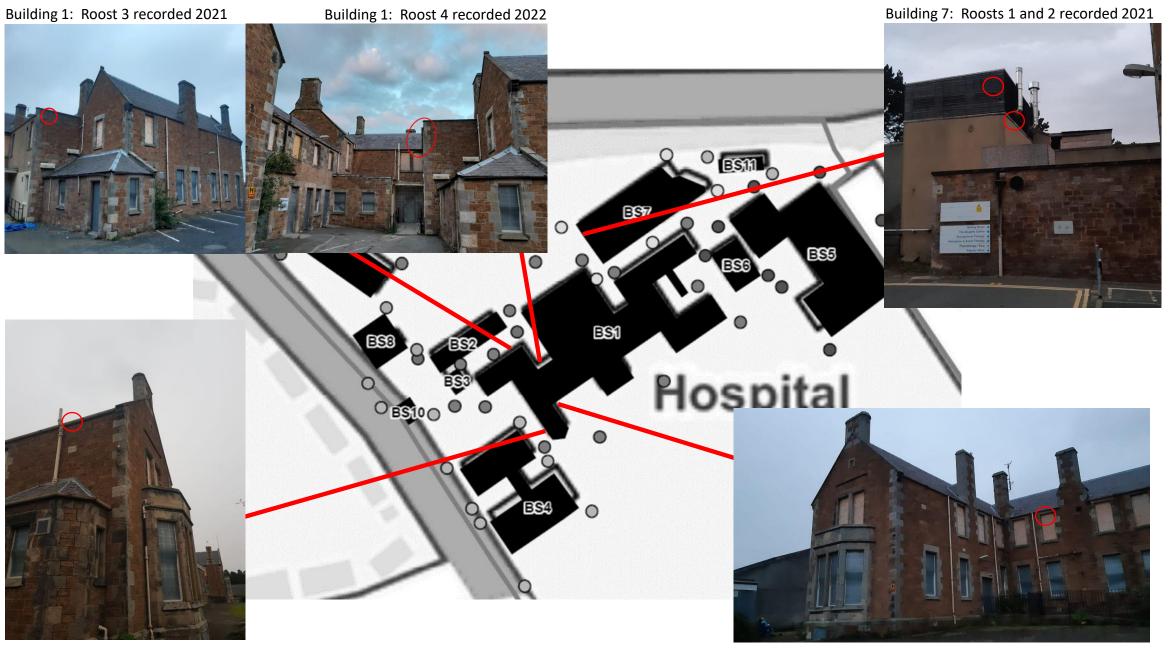
- **4.72** This building was subject to three nocturnal bat surveys in summer 2021. Three non-breeding soprano pipistrelle roosts were identified (**Appendix C**).
- **4.73** The West Wing of the main building was subject to an update nocturnal survey in June 2022. A single soprano pipistrelle bat was observed emerging from the northern aspect of the West Wing from a similar area as Roost 3 (**Appendix C**).

Building 1: Roost 2 recorded in 2021

Building 1: Roost 1 recorded in 2021

- **5.13** As non-breeding pipistrelle roosts had been confirmed, licences were issued by NatureScot to allow works to proceed. Buildings BS 7 and BS 14 were removed in early 2022, and intrusive and destructive works were undertaken to BS 1 and BS 9 in 2022. These works were completed in accordance with the licence conditions.

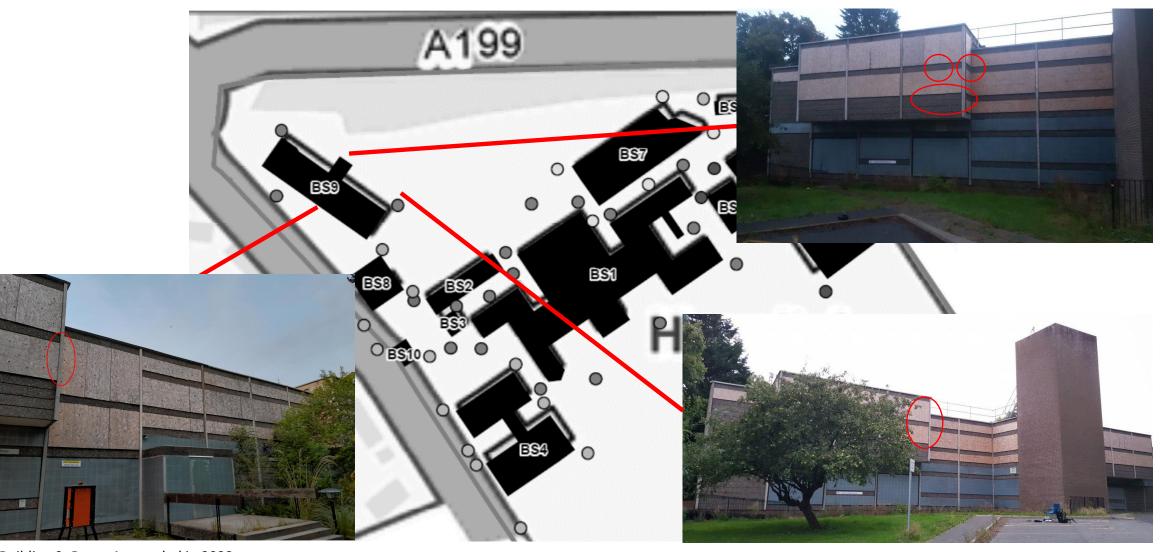
- **4.75** The building was subject to three nocturnal surveys in summer 2021. The Garleton Unit was initially considered to have low bat roost potential. However, three non-breeding common pipistrelle bat roosts were subsequently identified during nocturnal surveys, with each roost observed on shallow external features (**Appendix C**).

- **4.76** The building was subject to an update nocturnal survey in June 2022. Up to three pipistrelle bats were observed emerging from behind the plywood window boarding on the eastern aspect, corresponding to the same area as Roosts 1

- to 3 identified in 2021. In addition, a single common pipistrelle bat was observed emerging from behind the plywood window boarding on the western aspect (**Appendix C**).

Building 9: Roosts 1-3 recorded in 2021 and 2022
