## Dilapidation Survey - 14th of December 2020

Project: 301026 - Musselburgh Race Course, Dilapidation survey

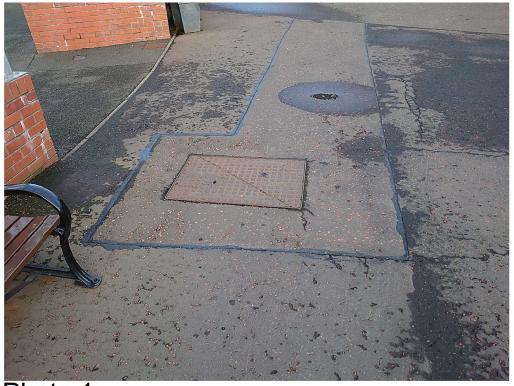
Photo 1

Grid Referen	ce (approx.)						
Ref No.	Easting (m)	Northing (m)	<b>Defect Class</b>	Defect Type	Comment	Photo No.	Recommendation	
East Lothian Council Area								
Area 1								
01	334851.119	673027.785	Carriageway	Crazing	Tar seam around path separated. Surface cracking and crazing in this area	1	Refer to Drawing 301026-C-200 rev E	
02	334848.895	673032.368	Carriageway	Ponding	Settlement causing ponding. No positive route to drain	2	Refer to Drawing 301026-C-200 rev E	
03	334861.711	673034.824	Carriageway	Crazing	Surface cracks	3,4,5	Refer to Drawing 301026-C-200 rev E	
04	334847.892	673039.868	Carriageway	Crazing	Surface cracks	6	Refer to Drawing 301026-C-200 rev E

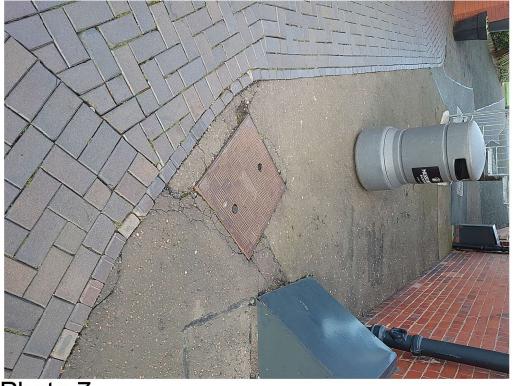
Photo 7

-		-	5	Area 2		·	
05	334845.615	673055.113	Walkway	Crack in asphalt	Surface cracking and crumbling around manhole and blockwork	7	Refer to Drawing 301026-C-200 rev E	
06	378523.698	673062.635	Walkway	Crazing	Surface cracks to asphalt	8	Refer to Drawing 301026-C-200 rev E	
07	334848.361	673063.338	Walkway	Asphalt patch	Tar seam to asphalt patch separated	9	Refer to Drawing 301026-C-200 rev E	
<del>-  </del>		_	,					
09	334847.548	673068.608	Walkway	Worn surface	Entire area of surface crumbling	11	Refer to Drawing 301026-C-200 rev E	
10	334852.131	673071.468	Walkway	Ponding	Settlement causing Ponding	12	Refer to Drawing 301026-C-200 rev E	
11	334862.325	673065.752	Walkway	Crazing	Severe crazing and cracking throughout front of grandstand	13	Refer to Drawing 301026-C-200 rev E	
12	334863.984	673065.228	Walkway	Longitudinal crack in	Separation of joints	14	Refer to Drawing 301026-C-200 rev E	
				wearing course	Area 3

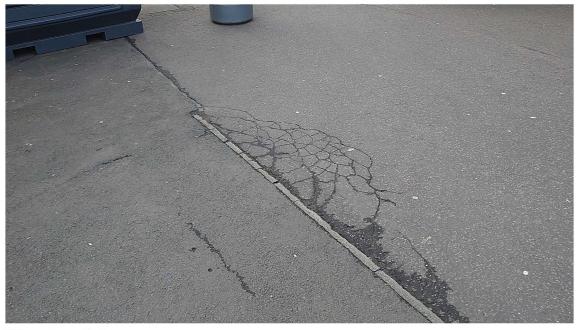
Photo 22

20	334932.871	673031.473	Carriageway	-		22	Refer to Drawing 301026-C-200 rev E	
21	334922.783	673023.017	Carriageway	Damaged kerbs	Entire length of kerbs damaged	23	Refer to Drawing 301026-C-200 rev E	
22	334930.029	673025.088	Carriageway	Asphalt patch	Exposed tar seam to various asphalt patches	24,25	Refer to Drawing 301026-C-200 rev E	
23	334925.612	673020.46	Carriageway	Crazing	Several areas of crazing	26	Refer to Drawing 301026-C-200 rev E	
24	334928.853	673014.917	Carriageway	Worn and crazing asphalt	Worn and crazing of asphalt around ramp and stair access	27	Refer to Drawing 301026-C-200 rev E	
					General areas			
25 W	West access to rais	sed area	Carriageway	Crazing	Crazing and separation of asphalt around joints	39	Resurface area	
26 B	26 Bottom of stairs at raised area		Carriageway	Excessive settlement	Excessive settlement to patches causing exposed joints	28,29,30,31	Break out and reinstate to suitable level

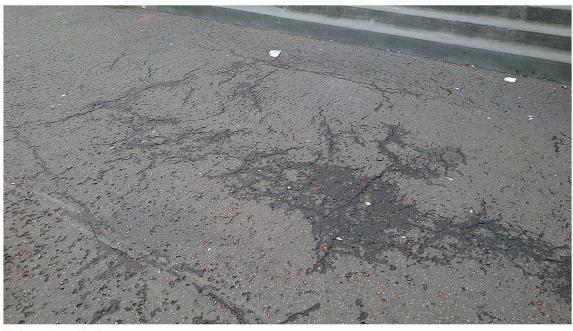
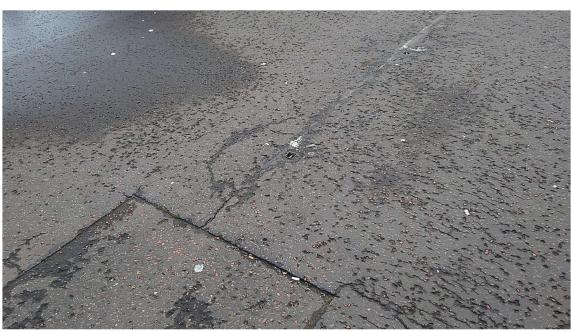
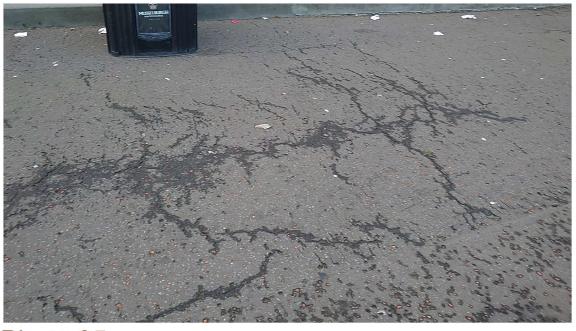
27 B	7 Betting area		Carriageway	Crazing	Crazing to asphalt throughout	32,33,34,35	Resurface area	
28 B	Behind grandstand		Carriageway	Crazing	Crazing to asphalt throughout	36	Resurface area	
29 B	Behind grandstand		Carriageway	Settlement around gully	Settlement around gully causing damage to joints	37	Break out and reinstate to suitable level	
	Behind grandstand		Carriageway	Crazing	Crazing to asphalt	38	Resurface area
