Hub South East Scotland

Herdmanflat Landscape Masterplan Ecological Appraisal Report

Project Number 12049

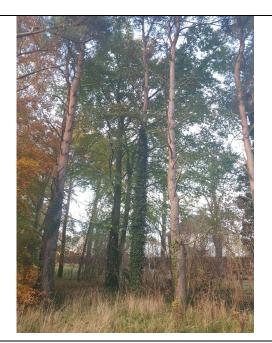
4.7 Mixed woodland plantation was recorded running along the south-western, south-eastern and northern site boundaries (Photograph 1, Appendix B). Woodland running along the south-eastern site boundary extends in its northern section towards the centre of the Site. Species present included Scots pine Pinus sylvestris, beech Fagus sylvatica, larch Larix sp., lime, elder Sambucus nigra, wild cherry Prunus avium, downy birch Betula pendula, sycamore Acre pseudoplatanoides and yew Taxus baccata. The understorey was dominated by young trees, shrubs and tall grasses. The woodland provides screening from roads present around the Site and serves as a resource for local biodiversity.

Photograph 1: Mixed woodland plantation
