East Lothian Council

Asset Name: Pinkie St Peters Primary School

Asset / Property Asbestos Management Plan

Property Address:	Pinkie St Peters Primary School, 44 Pinkie Road, Musselburgh, East Lothian EH21 7HA
Plan Issue Date:	8 th February 2024
Emergency Telephone Number (ELC Call Centre):	01875 824311 (Working Hours) 01875 612818 (Out of Hours) See Section 1.6 for Leave or Sickness Absence Day Time Contacts
Site Duty Holder:	Colette Bonnar, Head Teacher, East Lothian Council: Tel: 0131 665 2024: Email: cbonnar@pinkie-st-peters@elcschool.org.uk
Plan Author / Duty Holder:	Grant Fraser, Asbestos Manager, East Lothian Council: Mob: 07736 148929: Tel: 01620 827709 Email: gfraser@eastlothian.gov.uk

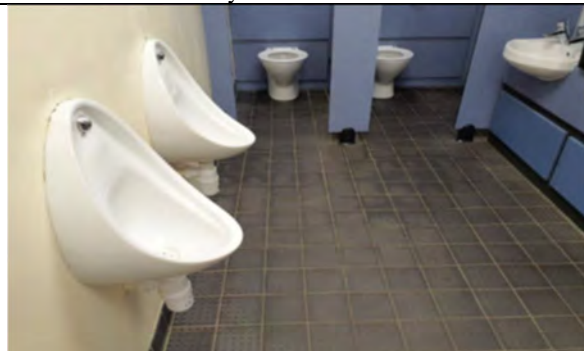
Photo 17: Concealed bitumen-based flooring adhesive (Chrysotile): Sample No: S0068: Room No: B01/FG/R031: Boys Toilets

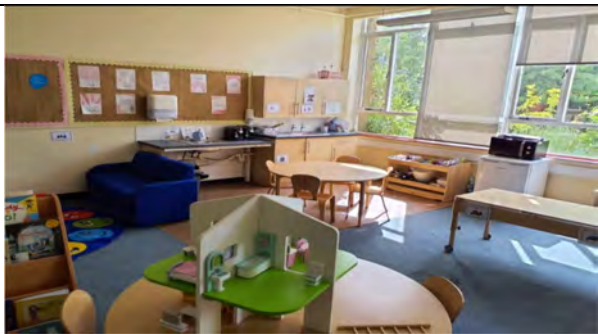
<p>Photo 28: Concealed bitumen-based flooring adhesive (Chrysotile): Sample No: S0068: Room No: B01/FG/R045: Classroom</p>	<p>7.29</p>

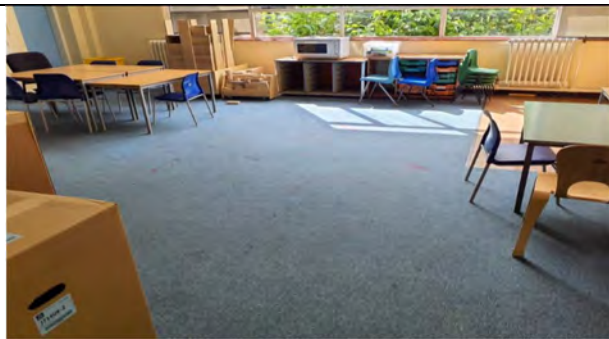
<p>Photo 29: Concealed bitumen-based flooring adhesive (Chrysotile): Sample No: S0068: Room No: B01/FG/R046: Classroom</p>	<p>7.30</p>

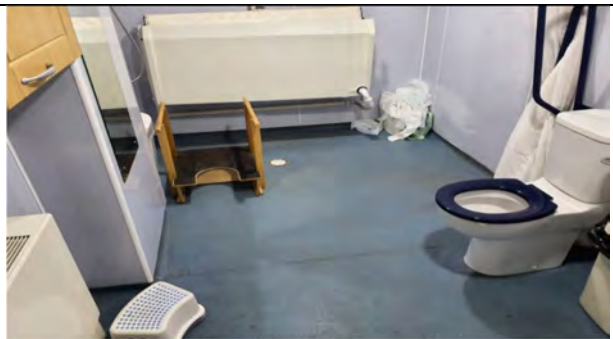
S0049	30	Disabled Toilet B01/FG/R047	Ground	Below visible floor coverings on concrete floor slab	Black coloured asbestos containing floor adhesive	Bitumen	Chrysotile	7.20 SQM	10/07/23 by HSL Ltd	C	Negligible exposure risk for normal use of the area	Inspect again before the end July 2024. Report any damage to ELC Call Centre	Any future planned removal will be NL asbestos works.	Arrange inspection before end July 2024 05/02/24 - GF

<p>Photo 30: Concealed bitumen-based flooring adhesive (Chrysotile): Sample No: S0049: Room No: B01/FG/R047: Disabled Toilet</p>

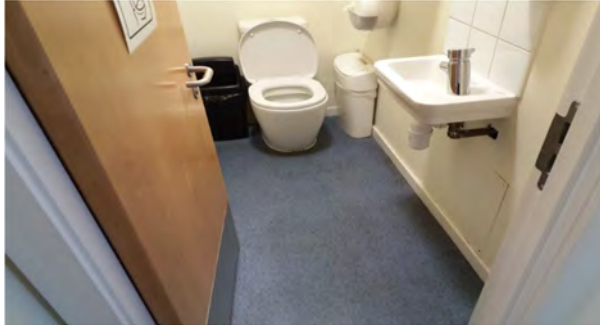
<p>Photo 34: Concealed bitumen-based flooring adhesive (Chrysotile): Sample No: S0049: Room No: B01/FG/R061: Toilet</p>	<p>7.35</p>

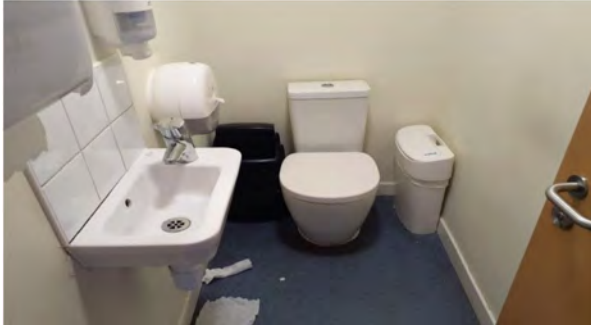
<p>Photo 35: Concealed bitumen-based flooring adhesive (Chrysotile): Sample No: S0049: Room No: B01/FG/R062: Toilet</p>	<p>7.36</p>

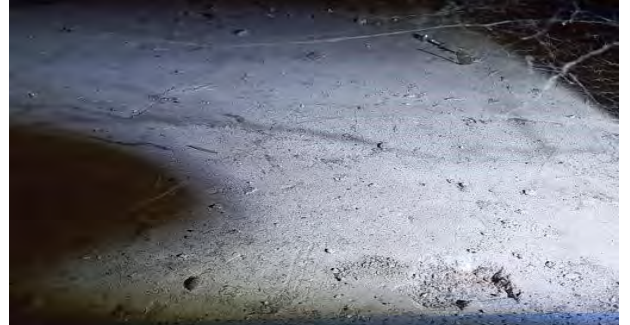
<p>Photo 36: Concealed bitumen-based flooring adhesive (Chrysotile): Sample No: S137: Room No: B01/FG/R063: Staff Base</p>

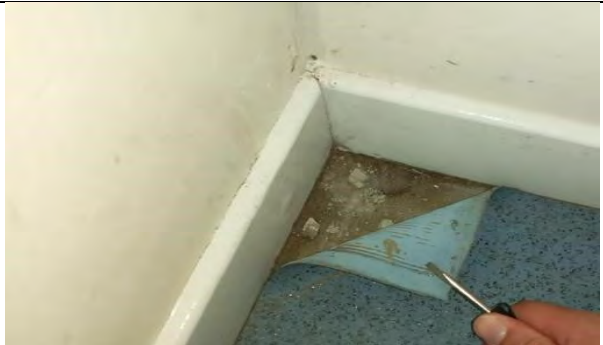
<p>Photo 40: Concealed bitumen-based flooring adhesive (Chrysotile): Sample No: S0049: Room No: B01/FG/R065: Circulation Area</p>	<p>7.41</p>

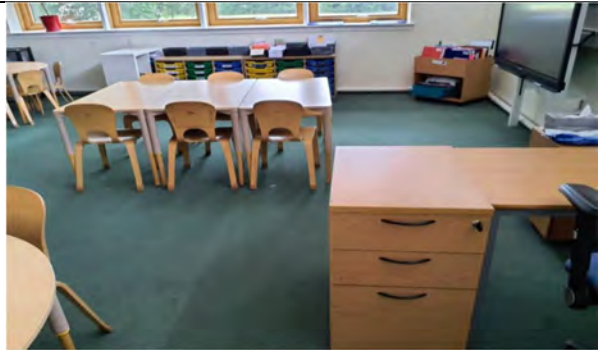
<p>Photo 47: Concealed red coloured vinyl floor tiles (Chrysotile): Sample No: S0079: Room No: B01/F1/R005: Classroom</p>	<p>7.48</p>

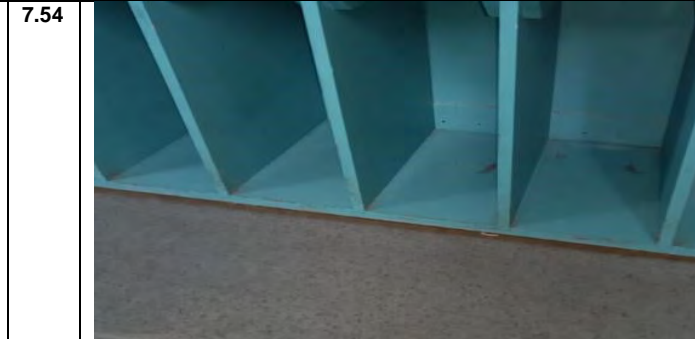
Photo 54: Concealed asbestos skirting boards (Chrysotile): Sample No: S007: Room No: B01/F1/R022: Circulation Area

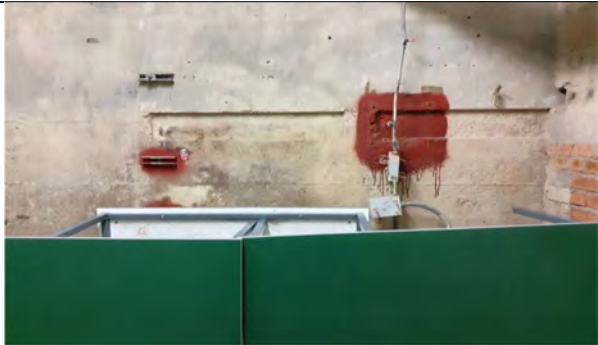
<p>Photo 64: Sealed asbestos thermal insulation debris to Wall 6 (Amostie & Chrysotile): Sample No: IOM30E: Room No: B01/FB/R001: Former Boiler House</p>	<p>7.65</p>

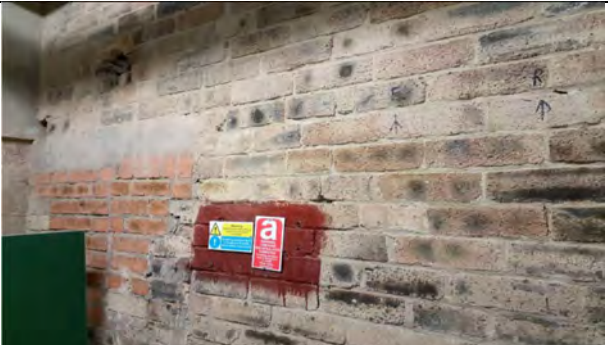
<p>Photo 66: Sealed asbestos thermal insulation debris to Wall 7 (Amostie & Chrysotile): Sample No: IOM30G: Room No: B01/FB/R001: Former Boiler House</p>
