Asbestos Re-inspection Report Up-date

Pinkie St Peters Primary School, 44 Pinkie Road, Musselburgh, East Lothian, EH21 7HA

Contact:	Grant Fraser	Issue Number:	2
Customer:	East Lothian Council	Survey Dates:	10 July 2023
Project No:	G24-00142	Report Issue Date:	08 February 2024

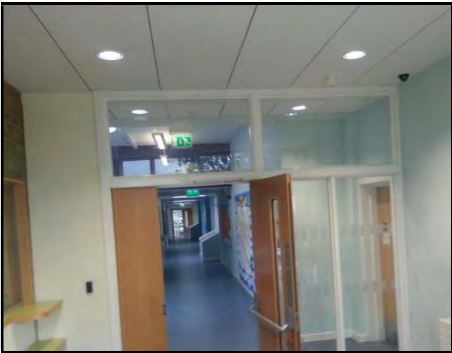
Building ID	Pinkie St Peters Primary School	Item Description	No Suspect Materials Seen
Sample No.		Material	-
Floor	Ground Floor	Asbestos Type	-
Room No.	R001	Extent	-
Room ID	Circulation Area	Notes: Ceiling void / Above suspended ceiling - Concrete roof, Brick and Plasterboard walls, MMMF tiles in metal grid, Timber framing. Other - Timber doors and surrounds, Timber skirtings, Metal doors and window frames, Metal radiator.

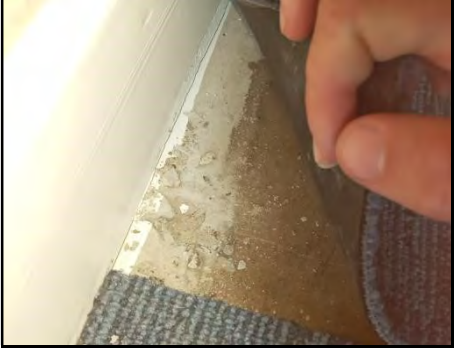
Building ID	Pinkie St Peters Primary School	Item Description	Bitumen adhesive to floor below modern screed and modern vinyl flooring below carpet
Sample No.	PSG13-01632 - 0049	Material	Bituminous Products
Floor	Ground Floor	Asbestos Type	Chrysotile
Room No.	R004	Extent	10m2
Room ID	Deputy Teacher	Notes: Ceiling void / Above suspended ceiling - Plasterboard ceiling, Plasterboard and timber clad steel beam, Brick & Plaster and Plasterboard walls, MMMF tiles in metal grid, MMMF insulated metal pipes, Metal cable trays. Walls - Plasterboard and timber stud partitions with MMMF insulated cavities. Other - Timber door and surrounds, Timber skirtings, Timber window frames with Quarry tiles sills, Metal radiator. Boxing's - MMMF insulated metal pipes within timber boxing at radiator on wall 3. Condition of ACM remains the same 11.07.2023

HSG 264 Material Assessment Scores				Priority Assessment Scores				Risk Priority Rating:
Product:	1	Condition:	0	Occupant Activity:	1	Likelihood of Disturbance:	2	3
Surface Treatment:	0	Asbestos Type:	1	Potential of Human Exposure:	3	Maintenance Activity:	1	
Material Score:	2	Material Category:	D	Priority Score:	7	Total Score (Overall):	9

Surveyor:	Reece Feenie
		Recommendation:	Manage and Monitor through annual re-inspection

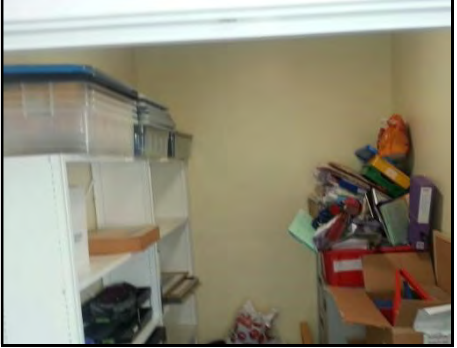
Building ID	Pinkie St Peters Primary School	Item Description	No Suspect Materials Seen
Sample No.		Material	-
Floor	Ground Floor	Asbestos Type	-
Room No.	R006A	Extent	-
Room ID	Resource	Notes: Ceiling void / Above suspended ceiling - Plasterboard ceiling, Brick & Plaster and Plasterboard walls, MMMF tiles in metal grid, Un-insulated metal pipes, Metal cable trays, Plastic flexi ducting. Other - Timber doors and surrounds, Timber skirtings.

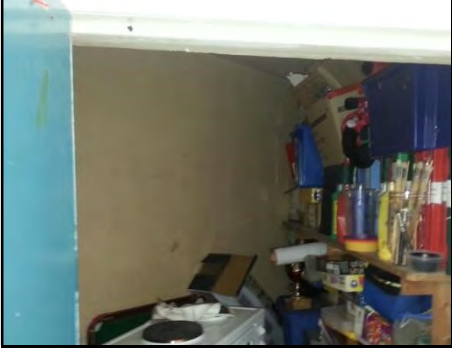
Building ID	Pinkie St Peters Primary School	Item Description	No Suspect Materials Seen
Sample No.		Material	-
Floor	Ground Floor	Asbestos Type	-
Room No.	R006B	Extent	-
Room ID	Storage	Notes: Other - Timber door and surrounds.

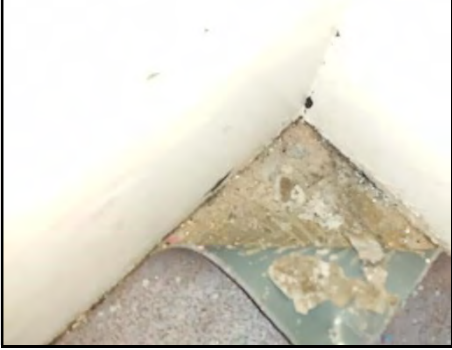
Building ID	Pinkie St Peters Primary School	Item Description	Bitumen adhesive to floor below carpet and modern vinyl flooring
Sample No.	PSG13-01632 - 0049	Material	Bituminous Products
Floor	Ground Floor	Asbestos Type	Chrysotile
Room No.	R007	Extent	50m2
Room ID	Classroom	Notes: Ceiling - Fibreboard ceiling tiles previously sampled and did not contain asbestos. Other - Timber doors and surrounds, Timber skirtings, Timber window frames with Quarry tiles sills, Metal radiators, Un-insulated metal pipes, Ceramic sink, Metal convector heater, Timber ceiling hatch. Condition of ACM remains the same 11.07.2023

HSG 264 Material Assessment Scores				Priority Assessment Scores				Risk Priority Rating:
Product:	1	Condition:	0	Occupant Activity:	1	Likelihood of Disturbance:	2	3
Surface Treatment:	0	Asbestos Type:	1	Potential of Human Exposure:	3	Maintenance Activity:	1	
Material Score:	2	Material Category:	D	Priority Score:	7	Total Score (Overall):	9

Surveyor:	Reece Feenie
		Recommendation:	Manage and Monitor through annual re-inspection

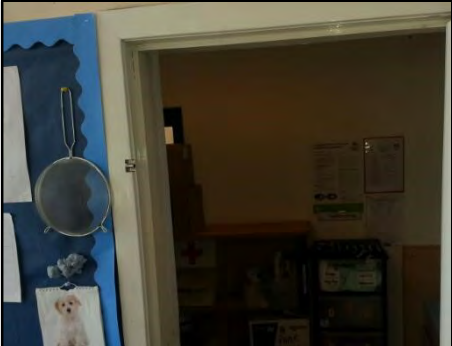
Building ID	Pinkie St Peters Primary School	Item Description	No Suspect Materials Seen
Sample No.		Material	-
Floor	Ground Floor	Asbestos Type	-
Room No.	R007A	Extent	-
Room ID	Storage	Notes: Other - Timber door and surrounds, Timber window frame, Modern metal sink heat pad, Un-insulated metal pipes.

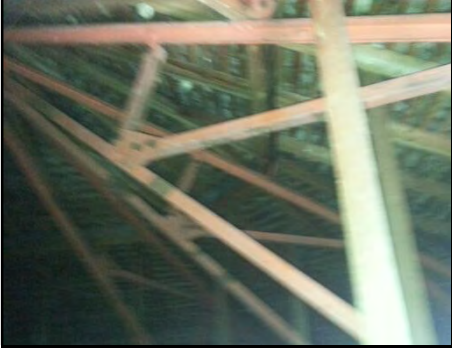
Building ID	Pinkie St Peters Primary School	Item Description	No Suspect Materials Seen
Sample No.		Material	-
Floor	Ground Floor	Asbestos Type	-
Room No.	R007B	Extent	-
Room ID	Classroom - Ceiling void / Attic	Notes:	Other - Metal trusses.

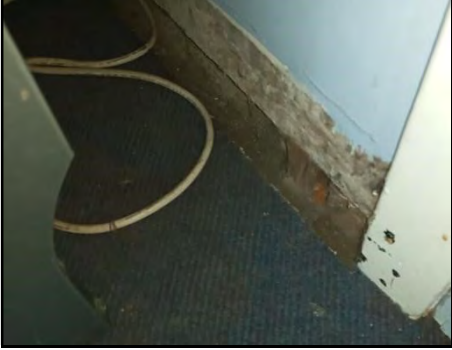
Building ID	Pinkie St Peters Primary School	Item Description	Bitumen adhesive to floor below carpet and modern vinyl flooring
Sample No.	PSG13-01632 - 0049	Material	Bituminous Products
Floor	Ground Floor	Asbestos Type	Chrysotile
Room No.	R008	Extent	50m2
Room ID	Classroom	Notes: Ceiling - Fibreboard ceiling tiles previously sampled and did not contain asbestos. Other - Timber doors and surrounds, Timber skirtings, Timber window frames with Quarry tiles sills, Metal radiators, Un-insulated metal pipes, Modern metal sinks and heat pads, Metal convector heater, Timber ceiling hatch. Condition of ACM remains the same 11.07.2023

HSG 264 Material Assessment Scores				Priority Assessment Scores				Risk Priority Rating:
Product:	1	Condition:	0	Occupant Activity:	1	Likelihood of Disturbance:	2	3
Surface Treatment:	0	Asbestos Type:	1	Potential of Human Exposure:	3	Maintenance Activity:	1	
Material Score:	2	Material Category:	D	Priority Score:	7	Total Score (Overall):	9

Surveyor:	Reece Feenie
		Recommendation:	Manage and Monitor through annual re-inspection

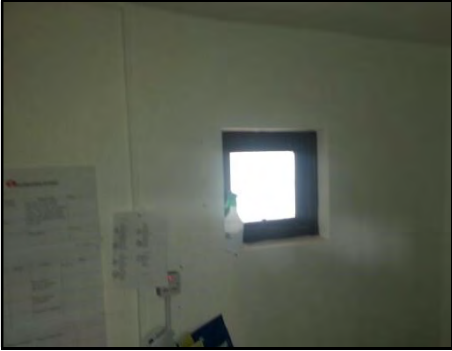
Building ID	Pinkie St Peters Primary School	Item Description	No Suspect Materials Seen
Sample No.		Material	-
Floor	Ground Floor	Asbestos Type	-
Room No.	R008A	Extent	-
Room ID	Storage	Notes: Other - Timber door and surrounds, Timber window frame, Un-insulated metal pipes.

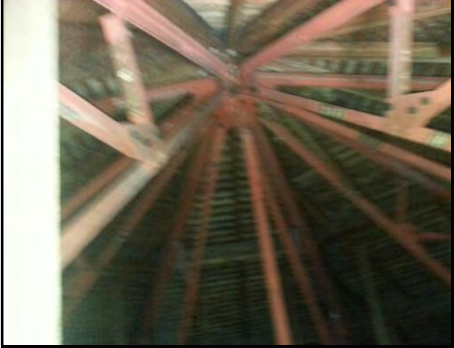
Building ID	Pinkie St Peters Primary School	Item Description	No Suspect Materials Seen
Sample No.		Material	-
Floor	Ground Floor	Asbestos Type	-
Room No.	R008B	Extent	-
Room ID	Classroom - Ceiling void / Attic	Notes:	Other - Metal trusses.

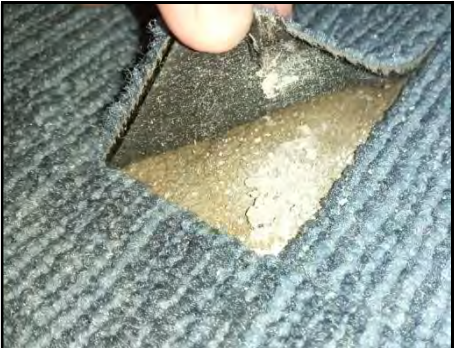
Building ID	Pinkie St Peters Primary School	Item Description	Bitumen adhesive to floor below modern screed
Sample No.	PSG13-01632 - 0055	Material	Bituminous Products
Floor	Ground Floor	Asbestos Type	Chrysotile
Room No.	R009	Extent	10m2
Room ID	Auxiliary	Notes:	Other - Timber door and surrounds, Timber skirtings, Timber window frames, Metal radiator, MMMF insulated metal pipe. Boxing's - MMMF insulated metal pipes within timber boxing on wall 5 at radiator. Condition of ACM remains the same 11.07.2023

HSG 264 Material Assessment Scores				Priority Assessment Scores				Risk Priority Rating:
Product:	1	Condition:	0	Occupant Activity:	1	Likelihood of Disturbance:	1	3
Surface Treatment:	0	Asbestos Type:	1	Potential of Human Exposure:	2	Maintenance Activity:	1	
Material Score:	2	Material Category:	D	Priority Score:	5	Total Score (Overall):	7

Surveyor:	Reece Feenie
		Recommendation:	Manage and Monitor through annual re-inspection

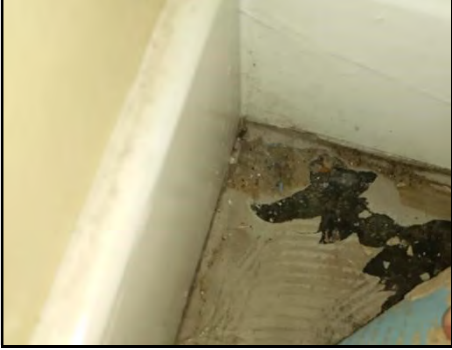
Building ID	Pinkie St Peters Primary School	Item Description	Bitumen adhesive to floor below modern screed
Sample No.	PSG13-01632 - 0049	Material	Bituminous Products
Floor	Ground Floor	Asbestos Type	Chrysotile
Room No.	R010	Extent	10m2
Room ID	Medical Room	Notes: Other - Timber doors and surrounds, Timber skirtings, Timber window frames, Metal radiator, Modern metal sink and heat pads, Modern ceramic wall tiles. Boxing's - MMMF insulated metal pipes within timber boxing on wall 3 at radiator. Condition of ACM remains the same 11.07.2023

HSG 264 Material Assessment Scores				Priority Assessment Scores				Risk Priority Rating:
Product:	1	Condition:	0	Occupant Activity:	1	Likelihood of Disturbance:	1	3
Surface Treatment:	0	Asbestos Type:	1	Potential of Human Exposure:	2	Maintenance Activity:	1	
Material Score:	2	Material Category:	D	Priority Score:	5	Total Score (Overall):	7

Surveyor:	Reece Feenie
		Recommendation:	Manage and Monitor through annual re-inspection

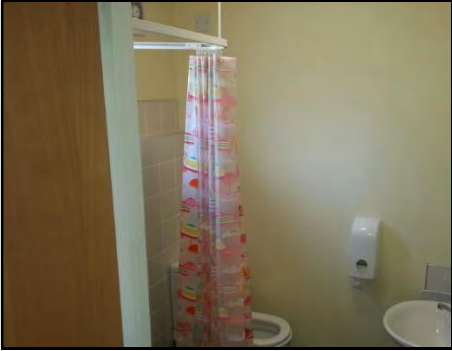
Building ID	Pinkie St Peters Primary School	Item Description	No Suspect Materials Seen
Sample No.		Material	-
Floor	Ground Floor	Asbestos Type	-
Room No.	R010A	Extent	-
Room ID	Shower Room	Notes: Other - Timber door and surrounds, Timber window frame, Ceramic cistern, Modern ceramic wall tiles. Boxing's - Un-insulated copper and plastic pipes within decorative timber boxing on wall 4.

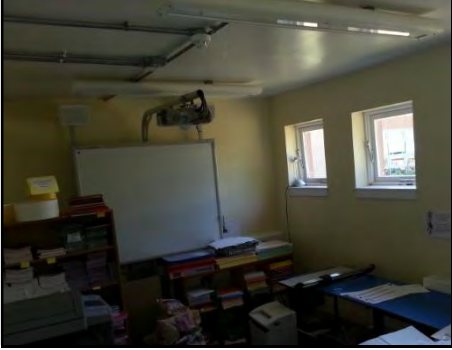
Building ID	Pinkie St Peters Primary School	Item Description	No Suspect Materials Seen
Sample No.		Material	-
Floor	Ground Floor	Asbestos Type	-
Room No.	R011	Extent	-
Room ID	Auxiliary	Notes: Floor - Carpet on Quarry tiles. Other - Timber door and surrounds, Timber skirtings, Timber window frames, Metal radiator. Boxing's - MMMF insulated metal pipes within timber boxing on wall 3 at radiator.

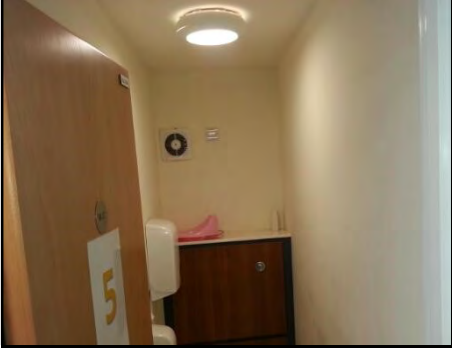
Building ID	Pinkie St Peters Primary School	Item Description	No Suspect Materials Seen
Sample No.		Material	-
Floor	Ground Floor	Asbestos Type	-
Room No.	R013	Extent	-
Room ID	W.C	Notes: Other - Timber door and surrounds, Modern ceramic wall and floor tiles. Walls - Plasterboard and timber stud partitions with MMMF insulated cavities, Foam insulated copper pipes and Un-insulated plastic pipes. Boxing's - Plastic cisterns, Un-insulated plastic pipes and foam insulated copper pipes within decorative timber boxing on wall 3.

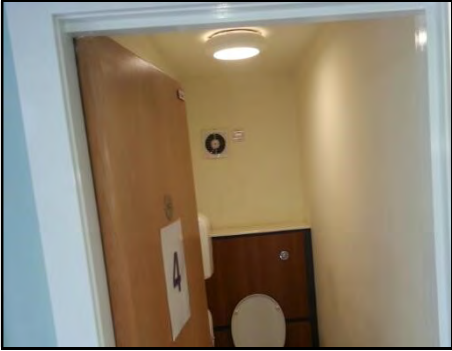
Building ID	Pinkie St Peters Primary School	Item Description	No Suspect Materials Seen
Sample No.		Material	-
Floor	Ground Floor	Asbestos Type	-
Room No.	R014	Extent	-
Room ID	W.C	Notes: Other - Timber door and surrounds, Modern ceramic wall and floor tiles. Walls - Plasterboard and timber stud partitions with MMMF insulated cavities, Foam insulated copper pipes and Un-insulated plastic pipes. Boxing's - Plastic cisterns, Un-insulated plastic pipes and foam insulated copper pipes within decorative timber boxing on wall 3.

HSG 264 Material Assessment Scores				Priority Assessment Scores				Risk Priority Rating:
Product:	0	Condition:	0	Occupant Activity:	0	Likelihood of Disturbance:	0	-
Surface Treatment:	0	Asbestos Type:	0	Potential of Human Exposure:	0	Maintenance Activity:	0	
Material Score:	0	Material Category:	-	Priority Score:	0	Total Score (Overall):	0

Surveyor:	Gordon Pryde
		Recommendation:	-

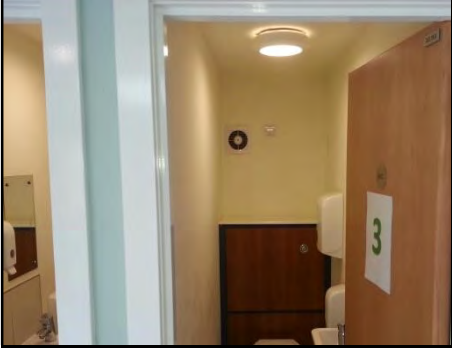
Building ID	Pinkie St Peters Primary School	Item Description	No Suspect Materials Seen
Sample No.		Material	-
Floor	Ground Floor	Asbestos Type	-
Room No.	R015	Extent	-
Room ID	W.C	Notes: Other - Timber door and surrounds, Modern ceramic wall and floor tiles. Walls - Plasterboard and timber stud partitions with MMMF insulated cavities, Foam insulated copper pipes and Un-insulated plastic pipes. Boxing's - Plastic cisterns, Un-insulated plastic pipes and foam insulated copper pipes within decorative timber boxing on wall 3.

HSG 264 Material Assessment Scores				Priority Assessment Scores				Risk Priority Rating:
Product:	0	Condition:	0	Occupant Activity:	0	Likelihood of Disturbance:	0	-
Surface Treatment:	0	Asbestos Type:	0	Potential of Human Exposure:	0	Maintenance Activity:	0	
Material Score:	0	Material Category:	-	Priority Score:	0	Total Score (Overall):	0

Surveyor:	Gordon Pryde
		Recommendation:	-

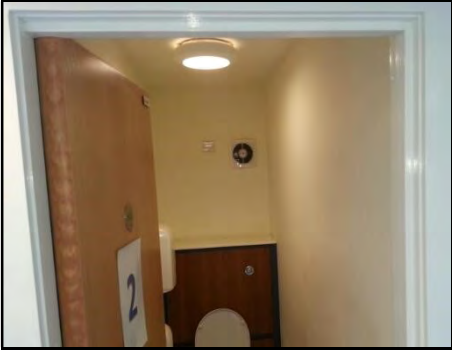
Building ID	Pinkie St Peters Primary School	Item Description	No Suspect Materials Seen
Sample No.		Material	-
Floor	Ground Floor	Asbestos Type	-
Room No.	R016	Extent	-
Room ID	W.C	Notes: Other - Timber door and surrounds, Modern ceramic wall and floor tiles. Walls - Plasterboard and timber stud partitions with MMMF insulated cavities, Foam insulated copper pipes and Un-insulated plastic pipes. Boxing's - Plastic cisterns, Un-insulated plastic pipes and foam insulated copper pipes within decorative timber boxing on wall 3.

HSG 264 Material Assessment Scores				Priority Assessment Scores				Risk Priority Rating:
Product:	0	Condition:	0	Occupant Activity:	0	Likelihood of Disturbance:	0	-
Surface Treatment:	0	Asbestos Type:	0	Potential of Human Exposure:	0	Maintenance Activity:	0	
Material Score:	0	Material Category:	-	Priority Score:	0	Total Score (Overall):	0

Surveyor:	Gordon Pryde
		Recommendation:	-

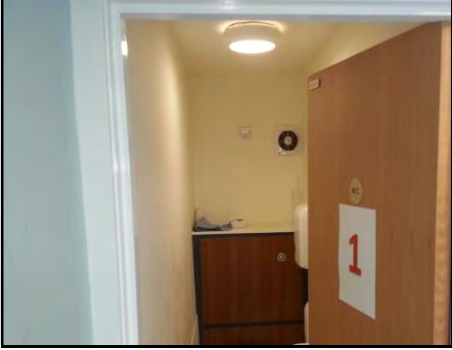
Building ID	Pinkie St Peters Primary School	Item Description	No Suspect Materials Seen
Sample No.		Material	-
Floor	Ground Floor	Asbestos Type	-
Room No.	R017	Extent	-
Room ID	W.C	Notes: Other - Timber door and surrounds, Modern ceramic wall and floor tiles. Walls - Plasterboard and timber stud partitions with MMMF insulated cavities, Foam insulated copper pipes and Un-insulated plastic pipes. Boxing's - Plastic cisterns, Un-insulated plastic pipes and foam insulated copper pipes within decorative timber boxing on wall 3.

HSG 264 Material Assessment Scores				Priority Assessment Scores				Risk Priority Rating:
Product:	0	Condition:	0	Occupant Activity:	0	Likelihood of Disturbance:	0	-
Surface Treatment:	0	Asbestos Type:	0	Potential of Human Exposure:	0	Maintenance Activity:	0	
Material Score:	0	Material Category:	-	Priority Score:	0	Total Score (Overall):	0

Surveyor:	Gordon Pryde
		Recommendation:	-

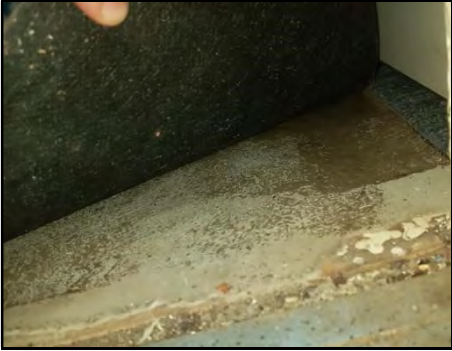
Building ID	Pinkie St Peters Primary School	Item Description	Bitumen adhesive to floor below modern vinyl flooring
Sample No.	PS001	Material	Bituminous Products
Floor	Ground Floor	Asbestos Type	Chrysotile
Room No.	R018	Extent	12m2
Room ID	DHT	Notes: Floor - Carpet on modern vinyl flooring on concrete. Other - Timber door and surrounds, Timber skirtings, Timber window frames, Metal radiator. Boxing's - MMMF insulated metal pipes within timber boxing on wall 3 at radiator. Condition of ACM remains the same 11.07.2023

HSG 264 Material Assessment Scores				Priority Assessment Scores				Risk Priority Rating:
Product:	1	Condition:	0	Occupant Activity:	1	Likelihood of Disturbance:	2	3
Surface Treatment:	0	Asbestos Type:	1	Potential of Human Exposure:	2	Maintenance Activity:	1	
Material Score:	2	Material Category:	D	Priority Score:	6	Total Score (Overall):	8

Surveyor:	Reece Feenie
		Recommendation:	Manage and Monitor through annual re-inspection

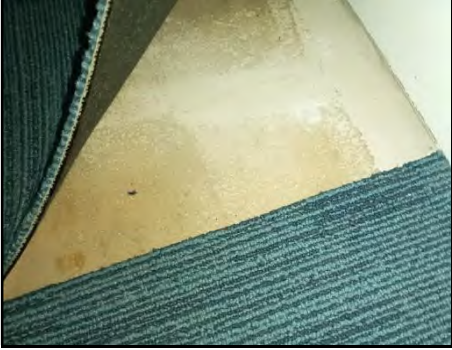
Building ID	Pinkie St Peters Primary School	Item Description	Bitumen adhesive to floor below modern screed
Sample No.	PS010	Material	Bituminous Products
Floor	Ground Floor	Asbestos Type	Chrysotile
Room No.	R025	Extent	52m2
Room ID	Library	Notes: Ceiling void / Above suspended ceiling - Plasterboard ceiling, Brick & Plaster and Plasterboard walls, MMMF tiles in metal grid, Metal conduits, MMMF insulated metal pipes. Other - Timber door and surrounds, Timber window frames, Timber skirtings, Metal radiator, Un-insulated metal pipes. Sample of Bitumen taken to confirm it contains Asbestos. Condition of ACM remains the same 11.07.23

HSG 264 Material Assessment Scores				Priority Assessment Scores				Risk Priority Rating:
Product:	1	Condition:	0	Occupant Activity:	1	Likelihood of Disturbance:	2	3
Surface Treatment:	0	Asbestos Type:	1	Potential of Human Exposure:	3	Maintenance Activity:	1	
Material Score:	2	Material Category:	D	Priority Score:	7	Total Score (Overall):	9

Surveyor:	Reece Feenie
		Recommendation:	Manage and Monitor through annual re-inspection

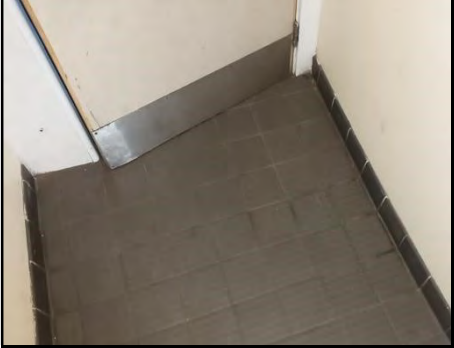
Building ID	Pinkie St Peters Primary School	Item Description	Bitumen adhesive to floor below modern ceramic tiles
Sample No.	PSG13-01632 - 0068	Material	Bituminous Products
Floor	Ground Floor	Asbestos Type	Chrysotile
Room No.	R030	Extent	2m2
Room ID	Girls Toilets	Notes: Ceiling void / Above suspended ceiling - Timber roof, Metal beams and trusses, Breezeblock and Plasterboard walls, MMMF tiles in metal grid, MMMF insulated pipework, Metal ducting. Other - Timber door and surrounds, Modern ceramic wall and floor tiles. Boxing's - MMMF insulated copper pipes and Un-insulated plastic pipes within decorative timber boxing on wall 4 below sinks. Plastic cisterns, MMMF insulated copper pipes and plastic waste pipes within decorative timber boxing on wall 6. There was no access below the modern ceramic floor tiles but Bitumen adhesive is strongly presumed to be present. The bitumen adhesive will only be present below the floor tiles as you enter this location as the rest of the location is part of a modern extension. Condition of ACM remains the same 10.07.2023

HSG 264 Material Assessment Scores				Priority Assessment Scores			Risk Priority Rating:
Product:	1	Condition:	0	Occupant Activity:	0	Likelihood of Disturbance:	1
Surface Treatment:	0	Asbestos Type:	1	Potential of Human Exposure:	2	Maintenance Activity:	0
Material Score:	2	Material Category:	D	Priority Score:	3	Total Score (Overall):	5
							3

Surveyor:	Reece Feenie
		Recommendation:	Manage and Monitor through annual re-inspection

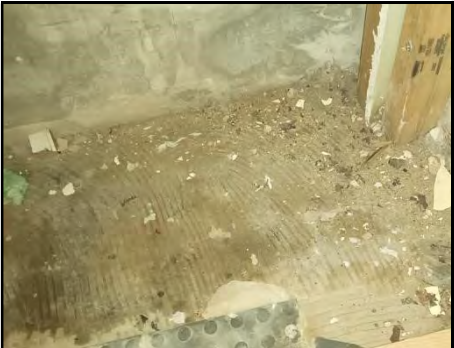
Building ID	Pinkie St Peters Primary School	Item Description	Bitumen adhesive to floor below modern ceramic tiles
Sample No.	PSG13-01632 - 0068	Material	Bituminous Products
Floor	Ground Floor	Asbestos Type	Chrysotile
Room No.	R031	Extent	10m2
Room ID	Boy's Toilets	Notes: Other - Timber door and surrounds, Metal radiator, Modern ceramic wall and floor tiles. Boxing's - MMMF insulated copper pipes and Un-insulated plastic pipes within decorative timber boxing on wall 1 below sinks. Plastic cisterns, MMMF insulated copper pipes and plastic waste pipes within decorative timber boxing on wall 4. Condition of ACM remains the same 10.07.2023

HSG 264 Material Assessment Scores				Priority Assessment Scores			Risk Priority Rating:
Product:	1	Condition:	0	Occupant Activity:	0	Likelihood of Disturbance:	1
Surface Treatment:	0	Asbestos Type:	1	Potential of Human Exposure:	2	Maintenance Activity:	1
Material Score:	2	Material Category:	D	Priority Score:	4	Total Score (Overall):	6
							3

Surveyor:	Reece Feenie
		Recommendation:	Manage and Monitor through annual re-inspection

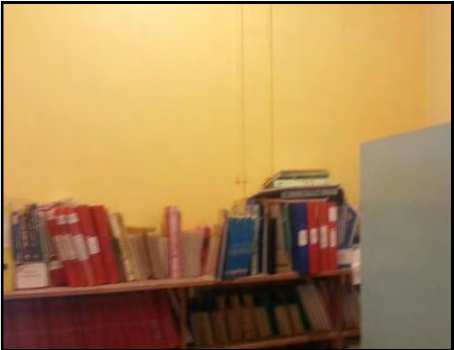
Building ID	Pinkie St Peters Primary School	Item Description	No Suspect Materials Seen
Sample No.		Material	-
Floor	Ground Floor	Asbestos Type	-
Room No.	R035	Extent	-
Room ID	Storage	Notes: Other - Timber door and surrounds, Metal conduits.

HSG 264 Material Assessment Scores				Priority Assessment Scores				Risk Priority Rating:
Product:	0	Condition:	0	Occupant Activity:	0	Likelihood of Disturbance:	0	-
Surface Treatment:	0	Asbestos Type:	0	Potential of Human Exposure:	0	Maintenance Activity:	0	
Material Score:	0	Material Category:	-	Priority Score:	0	Total Score (Overall):	0

Surveyor:	Gordon Pryde
		Recommendation:	-

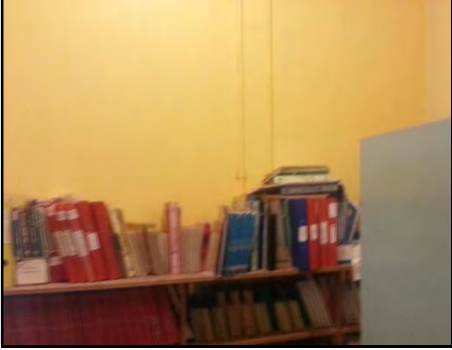
Building ID	Pinkie St Peters Primary School	Item Description	No Suspect Materials Seen
Sample No.		Material	-
Floor	Ground Floor	Asbestos Type	-
Room No.	R036	Extent	-
Room ID	Storage	Notes: Other - Timber door and surrounds, Timber skirting, Metal conduits.

HSG 264 Material Assessment Scores				Priority Assessment Scores				Risk Priority Rating:
Product:	0	Condition:	0	Occupant Activity:	0	Likelihood of Disturbance:	0	-
Surface Treatment:	0	Asbestos Type:	0	Potential of Human Exposure:	0	Maintenance Activity:	0	
Material Score:	0	Material Category:	-	Priority Score:	0	Total Score (Overall):	0

Surveyor:	Gordon Pryde
		Recommendation:	-

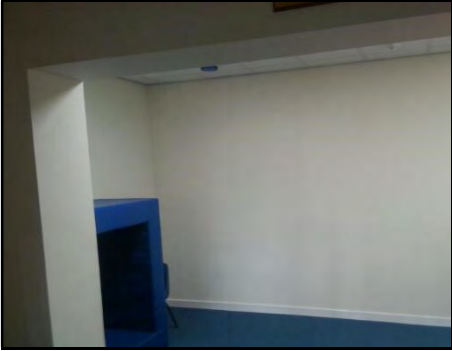
Building ID	Pinkie St Peters Primary School	Item Description	No Suspect Materials Seen
Sample No.		Material	-
Floor	Ground Floor	Asbestos Type	-
Room No.	R037	Extent	-
Room ID	Tutorial Room	Notes: Ceiling void / Above suspended ceiling - Plasterboard ceiling, Timber and metal beams roof, Brick & Plaster and Plasterboard walls, MMMF tiles in metal grid, Un-insulated metal pipes, Metal ducting, Plastic flexi ducting. Other - Timber door and surrounds, Timber skirtings, Ceramic sink, MMMF insulated copper pipes.

HSG 264 Material Assessment Scores				Priority Assessment Scores				Risk Priority Rating:
Product:	0	Condition:	0	Occupant Activity:	0	Likelihood of Disturbance:	0	-
Surface Treatment:	0	Asbestos Type:	0	Potential of Human Exposure:	0	Maintenance Activity:	0	
Material Score:	0	Material Category:	-	Priority Score:	0	Total Score (Overall):	0

Surveyor:	Gordon Pryde
		Recommendation:	-

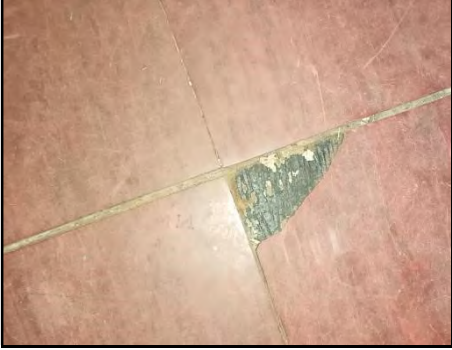
Building ID	Pinkie St Peters Primary School	Item Description	Bitumen adhesive to floor below modern vinyl flooring
Sample No.	PSG13-01632 - 0068	Material	Bituminous Products
Floor	Ground Floor	Asbestos Type	Chrysotile
Room No.	R039	Extent	10m2
Room ID	Storage	Notes: Other - Timber door and surrounds, Rubber skirtings. Condition of ACM remains the same 11.07.2023

HSG 264 Material Assessment Scores				Priority Assessment Scores				Risk Priority Rating:
Product:	1	Condition:	0	Occupant Activity:	0	Likelihood of Disturbance:	1	3
Surface Treatment:	0	Asbestos Type:	1	Potential of Human Exposure:	2	Maintenance Activity:	1	
Material Score:	2	Material Category:	D	Priority Score:	4	Total Score (Overall):	6

Surveyor:	Reece Feenie
		Recommendation:	Manage and Monitor through annual re-inspection

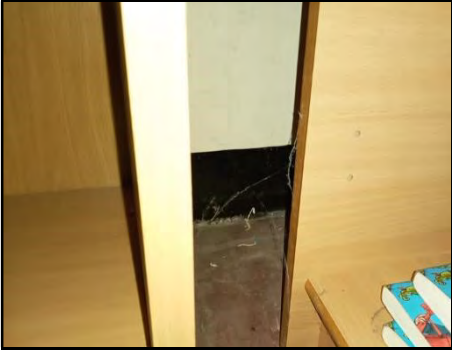
Building ID	Pinkie St Peters Primary School	Item Description	Black resin skirtings on wall 3
Sample No.	PSG13-01632 - 0131	Material	Resin Products
Floor	Ground Floor	Asbestos Type	Chrysotile
Room No.	R039	Extent	5lin m
Room ID	Storage	Notes: Other - Timber door and surrounds, Rubber skirtings. Condition of ACM remains the same 11.07.2023

HSG 264 Material Assessment Scores				Priority Assessment Scores				Risk Priority Rating:
Product:	1	Condition:	1	Occupant Activity:	0	Likelihood of Disturbance:	1	3
Surface Treatment:	0	Asbestos Type:	1	Potential of Human Exposure:	2	Maintenance Activity:	1	
Material Score:	3	Material Category:	D	Priority Score:	4	Total Score (Overall):	7

Surveyor:	Reece Feenie
		Recommendation:	Manage and Monitor through annual re-inspection

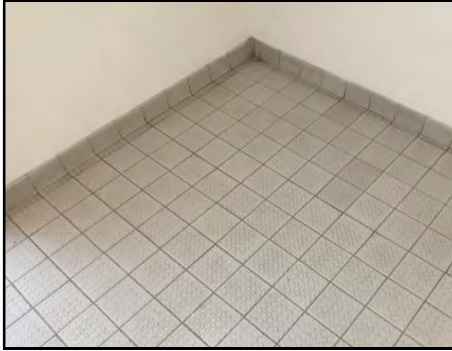
Building ID	Pinkie St Peters Primary School
Sample No.	PSG13-01632 - 0068
Floor	Ground Floor
Room No.	R040
Room ID	Girls Toilets

Item Description	Bitumen adhesive to floor below modern ceramic tiles
Material	Bituminous Products
Asbestos Type	Chrysotile
Extent	5m2

Notes: Ceiling void / Above suspended ceiling - Timber and concrete roofs, Breezeblock and Plasterboard walls, MMMF tiles in metal grid, MMMF insulated pipework, Metal ducting. Other - Timber door and surrounds, Modern ceramic wall and floor tiles. Boxing's - MMMF insulated copper pipes and Un-insulated plastic pipes within decorative timber boxing on wall 3 below sinks. Plastic cisterns, MMMF insulated copper pipes and plastic waste pipes within decorative timber boxing on wall 5. There was no access below the modern ceramic floor tiles but Bitumen adhesive is strongly presumed to be present. The bitumen adhesive will only be present below the floor tiles as you enter this location as the rest of the location is part of a modern extension.	
Condition of ACM remains the same 11.07.2023	
Surveyor:	Reece Feenie
Recommendation:	Manage and Monitor through annual re-inspection

HSG 264 Material Assessment Scores				Priority Assessment Scores			Risk Priority Rating:
Product:	1	Condition:	0	Occupant Activity:	0	Likelihood of Disturbance:	1
Surface Treatment:	0	Asbestos Type:	1	Potential of Human Exposure:	2	Maintenance Activity:	0
Material Score:	2	Material Category:	D	Priority Score:	3	Total Score (Overall):	5

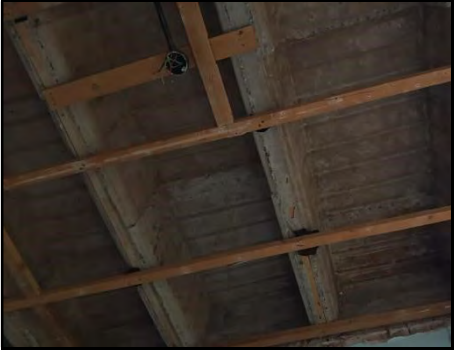
Building ID	Pinkie St Peters Primary School	Item Description	Bitumen packers
Sample No.	PS144	Material	Bituminous Products
Floor	Ground Floor	Asbestos Type	No Asbestos Detected
Room No.	R044A	Extent	-
Room ID	Classroom Ceiling Void	Notes:

HSG 264 Material Assessment Scores				Priority Assessment Scores				Risk Priority Rating:
Product:	0	Condition:	0	Occupant Activity:	0	Likelihood of Disturbance:	0	-
Surface Treatment:	0	Asbestos Type:	0	Potential of Human Exposure:	0	Maintenance Activity:	0	
Material Score:	0	Material Category:	-	Priority Score:	0	Total Score (Overall):	0

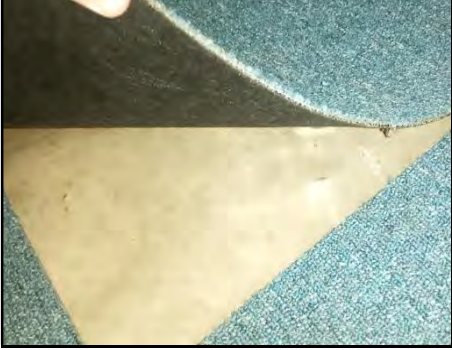
Building ID	Pinkie St Peters Primary School	Item Description	Bitumen adhesive to floor below carpet and modern vinyl flooring
Sample No.	PSG13-01632 - 0068	Material	Bituminous Products
Floor	Ground Floor	Asbestos Type	Chrysotile
Room No.	R045	Extent	50m2
Room ID	Classroom	Notes: Other - Timber doors and surrounds, Rubber skirtings, Timber window frames, Modern metal sink and heat pads, Metal radiators, Un-insulated metal pipes, Modern ceramic wall tiles. Condition of ACM remains the same 11.07.2023

HSG 264 Material Assessment Scores				Priority Assessment Scores				Risk Priority Rating:
Product:	1	Condition:	0	Occupant Activity:	1	Likelihood of Disturbance:	2	3
Surface Treatment:	0	Asbestos Type:	1	Potential of Human Exposure:	3	Maintenance Activity:	1	
Material Score:	2	Material Category:	D	Priority Score:	7	Total Score (Overall):	9

Surveyor:	Reece Feenie
		Recommendation:	Manage and Monitor through annual re-inspection

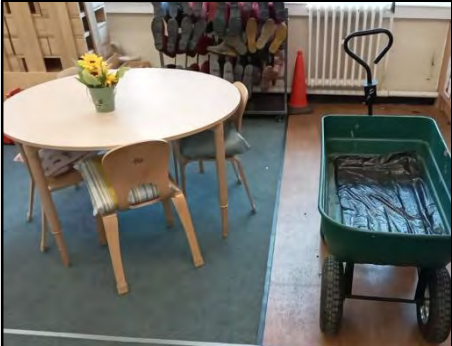
Building ID	Pinkie St Peters Primary School	Item Description	Bitumen adhesive to floor below carpet and modern vinyl flooring
Sample No.	PSG13-01632 - 0068	Material	Bituminous Products
Floor	Ground Floor	Asbestos Type	Chrysotile
Room No.	R046	Extent	52m2
Room ID	Classroom	Notes: Other - Timber doors and surrounds, Rubber skirtings, Timber window frames, Modern metal sink and heat pads, Metal radiators, Un-insulated metal pipes. Condition of ACM remains the same 10.07.2023

HSG 264 Material Assessment Scores				Priority Assessment Scores				Risk Priority Rating:
Product:	1	Condition:	0	Occupant Activity:	1	Likelihood of Disturbance:	2	3
Surface Treatment:	0	Asbestos Type:	1	Potential of Human Exposure:	3	Maintenance Activity:	1	
Material Score:	2	Material Category:	D	Priority Score:	7	Total Score (Overall):	9

Surveyor:	Reece Feenie
		Recommendation:	Manage and Monitor through annual re-inspection

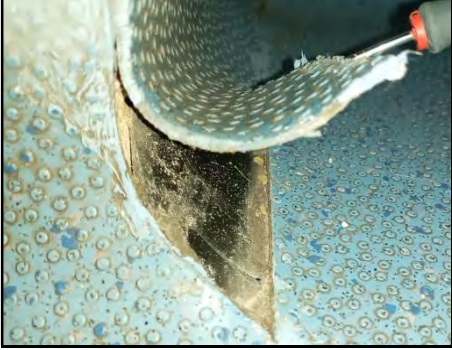
Building ID	Pinkie St Peters Primary School	Item Description	Bitumen adhesive to floor below modern vinyl flooring
Sample No.	PSG13-01632 - 0049	Material	Bituminous Products
Floor	Ground Floor	Asbestos Type	Chrysotile
Room No.	R047	Extent	9m2
Room ID	Disabled Toilet	Notes: Walls - Wetboard panels, No access behind Wetboard wall panels so not to cause irreparable damage. Other - Timber door and surrounds, Metal radiator, Ceramic cistern, Un-insulated copper and plastic pipes. Condition of ACM remains the same 11.07.2023

HSG 264 Material Assessment Scores				Priority Assessment Scores				Risk Priority Rating:
Product:	1	Condition:	0	Occupant Activity:	0	Likelihood of Disturbance:	1	3
Surface Treatment:	0	Asbestos Type:	1	Potential of Human Exposure:	2	Maintenance Activity:	1	
Material Score:	2	Material Category:	D	Priority Score:	4	Total Score (Overall):	6

Surveyor:	Reece Feenie
		Recommendation:	Manage and Monitor through annual re-inspection

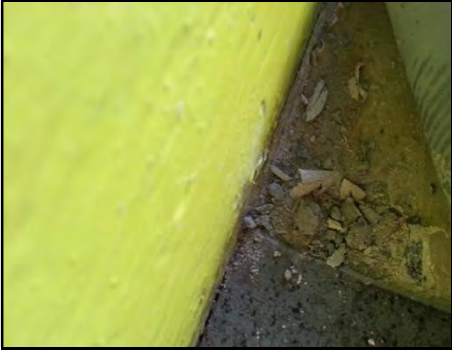
Building ID	Pinkie St Peters Primary School	Item Description	Bitumen adhesive to floor on original concrete floor below modern vinyl flooring
Sample No.	PS009	Material	Screed
Floor	Ground Floor	Asbestos Type	No Asbestos Detected
Room No.	R049	Extent	-
Room ID	Dining Area	Notes: Ceiling - Fibreboard tiles - Previously sampled and did not contain asbestos, Timber clad metal beams. Other - Timber doors and surrounds, Metal doors and surrounds, Timber skirtings, Timber window frames, Metal radiators, Un-insulated metal pipes, Steel beams.

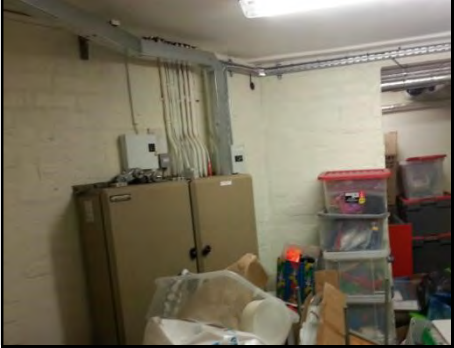
Building ID	Pinkie St Peters Primary School	Item Description	No Suspect Materials Seen
Sample No.		Material	-
Floor	Ground Floor	Asbestos Type	-
Room No.	R049A	Extent	-
Room ID	Switch Room	Notes: Other - Timber doors and surrounds, Metal downpipe, MMMF insulated metal pipes, Un-insulated metal pipes, Modern electrics distribution boards.

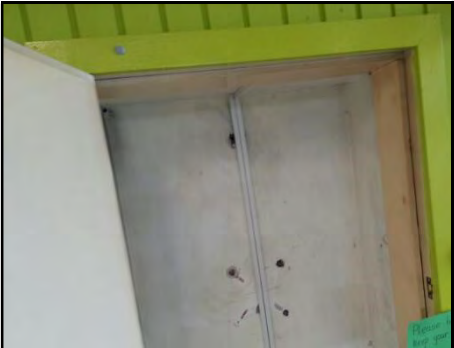
Building ID	Pinkie St Peters Primary School	Item Description	No Suspect Materials Seen
Sample No.		Material	-
Floor	Ground Floor	Asbestos Type	-
Room No.	R049B	Extent	-
Room ID	Cupboard	Notes: Other - Timber door and surrounds.

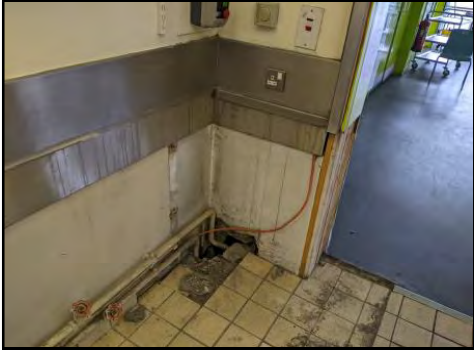
Building ID	Pinkie St Peters Primary School	Item Description	Floor screed
Sample No.	PS136 - IOM	Material	Screed
Floor	Ground Floor	Asbestos Type	No Asbestos Detected
Room No.	R050	Extent	-
Room ID	Kitchen	Notes:	Sampled by customer 18/07/2022

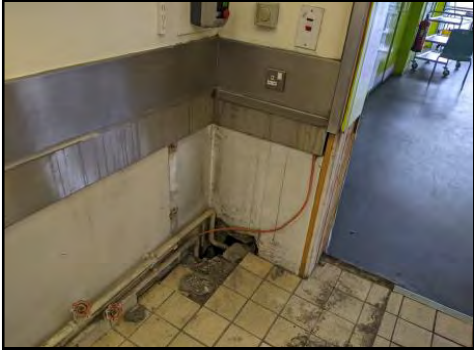
Building ID	Pinkie St Peters Primary School	Item Description	Mastic to floor
Sample No.	PS137 - IOM	Material	Mastics
Floor	Ground Floor	Asbestos Type	No Asbestos Detected
Room No.	R050	Extent	-
Room ID	Kitchen	Notes: Sampled by customer 18/07/2022

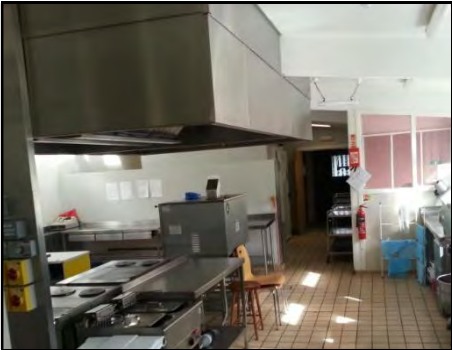
Building ID	Pinkie St Peters Primary School	Item Description	No Suspect Materials Seen
Sample No.		Material	-
Floor	Ground Floor	Asbestos Type	-
Room No.	R050A	Extent	-
Room ID	Kitchen	Notes: Ceiling - Timber clad metal beams. Metal and plastic skylight with timber surrounds. Other - Metal roller shutter door, Timber doors and surrounds, Timber window frames, Plasterboard panels above servery hatches, Metal sinks - Bitumen coating to sinks previously sampled and did not contain asbestos, Ceramic wall tiles adhesive previously sampled and did not contain asbestos. Boxing's - Metal downpipe within timber riser on wall 1. An inspection to the rear of the stainless steel panels below counters revealed, Timber fitted cabinets, Metal pipes and Quarry tiled floor.

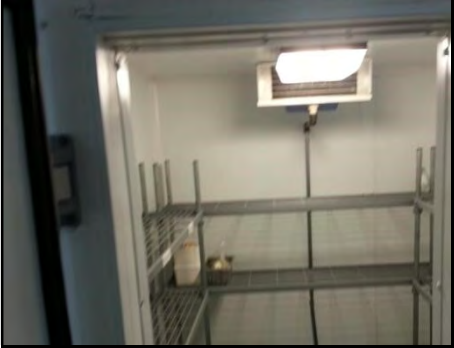
Building ID	Pinkie St Peters Primary School	Item Description	No Suspect Materials Seen
Sample No.		Material	-
Floor	Ground Floor	Asbestos Type	-
Room No.	R050B	Extent	-
Room ID	Kitchen Store	Notes: Ceiling void - Timber roof, Steel beam, Brick walls, Timber and polystyrene floor, Foam insulated metal pipes. Other - Metal door and surrounds.

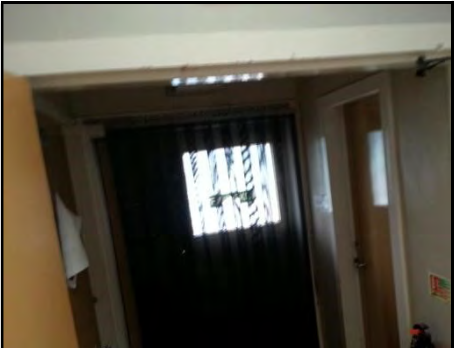
Building ID	Pinkie St Peters Primary School	Item Description	No Suspect Materials Seen
Sample No.		Material	-
Floor	Ground Floor	Asbestos Type	-
Room No.	R050C	Extent	-
Room ID	Circulation Area	Notes: Other - Timber doors and surrounds.

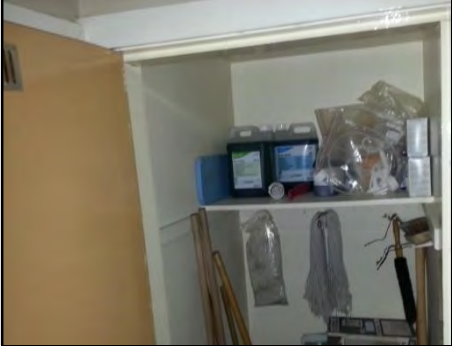
Building ID	Pinkie St Peters Primary School	Item Description	No Suspect Materials Seen
Sample No.		Material	-
Floor	Ground Floor	Asbestos Type	-
Room No.	R050D	Extent	-
Room ID	Kitchen Store	Notes:	Other - Timber door and surrounds, Timber skirtings.

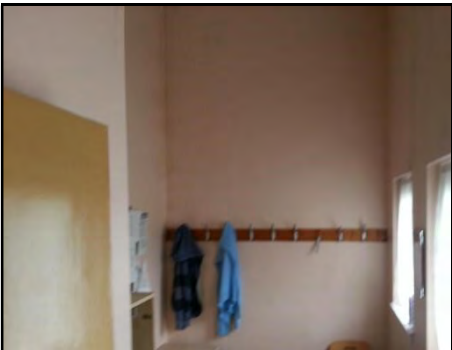
Building ID	Pinkie St Peters Primary School	Item Description	No Suspect Materials Seen
Sample No.		Material	-
Floor	Ground Floor	Asbestos Type	-
Room No.	R050E	Extent	-
Room ID	Staff Room	Notes:	Other - Timber door and surrounds, Timber skirtings, Timber window frames.

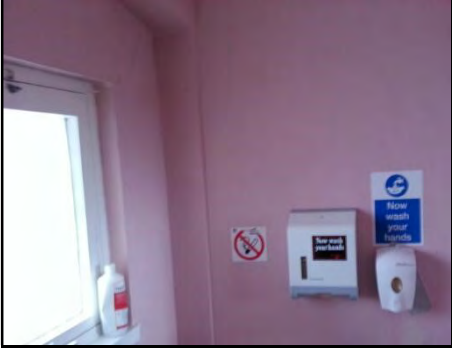
Building ID	Pinkie St Peters Primary School	Item Description	No Suspect Materials Seen
Sample No.		Material	-
Floor	Ground Floor	Asbestos Type	-
Room No.	R050F	Extent	-
Room ID	Toilet	Notes: Other - Timber door and surrounds, Timber skirtings, Timber window frame, Plastic cistern. .

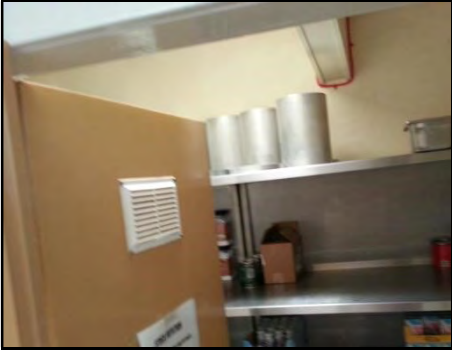
Building ID	Pinkie St Peters Primary School	Item Description	No Suspect Materials Seen
Sample No.		Material	-
Floor	Ground Floor	Asbestos Type	-
Room No.	R050G	Extent	-
Room ID	Kitchen Store	Notes: Ceiling - Metal and plastic skylight with timber and Plasterboard surrounds. Other - Timber door and surrounds, Timber skirtings.

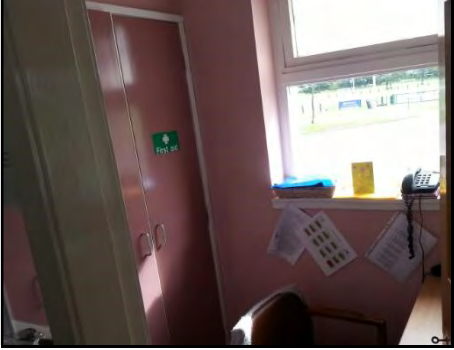
Building ID	Pinkie St Peters Primary School	Item Description	No Suspect Materials Seen
Sample No.		Material	-
Floor	Ground Floor	Asbestos Type	-
Room No.	R050H	Extent	-
Room ID	Office	Notes: Other - Timber door and surrounds, Timber skirtings, Timber window frame, Timber fitted cabinets.

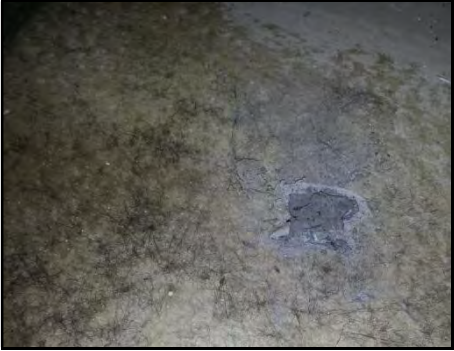
Building ID	Pinkie St Peters Primary School	Item Description	Bitumen adhesive to floor below modern screed
Sample No.	PS002	Material	Screed
Floor	Ground Floor	Asbestos Type	No Asbestos Detected
Room No.	R052	Extent	-
Room ID	GP Room	Notes: Ceiling - Plastic and metal skylight with plasterboard surrounds. Ceiling void / Above suspended ceiling - Plasterboard ceiling, Brick and Plasterboard walls, MMMF tiles in metal grid, MMMF insulated metal pipes, Metal cable trays. Walls - Plasterboard and timber stud partitions with MMMF insulated cavities. Other - Timber door and surrounds, Timber skirtings, Timber window frames, Metal radiators, Modern ceramic wall tiles, Modern metal sinks and heat pads.

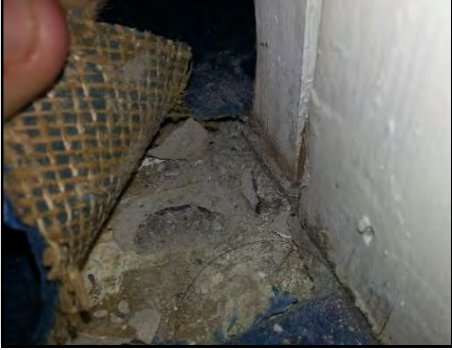
Building ID	Pinkie St Peters Primary School	Item Description	Bitumen adhesive to floor below modern screed
Sample No.	VSS002	Material	Screed
Floor	Ground Floor	Asbestos Type	No Asbestos Detected
Room No.	R052A	Extent	-
Room ID	Store	Notes: Ceiling void / Above suspended ceiling - Plasterboard and concrete ceiling, Brick and Plasterboard walls, MMMF tiles in metal grid, MMMF insulated metal pipes, Metal cable trays. Walls - Plasterboard and timber stud partitions with MMMF insulated cavities. Other - Timber door and surrounds, Timber skirtings, Timber window frame.

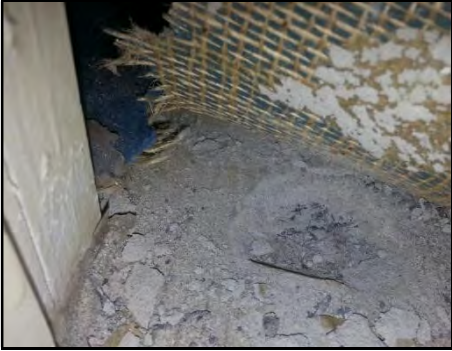
Building ID	Pinkie St Peters Primary School	Item Description	Bitumen adhesive to floor below modern screed
Sample No.	VSS002	Material	Screed
Floor	Ground Floor	Asbestos Type	No Asbestos Detected
Room No.	R053	Extent	-
Room ID	Store	Notes: Ceiling void / Above suspended ceiling - Plasterboard and concrete ceiling, Brick and Plasterboard walls, MMMF tiles in metal grid, MMMF insulated metal pipes, Metal cable trays. Walls - Plasterboard and timber stud partitions with MMMF insulated cavities. Other - Timber door and surrounds, Timber skirtings.

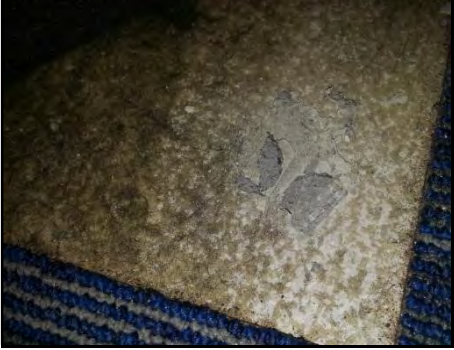
Building ID	Pinkie St Peters Primary School	Item Description	Bitumen adhesive to floor below modern screed
Sample No.	VSS002	Material	Screed
Floor	Ground Floor	Asbestos Type	No Asbestos Detected
Room No.	R054	Extent	-
Room ID	GP Room	Notes: Ceiling - Plastic and metal skylight with plasterboard surrounds. Ceiling void / Above suspended ceiling - Plasterboard and concrete ceiling, Brick and Plasterboard walls, MMMF tiles in metal grid, MMMF insulated metal pipes, Metal cable trays. Walls - Plasterboard and timber stud partitions with MMMF insulated cavities. Other - Timber door and surrounds, Timber skirtings, Timber window frames, Metal radiators, Modern ceramic wall tiles, Modern metal sinks and heat pads.

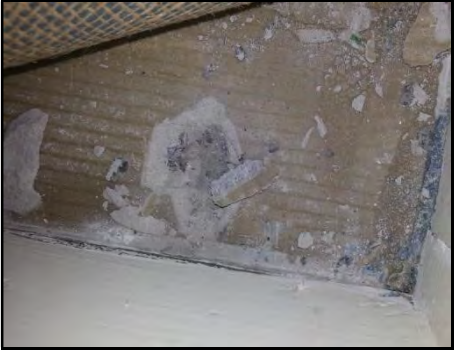
Building ID	Pinkie St Peters Primary School	Item Description	Bitumen adhesive to floor below modern screed
Sample No.	VSS002	Material	Screed
Floor	Ground Floor	Asbestos Type	No Asbestos Detected
Room No.	R054A	Extent	-
Room ID	Store	Notes: Ceiling void / Above suspended ceiling - Plasterboard and concrete ceiling, Brick and Plasterboard walls, MMMF tiles in metal grid, MMMF insulated metal pipes, Metal cable trays. Walls - Plasterboard and timber stud partitions with MMMF insulated cavities. Other - Timber door and surrounds, Timber skirtings.

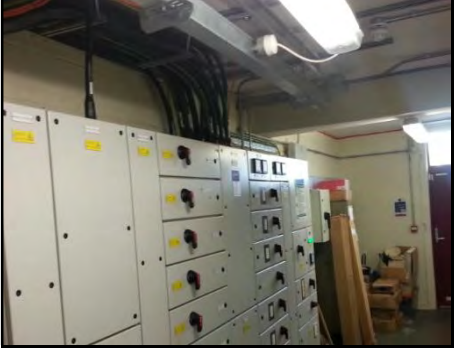
Building ID	Pinkie St Peters Primary School	Item Description	No Suspect Materials Seen
Sample No.		Material	-
Floor	Ground Floor	Asbestos Type	-
Room No.	R055	Extent	-
Room ID	Plant Room	Notes: Other - Timber doors and surrounds, Modern electrics distribution boards.

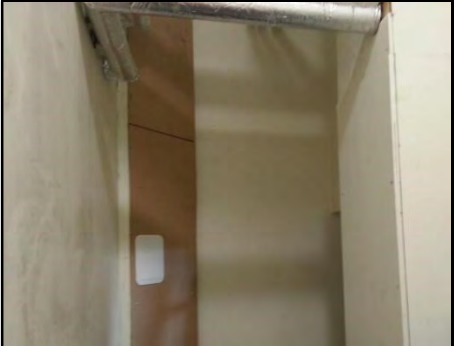
Building ID	Pinkie St Peters Primary School	Item Description	No Suspect Materials Seen
Sample No.		Material	-
Floor	Ground Floor	Asbestos Type	-
Room No.	R055A	Extent	-
Room ID	Plant Room	Notes: Other - Timber doors and surrounds, MMMF insulated metal pipes, Plastic waste pipe. Boxing's - Plastic downpipe and un-insulated metal pipes within timber riser on wall 1 / 2. MMMF and Hessian insulated metal pipes within timber riser on wall 3.

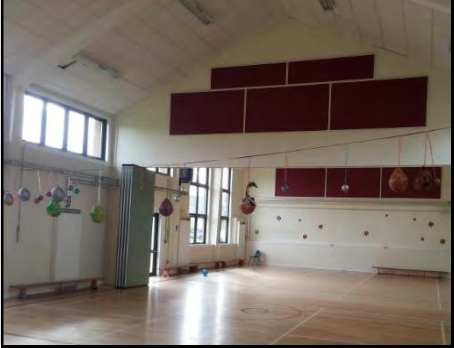
Building ID	Pinkie St Peters Primary School	Item Description	No Suspect Materials Seen
Sample No.		Material	-
Floor	Ground Floor	Asbestos Type	-
Room No.	R056	Extent	-
Room ID	Hall / Theatre	Notes: Ceiling void - Foil wrapped MMMF insulation above timber roof joists, concrete beams, Brick & Plaster walls, MMMF tiles in metal grid. Other - Timber doors and surrounds, Timber skirtings, Timber window frames, Metal radiators, MMMF insulated metal pipes.

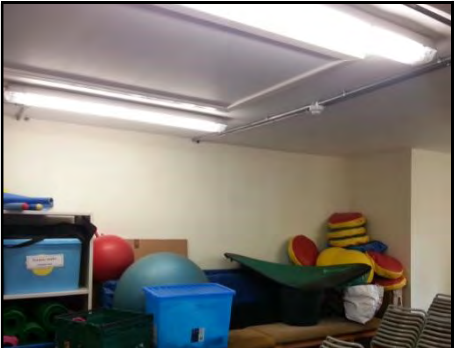
Building ID	Pinkie St Peters Primary School	Item Description	No Suspect Materials Seen
Sample No.		Material	-
Floor	Ground Floor	Asbestos Type	-
Room No.	R056A	Extent	-
Room ID	Storage	Notes: Other - Timber doors and surrounds, Timber window frames, Un-insulated metal pipes, Metal conduits.

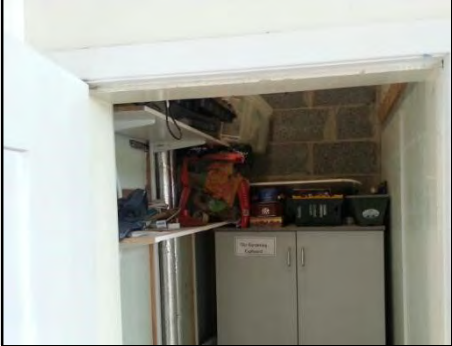
Building ID	Pinkie St Peters Primary School	Item Description	No Suspect Materials Seen
Sample No.		Material	-
Floor	Ground Floor	Asbestos Type	-
Room No.	R056B	Extent	-
Room ID	Store	Notes: Other - Timber door and surrounds, MMMF insulated metal pipes, Plastic waste pipe.

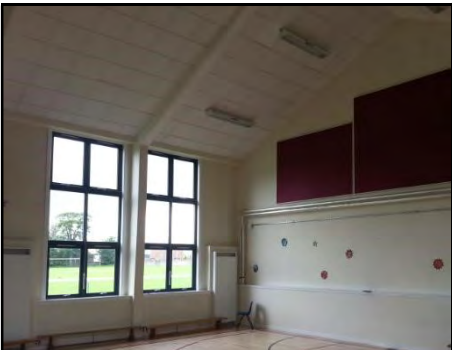
Building ID	Pinkie St Peters Primary School	Item Description	No Suspect Materials Seen
Sample No.		Material	-
Floor	Ground Floor	Asbestos Type	-
Room No.	R057	Extent	-
Room ID	Hall / Theatre	Notes: Ceiling void - Foil wrapped MMMF insulation above timber roof joists, concrete beams, Brick & Plaster walls, MMMF tiles in metal grid. Other - Timber doors and surrounds, Timber skirtings, Timber window frames, Metal radiators, MMMF insulated metal pipes.

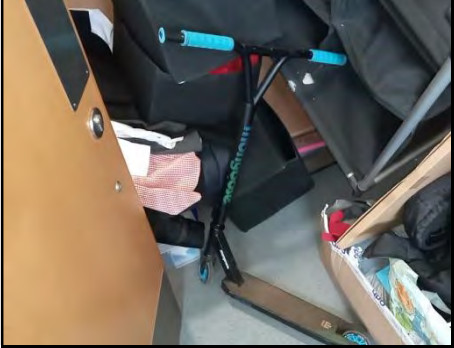
Building ID	Pinkie St Peters Primary School	Item Description	Bitumen adhesive and screed to floor
Sample No.	PS136	Material	Bituminous Products
Floor	Ground Floor	Asbestos Type	Chrysotile
Room No.	R058	Extent	2m2
Room ID	Circulation Area	Notes: The Bitumen adhesive is only on the concrete section of floor as marked on the plan. Limited access due to stored items Presume condition of ACM remains the same 11.07.2023

HSG 264 Material Assessment Scores				Priority Assessment Scores				Risk Priority Rating:
Product:	1	Condition:	0	Occupant Activity:	1	Likelihood of Disturbance:	2	3
Surface Treatment:	0	Asbestos Type:	1	Potential of Human Exposure:	2	Maintenance Activity:	1	
Material Score:	2	Material Category:	D	Priority Score:	6	Total Score (Overall):	8

Surveyor:	Reece Feenie
		Recommendation:	Manage and Monitor through annual re-inspection

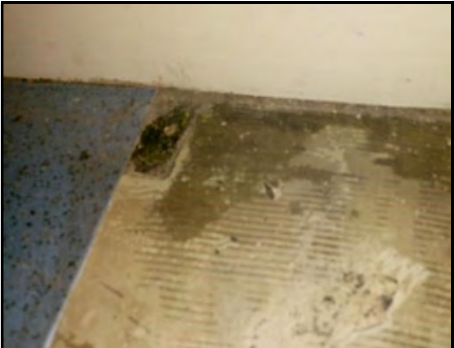
Building ID	Pinkie St Peters Primary School	Item Description	Bitumen adhesive and screed to floor
Sample No.	PS135	Material	Bituminous Products
Floor	Ground Floor	Asbestos Type	Chrysotile
Room No.	R059	Extent	15m2
Room ID	Janitors Office	Notes: Condition of ACM remains the same 11.07.2023

HSG 264 Material Assessment Scores				Priority Assessment Scores				Risk Priority Rating:
Product:	1	Condition:	0	Occupant Activity:	1	Likelihood of Disturbance:	2	3
Surface Treatment:	0	Asbestos Type:	1	Potential of Human Exposure:	2	Maintenance Activity:	1	
Material Score:	2	Material Category:	D	Priority Score:	6	Total Score (Overall):	8

Surveyor:	Reece Feenie
		Recommendation:	Manage and Monitor through annual re-inspection

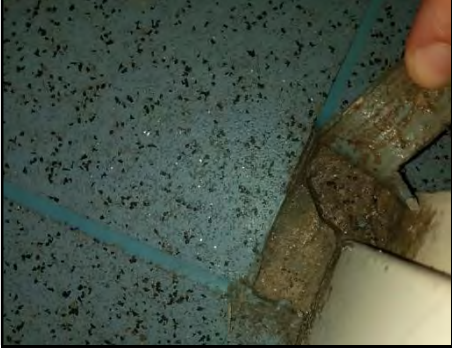
Building ID	Pinkie St Peters Primary School	Item Description	Bitumen adhesive to floor below modern screed
Sample No.	PSG13-01632 - 0049	Material	Bituminous Products
Floor	Ground Floor	Asbestos Type	Chrysotile
Room No.	R060	Extent	6m2
Room ID	W.C	Notes: Other - Timber door and surrounds, Timber window frame with Quarry tiles sills, Metal radiator, Ceramic cistern, Modern ceramic wall tiles. Condition of ACM remains the same 11.07.2023

HSG 264 Material Assessment Scores				Priority Assessment Scores				Risk Priority Rating:
Product:	1	Condition:	0	Occupant Activity:	0	Likelihood of Disturbance:	1	3
Surface Treatment:	0	Asbestos Type:	1	Potential of Human Exposure:	2	Maintenance Activity:	1	
Material Score:	2	Material Category:	D	Priority Score:	4	Total Score (Overall):	6

Surveyor:	Reece Feenie
		Recommendation:	Manage and Monitor through annual re-inspection

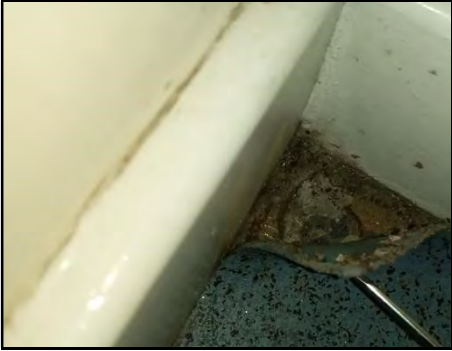
Building ID	Pinkie St Peters Primary School	Item Description	Bitumen adhesive to floor below modern screed
Sample No.	PSG13-01632 - 0049	Material	Bituminous Products
Floor	Ground Floor	Asbestos Type	Chrysotile
Room No.	R061	Extent	3m2
Room ID	W.C	Notes: Walls - Plasterboard and timber stud partitions with MMMF insulated cavities, Foam insulated copper pipes and Un-insulated plastic pipes. Other - Timber door and surrounds, Ceramic cistern, Modern ceramic wall tiles. Condition of ACM remains the same 11.07.2023

HSG 264 Material Assessment Scores				Priority Assessment Scores				Risk Priority Rating:
Product:	1	Condition:	0	Occupant Activity:	0	Likelihood of Disturbance:	1	3
Surface Treatment:	0	Asbestos Type:	1	Potential of Human Exposure:	2	Maintenance Activity:	1	
Material Score:	2	Material Category:	D	Priority Score:	4	Total Score (Overall):	6

Surveyor:	Reece Feenie
		Recommendation:	Manage and Monitor through annual re-inspection

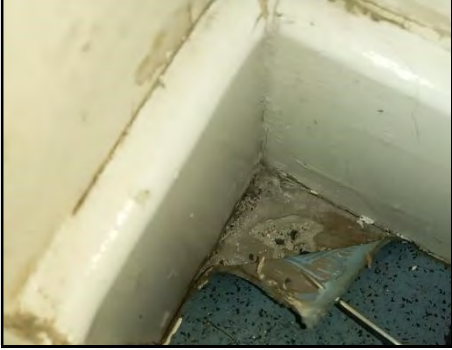
Building ID	Pinkie St Peters Primary School	Item Description	Bitumen adhesive to floor below modern screed
Sample No.	PSG13-01632 - 0049	Material	Bituminous Products
Floor	Ground Floor	Asbestos Type	Chrysotile
Room No.	R062	Extent	3m2
Room ID	W.C	Notes: Walls - Plasterboard and timber stud partitions with MMMF insulated cavities, Foam insulated copper pipes and Un-insulated plastic pipes. Other - Timber door and surrounds, Ceramic cistern, Modern ceramic wall tiles. Condition of ACM remains the same 11.07.2023

HSG 264 Material Assessment Scores				Priority Assessment Scores				Risk Priority Rating:
Product:	1	Condition:	0	Occupant Activity:	0	Likelihood of Disturbance:	1	3
Surface Treatment:	0	Asbestos Type:	1	Potential of Human Exposure:	2	Maintenance Activity:	1	
Material Score:	2	Material Category:	D	Priority Score:	4	Total Score (Overall):	6

Surveyor:	Reece Feenie
		Recommendation:	Manage and Monitor through annual re-inspection

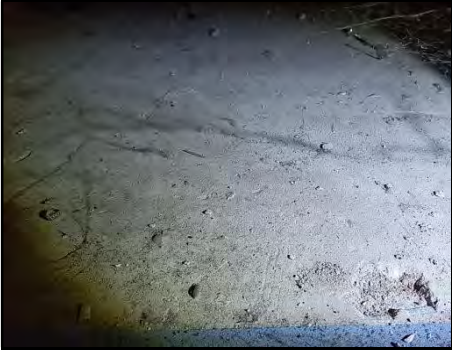
Building ID	Pinkie St Peters Primary School	Item Description	Bitumen adhesive and screed to floor below kitchen units and modern vinyl
Sample No.	PS137	Material	Bituminous Products
Floor	Ground Floor	Asbestos Type	Chrysotile
Room No.	R063	Extent	18m2
Room ID	Staff Room / Workbase	Notes: Condition of ACM remains the same 11.07.2023

HSG 264 Material Assessment Scores				Priority Assessment Scores				Risk Priority Rating:
Product:	1	Condition:	0	Occupant Activity:	1	Likelihood of Disturbance:	2	3
Surface Treatment:	0	Asbestos Type:	1	Potential of Human Exposure:	2	Maintenance Activity:	1	
Material Score:	2	Material Category:	D	Priority Score:	6	Total Score (Overall):	8

Surveyor:	Reece Feenie
		Recommendation:	Manage and Monitor through annual re-inspection

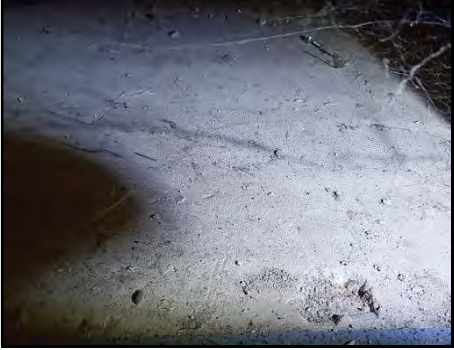
Building ID	Pinkie St Peters Primary School	Item Description	Bitumen adhesive and screed to floor below Carpet tiles
Sample No.	PS138	Material	Bituminous Products
Floor	Ground Floor	Asbestos Type	Chrysotile
Room No.	R063	Extent	60m2
Room ID	Staff Room / Workbase	Notes: Condition of ACM remains the same 11.07.2023

HSG 264 Material Assessment Scores				Priority Assessment Scores				Risk Priority Rating:
Product:	1	Condition:	0	Occupant Activity:	1	Likelihood of Disturbance:	2	3
Surface Treatment:	0	Asbestos Type:	1	Potential of Human Exposure:	2	Maintenance Activity:	1	
Material Score:	2	Material Category:	D	Priority Score:	6	Total Score (Overall):	8

Surveyor:	Reece Feenie
		Recommendation:	Manage and Monitor through annual re-inspection
