Asbestos Re-inspection Report Up-date

Pinkie St Peters Primary School, 44 Pinkie Road, Musselburgh, East Lothian, EH21 7HA

Contact:	Grant Fraser	Issue Number:	2
Customer:	East Lothian Council	Survey Dates:	10 July 2023
Project No:	G24-00142	Report Issue Date:	08 February 2024

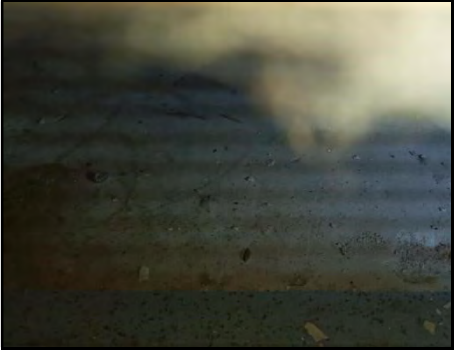
Building ID	Pinkie St Peters Primary School	Item Description	Bitumen adhesive to floor below modern screed
Sample No.	PSG13-01632 - 0049	Material	Bituminous Products
Floor	Ground Floor	Asbestos Type	Chrysotile
Room No.	R063	Extent	78m2
Room ID	Staff Room / Workbase	Notes: Other - Timber doors and surrounds, Timber skirtings, Timber window frames with Quarry tiles sills, Metal radiator, Modern ceramic wall tiles, Modern metal sink and heat pads. Boxing's - MMMF insulated metal pipes within timber boxing's on wall 1 / 4. Condition of ACM remains the same 11.07.2023

HSG 264 Material Assessment Scores				Priority Assessment Scores				Risk Priority Rating:
Product:	1	Condition:	0	Occupant Activity:	1	Likelihood of Disturbance:	2	3
Surface Treatment:	0	Asbestos Type:	1	Potential of Human Exposure:	3	Maintenance Activity:	1	
Material Score:	2	Material Category:	D	Priority Score:	7	Total Score (Overall):	9

Surveyor:	Reece Feenie
		Recommendation:	Manage and Monitor through annual re-inspection

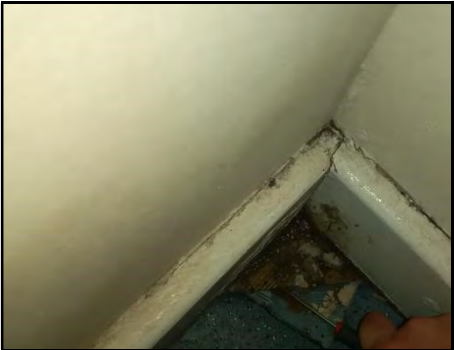
Building ID	Pinkie St Peters Primary School	Item Description	Bitumen adhesive to floor below modern screed
Sample No.	PSG13-01632 - 0049	Material	Bituminous Products
Floor	Ground Floor	Asbestos Type	Chrysotile
Room No.	R064A	Extent	52m2
Room ID	Circulation Area	Notes: Ceiling void / Above suspended ceiling - Plasterboard ceiling, Brick & Plaster and Plasterboard walls, MMMF tiles in metal grid, Metal cable trays, MMMF insulated metal pipes. Other - Timber doors and surrounds, Timber skirtings, Timber window frames, Metal radiators. Boxing's - MMMF insulated metal pipes within timber ceiling boxing's. MMMF insulated copper pipes and Un-insulated copper pipes within Plasterboard riser on wall 4 behind metal hatch doors. Condition of ACM remains the same 11.07.2023

HSG 264 Material Assessment Scores				Priority Assessment Scores				Risk Priority Rating:
Product:	1	Condition:	0	Occupant Activity:	0	Likelihood of Disturbance:	2	3
Surface Treatment:	0	Asbestos Type:	1	Potential of Human Exposure:	2	Maintenance Activity:	1	
Material Score:	2	Material Category:	D	Priority Score:	5	Total Score (Overall):	7

Surveyor:	Reece Feenie
		Recommendation:	Manage and Monitor through annual re-inspection

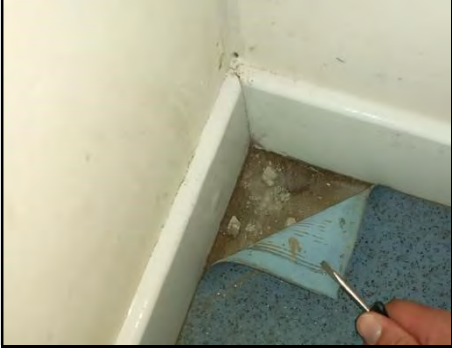
Building ID	Pinkie St Peters Primary School	Item Description	Bitumen adhesive to floor below modern screed
Sample No.	PSG13-01632 - 0049	Material	Bituminous Products
Floor	Ground Floor	Asbestos Type	Chrysotile
Room No.	R065	Extent	47m2
Room ID	Circulation Area	Notes: Ceiling - Glass skylights with concrete surrounds. Other - Timber doors and surrounds, Timber skirtings, Metal radiators. Condition of ACM remains the same 11.07.2023

HSG 264 Material Assessment Scores				Priority Assessment Scores				Risk Priority Rating:
Product:	1	Condition:	0	Occupant Activity:	1	Likelihood of Disturbance:	2	3
Surface Treatment:	0	Asbestos Type:	1	Potential of Human Exposure:	2	Maintenance Activity:	1	
Material Score:	2	Material Category:	D	Priority Score:	6	Total Score (Overall):	8

Surveyor:	Reece Feenie
		Recommendation:	Manage and Monitor through annual re-inspection

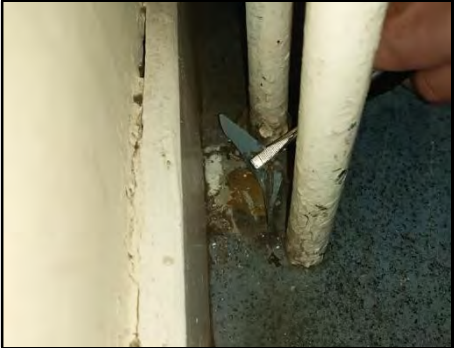
Building ID	Pinkie St Peters Primary School	Item Description	Bitumen adhesive to floor below modern screed
Sample No.	PSG13-01632 - 0068	Material	Bituminous Products
Floor	Ground Floor	Asbestos Type	Chrysotile
Room No.	R067	Extent	80m2
Room ID	Circulation Area	Notes: Ceiling void / Above suspended ceiling - Plasterboard and concrete ceilings, Brick & Plaster and Plasterboard walls, MMMF tiles in metal grid, Metal cable trays, MMMF insulated metal pipes. Other - Timber doors and surrounds, Timber skirtings, Timber window frames, Metal radiators, Modern metal encased trip switch electrics. Condition of ACM remains the same 10.07.2023

HSG 264 Material Assessment Scores				Priority Assessment Scores				Risk Priority Rating:
Product:	1	Condition:	0	Occupant Activity:	0	Likelihood of Disturbance:	2	3
Surface Treatment:	0	Asbestos Type:	1	Potential of Human Exposure:	2	Maintenance Activity:	1	
Material Score:	2	Material Category:	D	Priority Score:	5	Total Score (Overall):	7

Surveyor:	Reece Feenie
		Recommendation:	Manage and Monitor through annual re-inspection

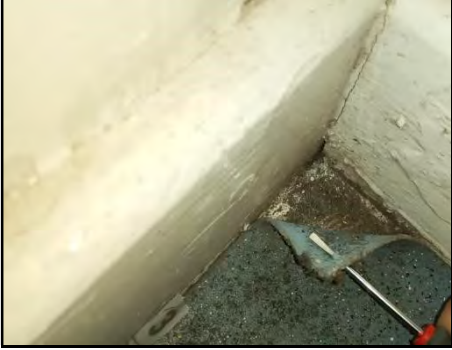
Building ID	Pinkie St Peters Primary School	Item Description	Bitumen adhesive to floor below modern screed
Sample No.	PSG13-01632 - 0049	Material	Bituminous Products
Floor	Ground Floor	Asbestos Type	Chrysotile
Room No.	R068	Extent	18m2
Room ID	Circulation Area	Notes: Ceiling - Plastic skylight with concrete surrounds. Ceiling void / Above suspended ceiling - Plasterboard ceiling, Brick & Plaster and Plasterboard walls, MMMF tiles in metal grid, Metal cable trays, MMMF insulated metal pipes. Other - Timber doors and surrounds, Timber skirtings, Timber window frames, Rubber stairs coverings. Condition of ACM remains the same 11.07.2023

HSG 264 Material Assessment Scores				Priority Assessment Scores				Risk Priority Rating:
Product:	1	Condition:	0	Occupant Activity:	0	Likelihood of Disturbance:	2	3
Surface Treatment:	3	Asbestos Type:	1	Potential of Human Exposure:	2	Maintenance Activity:	1	
Material Score:	5	Material Category:	C	Priority Score:	5	Total Score (Overall):	10

Surveyor:	Reece Feenie
		Recommendation:	Manage and Monitor through annual re-inspection

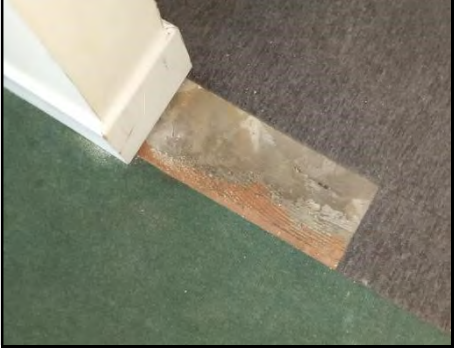
Building ID	Pinkie St Peters Primary School	Item Description	Bitumen adhesive to Red vinyl floor tiles and below carpet and modern vinyl flooring
Sample No.	PS003	Material	Bituminous Products
Floor	First Floor	Asbestos Type	Chrysotile
Room No.	R005	Extent	56m2
Room ID	Classroom	Notes: Other - Timber door and surrounds, Timber window frames, Metal radiators, Un-insulated metal pipes, Ceramic sink Condition of ACM remains the same 11.07.2023

HSG 264 Material Assessment Scores				Priority Assessment Scores				Risk Priority Rating:
Product:	1	Condition:	0	Occupant Activity:	1	Likelihood of Disturbance:	2	3
Surface Treatment:	0	Asbestos Type:	1	Potential of Human Exposure:	3	Maintenance Activity:	0	
Material Score:	2	Material Category:	D	Priority Score:	6	Total Score (Overall):	8

Surveyor:	Reece Feenie
		Recommendation:	Manage and Monitor through annual re-inspection

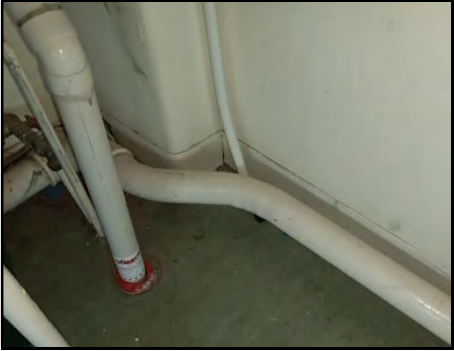
Building ID	Pinkie St Peters Primary School	Item Description	Black resin skirtings
Sample No.	PSG13-01632 - 0078	Material	Resin Products
Floor	First Floor	Asbestos Type	Chrysotile
Room No.	R005	Extent	26lin m
Room ID	Classroom	Notes: Other - Timber door and surrounds, Timber window frames, Metal radiators, Un-insulated metal pipes, Ceramic sink Condition of ACM remains the same 11.07.2023

HSG 264 Material Assessment Scores				Priority Assessment Scores				Risk Priority Rating:
Product:	1	Condition:	0	Occupant Activity:	1	Likelihood of Disturbance:	2	3
Surface Treatment:	0	Asbestos Type:	1	Potential of Human Exposure:	3	Maintenance Activity:	1	
Material Score:	2	Material Category:	D	Priority Score:	7	Total Score (Overall):	9

Surveyor:	Reece Feenie
		Recommendation:	Manage and Monitor through annual re-inspection

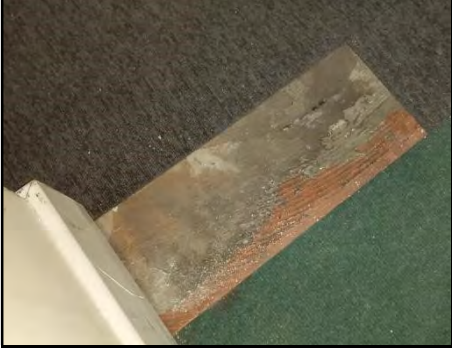
Building ID	Pinkie St Peters Primary School	Item Description	Red vinyl floor tiles below carpet
Sample No.	PSG13-01632 - 0079	Material	Floor Tiles
Floor	First Floor	Asbestos Type	Chrysotile
Room No.	R005	Extent	38m2
Room ID	Classroom	Notes: Other - Timber door and surrounds, Timber window frames, Metal radiators, Un-insulated metal pipes, Ceramic sink Condition of ACM remains the same 11.07.2023

HSG 264 Material Assessment Scores				Priority Assessment Scores				Risk Priority Rating:
Product:	1	Condition:	0	Occupant Activity:	1	Likelihood of Disturbance:	2	3
Surface Treatment:	0	Asbestos Type:	1	Potential of Human Exposure:	3	Maintenance Activity:	1	
Material Score:	2	Material Category:	D	Priority Score:	7	Total Score (Overall):	9

Surveyor:	Reece Feenie
		Recommendation:	Manage and Monitor through annual re-inspection

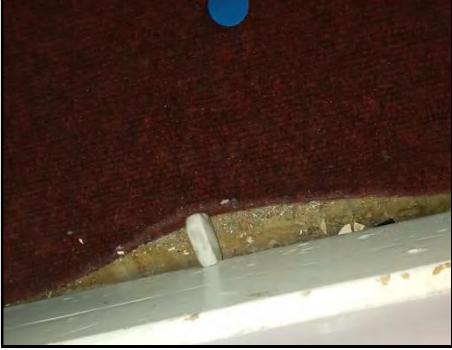
Building ID	Pinkie St Peters Primary School	Item Description	Red vinyl floor tiles below carpet and modern vinyl flooring
Sample No.	PSG13-01632 - 0079	Material	Floor Tiles
Floor	First Floor	Asbestos Type	Chrysotile
Room No.	R011	Extent	8m2
Room ID	Classroom	Notes: Other - Timber door and surrounds, Timber skirtings, Timber window frames with Quarry tiles sills, Metal radiators, Un-insulated metal pipes, Ceramic sink Condition of ACM remains the same 11.07.2023

HSG 264 Material Assessment Scores				Priority Assessment Scores				Risk Priority Rating:
Product:	1	Condition:	0	Occupant Activity:	1	Likelihood of Disturbance:	1	3
Surface Treatment:	0	Asbestos Type:	1	Potential of Human Exposure:	3	Maintenance Activity:	1	
Material Score:	2	Material Category:	D	Priority Score:	6	Total Score (Overall):	8

Surveyor:	Reece Feenie
		Recommendation:	Manage and Monitor through annual re-inspection

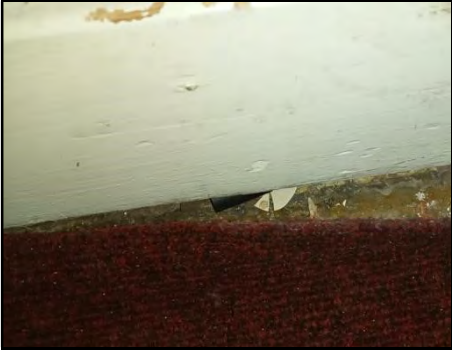
Building ID	Pinkie St Peters Primary School	Item Description	Bitumen adhesive to Red vinyl floor tiles and below carpet and modern vinyl flooring
Sample No.	VSS003	Material	Bituminous Products
Floor	First Floor	Asbestos Type	Chrysotile
Room No.	R011	Extent	56m2
Room ID	Classroom	Notes: Other - Timber door and surrounds, Timber skirtings, Timber window frames with Quarry tiles sills, Metal radiators, Un-insulated metal pipes, Ceramic sink. Condition of ACM remains the same 11.07.2023

HSG 264 Material Assessment Scores				Priority Assessment Scores				Risk Priority Rating:
Product:	1	Condition:	0	Occupant Activity:	1	Likelihood of Disturbance:	1	3
Surface Treatment:	0	Asbestos Type:	1	Potential of Human Exposure:	3	Maintenance Activity:	1	
Material Score:	2	Material Category:	D	Priority Score:	6	Total Score (Overall):	8

Surveyor:	Reece Feenie
		Recommendation:	Manage and Monitor through annual re-inspection

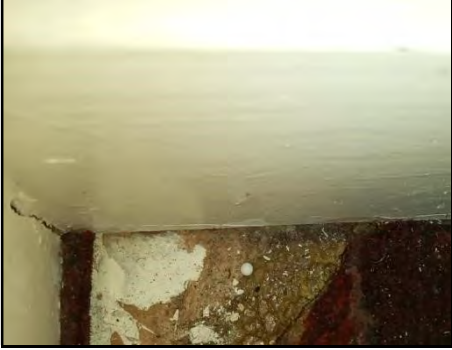
Building ID	Pinkie St Peters Primary School	Item Description	Bitumen adhesive to floor below Beige vinyl floor covering
Sample No.	VSS003	Material	Bituminous Products
Floor	First Floor	Asbestos Type	Chrysotile
Room No.	R012	Extent	56m2
Room ID	Classroom	Notes: Floor - Beige vinyl floor covering below carpet and modern vinyl flooring previously sampled and did not contain asbestos. Other - Timber door and surrounds, Timber skirtings, Timber window frames with Quarry tiles sills, Metal radiators, Un-insulated metal pipes, Ceramic sink Condition of ACM remains the same 11.07.2023

HSG 264 Material Assessment Scores				Priority Assessment Scores				Risk Priority Rating:
Product:	1	Condition:	0	Occupant Activity:	1	Likelihood of Disturbance:	2	3
Surface Treatment:	0	Asbestos Type:	1	Potential of Human Exposure:	3	Maintenance Activity:	0	
Material Score:	2	Material Category:	D	Priority Score:	6	Total Score (Overall):	8

Surveyor:	Reece Feenie
		Recommendation:	Manage and Monitor through annual re-inspection

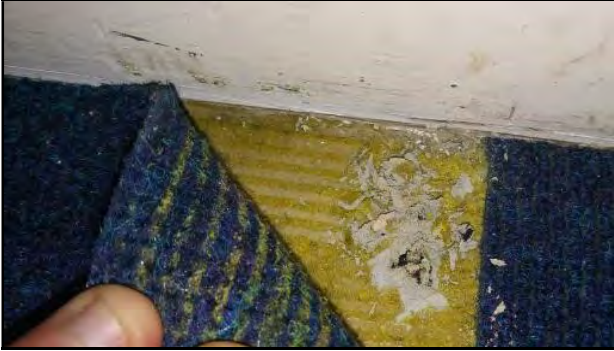
Building ID	Pinkie St Peters Primary School	Item Description	Bitumen adhesive to floor below carpet and modern vinyl flooring
Sample No.	PS004	Material	Bituminous Products
Floor	First Floor	Asbestos Type	Chrysotile
Room No.	R013	Extent	56m2
Room ID	Classroom	Notes: Other - Timber door and surrounds, Timber skirtings, Timber window frames with Quarry tiles sills, Metal radiators, Un-insulated metal pipes, Ceramic sink Condition of ACM remains the same 11.07.2023

HSG 264 Material Assessment Scores				Priority Assessment Scores				Risk Priority Rating:
Product:	1	Condition:	0	Occupant Activity:	1	Likelihood of Disturbance:	2	3
Surface Treatment:	0	Asbestos Type:	1	Potential of Human Exposure:	3	Maintenance Activity:	1	
Material Score:	2	Material Category:	D	Priority Score:	7	Total Score (Overall):	9

Surveyor:	Reece Feenie
		Recommendation:	Manage and Monitor through annual re-inspection

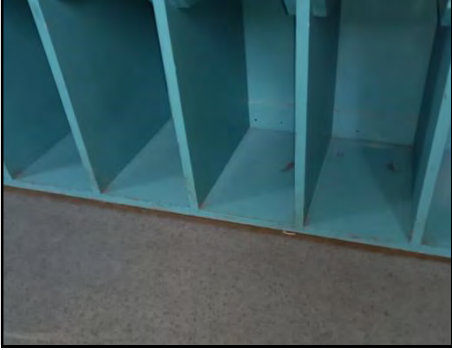
Building ID	Pinkie St Peters Primary School	Item Description	Black resin skirtings behind shoe boxes outside locations R011 and R012
Sample No.	PSG13-01632 - 0078	Material	Resin Products
Floor	First Floor	Asbestos Type	Chrysotile
Room No.	R022	Extent	12lin m
Room ID	Circulation Areas	Notes: Other - Timber doors and surrounds, Timber skirtings, Timber window frames with Quarry tiles sills, Metal radiators, Un-insulated metal pipes, Modern metal encased trip switch electrics. Condition of ACM remains the same 11.07.2023

HSG 264 Material Assessment Scores				Priority Assessment Scores			Risk Priority Rating:
Product:	1	Condition:	0	Occupant Activity:	0	Likelihood of Disturbance:	2
Surface Treatment:	0	Asbestos Type:	1	Potential of Human Exposure:	2	Maintenance Activity:	1
Material Score:	2	Material Category:	D	Priority Score:	5	Total Score (Overall):	7
							3

Surveyor:	Reece Feenie
		Recommendation:	Manage and Monitor through annual re-inspection

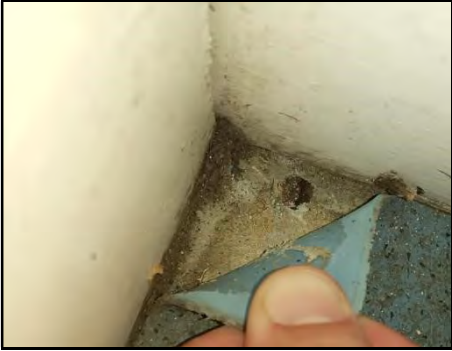
Building ID	Pinkie St Peters Primary School	Item Description	Bitumen adhesive to floor below modern vinyl flooring
Sample No.	VSS008	Material	Bituminous Products
Floor	First Floor	Asbestos Type	Chrysotile
Room No.	R022A	Extent	14m2
Room ID	Circulation Areas	Notes: Ceiling - Plastic skylight. Floor - Rubber stairs coverings. Other - Timber doors and surrounds, Timber skirtings, Timber window frames with Quarry tiles sills, Un-insulated metal pipes. Condition of ACM remains the same 11.07.2023

HSG 264 Material Assessment Scores				Priority Assessment Scores			Risk Priority Rating:
Product:	1	Condition:		Occupant Activity:	0	Likelihood of Disturbance:	0
Surface Treatment:		Asbestos Type:	1	Potential of Human Exposure:	0	Maintenance Activity:	0
Material Score:	2	Material Category:	D	Priority Score:	0	Total Score (Overall):	2
							3

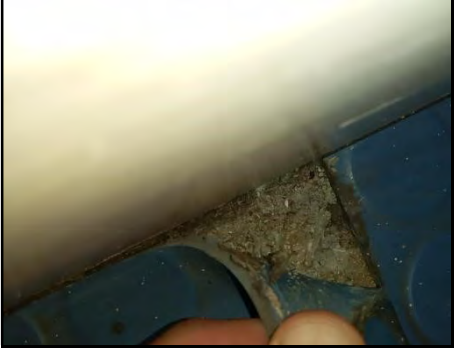
Building ID	Pinkie St Peters Primary School	Item Description	Red vinyl floor tiles below rubber floor tiles
Sample No.	VSS007	Material	Floor Tiles
Floor	First Floor	Asbestos Type	Chrysotile
Room No.	R022B	Extent	2m2
Room ID	Circulation Areas	Notes: Ceiling - Plastic skylight. Floor - Rubber stairs coverings. Other - Timber door and surrounds, Timber skirtings. Condition of ACM remains the same 11.07.2023

HSG 264 Material Assessment Scores				Priority Assessment Scores				Risk Priority Rating:
Product:	1	Condition:	0	Occupant Activity:	0	Likelihood of Disturbance:	1	3
Surface Treatment:	0	Asbestos Type:	1	Potential of Human Exposure:	2	Maintenance Activity:	0	
Material Score:	2	Material Category:	D	Priority Score:	3	Total Score (Overall):	5

Surveyor:	Reece Feenie
		Recommendation:	Manage and Monitor through annual re-inspection

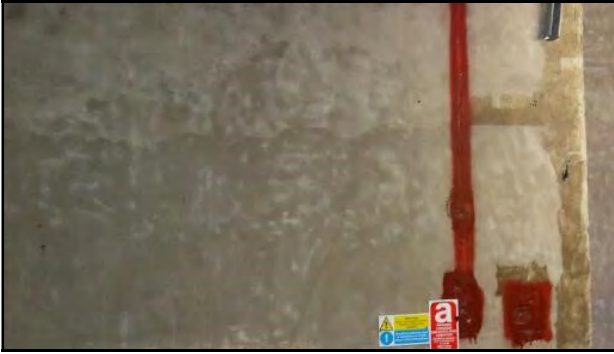
Building ID	Pinkie St Peters Primary School	Item Description	Insulation Residues Insulation residue on Wall 9
Sample No.	SP010	Material	Insulation Residues
Floor	First Basement Level	Asbestos Type	Presumed Asbestos
Room No.	R001	Extent	5lin m
Room ID	Former Boiler House Wall 9	Notes: The residues are marked with red paint where the wall couldn't be blasted without damaging fittings during previous removal works. The residues have to be referred back to previous survey G13-01632. The exact size of residues left on this wall is 495cm. Other - MMMF insulated metal pipes, Metal conduits. No access due to door being locked and no key available. Previous photo used for reference. Presume condition of ACM remains the same - 11.07.2023

HSG 264 Material Assessment Scores				Priority Assessment Scores				Risk Priority Rating:
Product:	3	Condition:	1	Occupant Activity:	0	Likelihood of Disturbance:	1	3
Surface Treatment:	2	Asbestos Type:	3	Potential of Human Exposure:	0	Maintenance Activity:	0	
Material Score:	9	Material Category:	B	Priority Score:	1	Total Score (Overall):	10

Surveyor:	Reece Feenie
		Recommendation:	Manage and Monitor through annual re-inspection

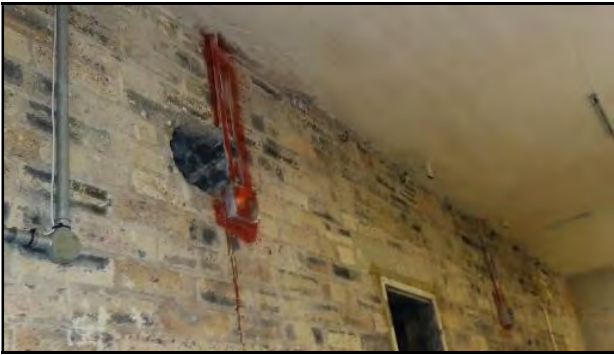
Building ID	Pinkie St Peters Primary School	Item Description	Insulation Residues Insulation residue on Wall 3
Sample No.	SP003	Material	Insulation Residues
Floor	First Basement Level	Asbestos Type	Presumed Asbestos
Room No.	R001	Extent	1.7lin m
Room ID	Former Boiler House Wall 3	Notes: The residues are marked with red paint where the wall couldn't be blasted without damaging fittings during previous removal works. The residues have to be referred back to previous survey G13-01632. The exact size of residues left on this wall is 174cm. Other - MMMF insulated metal pipes, Metal conduits. No access due to door being locked and no key available. Previous photo used for reference. Presume condition of ACM remains the same - 11.07.2023

HSG 264 Material Assessment Scores				Priority Assessment Scores				Risk Priority Rating:
Product:	3	Condition:	1	Occupant Activity:	0	Likelihood of Disturbance:	1	3
Surface Treatment:	2	Asbestos Type:	3	Potential of Human Exposure:	0	Maintenance Activity:	0	
Material Score:	9	Material Category:	B	Priority Score:	1	Total Score (Overall):	10

Surveyor:	Reece Feenie
		Recommendation:	Manage and Monitor through annual re-inspection

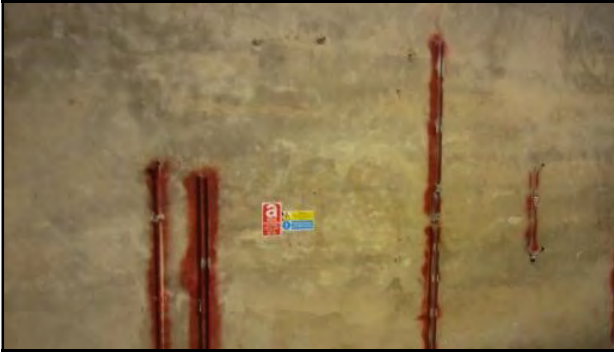
Building ID	Pinkie St Peters Primary School	Item Description	Insulation Residues Insulation residue on Wall 4
Sample No.	SP004	Material	Insulation Residues
Floor	First Basement Level	Asbestos Type	Presumed Asbestos
Room No.	R001	Extent	6.9lin m
Room ID	Former Boiler House Wall 4	Notes: The residues are marked with red paint where the wall couldn't be blasted without damaging fittings during previous removal works. The residues have to be referred back to previous survey G13-01632. The exact size of residues left on this wall is 690cm. Other - MMMF insulated metal pipes, Metal conduits. No access due to door being locked and no key available. Previous photo used for reference. Presume condition of ACM remains the same - 11.07.2023

HSG 264 Material Assessment Scores				Priority Assessment Scores				Risk Priority Rating:
Product:	3	Condition:	1	Occupant Activity:	0	Likelihood of Disturbance:	1	3
Surface Treatment:	2	Asbestos Type:	3	Potential of Human Exposure:	0	Maintenance Activity:	0	
Material Score:	9	Material Category:	B	Priority Score:	1	Total Score (Overall):	10

Surveyor:	Reece Feenie
		Recommendation:	Manage and Monitor through annual re-inspection

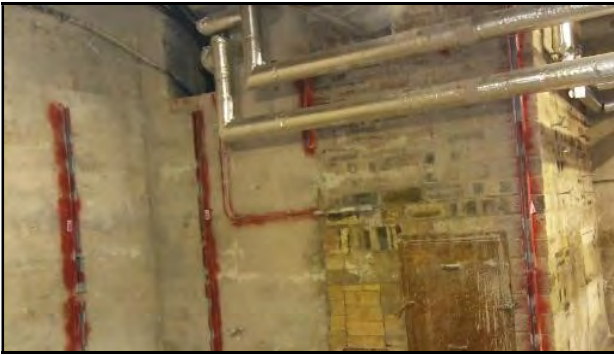
Building ID	Pinkie St Peters Primary School	Item Description	Insulation Residues Insulation residue on Wall 5
Sample No.	SP005	Material	Insulation Residues
Floor	First Basement Level	Asbestos Type	Presumed Asbestos
Room No.	R001	Extent	6.8lin m
Room ID	Former Boiler House Wall 5	Notes: The residues are marked with red paint where the wall couldn't be blasted without damaging fittings during previous removal works. The residues have to be referred back to previous survey G13-01632. The exact size of residues left on this wall is 680cm. Other - MMMF insulated metal pipes, Metal conduits. No access due to door being locked and no key available . Previous photo used for reference. Presume condition of ACM remains the same - 11.07.2023

HSG 264 Material Assessment Scores				Priority Assessment Scores				Risk Priority Rating:
Product:	3	Condition:	1	Occupant Activity:	0	Likelihood of Disturbance:	1	3
Surface Treatment:	2	Asbestos Type:	3	Potential of Human Exposure:	0	Maintenance Activity:	0	
Material Score:	9	Material Category:	B	Priority Score:	1	Total Score (Overall):	10

Surveyor:	Reece Feenie
		Recommendation:	Manage and Monitor through annual re-inspection

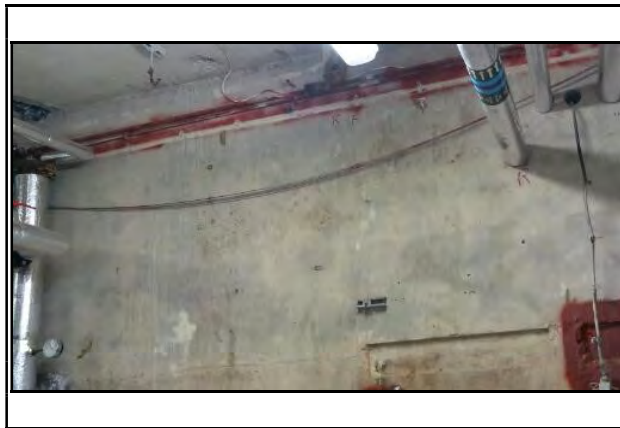
Building ID	Pinkie St Peters Primary School
Sample No.	SP006
Floor	First Basement Level
Room No.	R001
Room ID	Former Boiler House Wall 6

Item Description	Insulation Residues Insulation residue on Wall 6
-------------------------	--

Notes:
 The residues are marked with red paint where the wall couldn't be blasted without damaging fittings during previous removal works.
 The residues have to be referred back to previous survey G13-01632. The exact size of residues left on this wall is 560cm.
 Other - MMMF insulated metal pipes, Metal conduits.
 No access due to door being locked and no key available. Previous photo used for reference.
 Presume condition of ACM remains the same - 11.07.2023

HSG 264 Material Assessment Scores				Priority Assessment Scores				Risk Priority Rating:
Product:	3	Condition:	1	Occupant Activity:	0	Likelihood of Disturbance:	1	3
Surface Treatment:	2	Asbestos Type:	3	Potential of Human Exposure:	0	Maintenance Activity:	0	
Material Score:	9	Material Category:	B	Priority Score:	1	Total Score (Overall):	10

Recommendation:	Manage and Monitor through annual re-inspection
------------------------	---

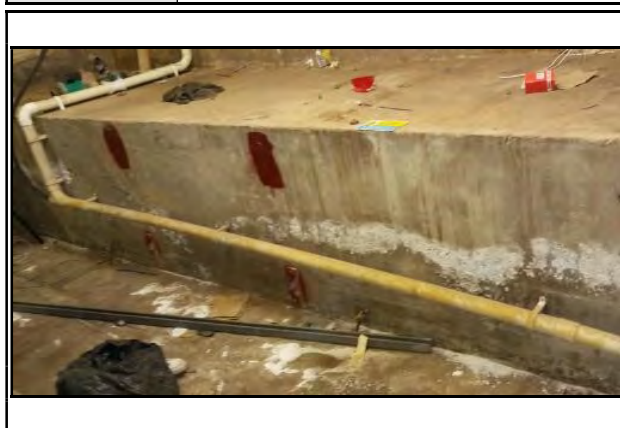
Building ID	Pinkie St Peters Primary School
Sample No.	SP007
Floor	First Basement Level
Room No.	R001
Room ID	Former Boiler House Wall 6 low level

Item Description	Insulation Residues Insulation residue on Wall 6 low level
-------------------------	--

Notes:
 The residues are marked with red paint where the wall couldn't be blasted without damaging fittings during previous removal works.
 The residues have to be referred back to previous survey G13-01632. The exact size of residues left on this wall is 84cm.
 Other - MMMF insulated metal pipes, Metal conduits.
 No access due to door being locked and no key available . Previous photo used for reference.
 Presume condition of ACM remains the same - 11.07.2023

HSG 264 Material Assessment Scores				Priority Assessment Scores				Risk Priority Rating:
Product:	3	Condition:	1	Occupant Activity:	0	Likelihood of Disturbance:	1	3
Surface Treatment:	2	Asbestos Type:	3	Potential of Human Exposure:	0	Maintenance Activity:	0	
Material Score:	9	Material Category:	B	Priority Score:	1	Total Score (Overall):	10

Recommendation:	Manage and Monitor through annual re-inspection
------------------------	---

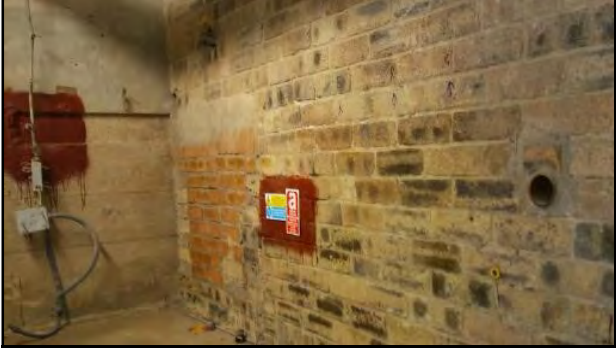
Building ID	Pinkie St Peters Primary School	Item Description	Insulation Residues Insulation residue on Wall 7
Sample No.	SP008	Material	Insulation Residues
Floor	First Basement Level	Asbestos Type	Presumed Asbestos
Room No.	R001	Extent	.67lin m
Room ID	Former Boiler House Wall 7	Notes: The residues are marked with red paint where the wall couldn't be blasted without damaging fittings during previous removal works. The residues have to be referred back to previous survey G13-01632. The exact size of residues left on this wall is 67cm. Other - MMMF insulated metal pipes, Metal conduits. No access due to door being locked and no key available. Previous photo used for reference. Presume condition of ACM remains the same - 11.07.2023.

HSG 264 Material Assessment Scores				Priority Assessment Scores				Risk Priority Rating:
Product:	3	Condition:	1	Occupant Activity:	0	Likelihood of Disturbance:	1	3
Surface Treatment:	2	Asbestos Type:	3	Potential of Human Exposure:	0	Maintenance Activity:	0	
Material Score:	9	Material Category:	B	Priority Score:	1	Total Score (Overall):	10

Surveyor:	Reece Feenie
		Recommendation:	Manage and Monitor through annual re-inspection

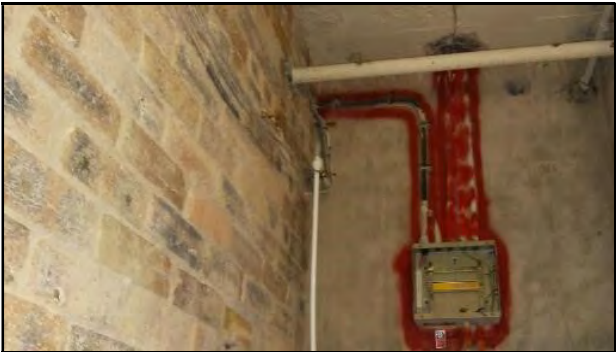
Building ID	Pinkie St Peters Primary School	Item Description	Insulation Residues Insulation residue on Wall 8
Sample No.	SP009	Material	Insulation Residues
Floor	First Basement Level	Asbestos Type	Presumed Asbestos
Room No.	R001	Extent	3.7lin m
Room ID	Former Boiler House Wall 8	Notes: The residues are marked with red paint where the wall couldn't be blasted without damaging fittings during previous removal works. The residues have to be referred back to previous survey G13-01632. The exact size of residues left on this wall is 365cm. Other - MMMF insulated metal pipes, Metal conduits. No access due to door being locked and no key available. Previous photo used for reference. Presume condition of ACM remains the same - 11.07.2023.

HSG 264 Material Assessment Scores				Priority Assessment Scores				Risk Priority Rating:
Product:	3	Condition:	1	Occupant Activity:	0	Likelihood of Disturbance:	1	3
Surface Treatment:	2	Asbestos Type:	3	Potential of Human Exposure:	0	Maintenance Activity:	0	
Material Score:	9	Material Category:	B	Priority Score:	1	Total Score (Overall):	10

Surveyor:	Reece Feenie
		Recommendation:	Manage and Monitor through annual re-inspection

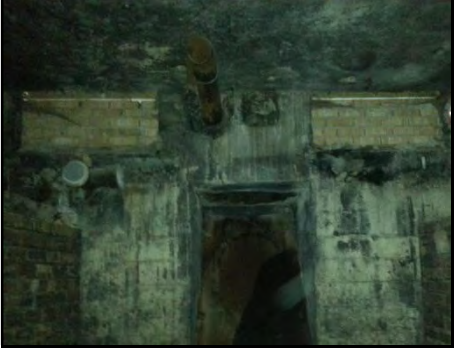
Building ID	Pinkie St Peters Primary School	Item Description	No Suspect Materials Seen
Sample No.		Material	-
Floor	First Basement Level	Asbestos Type	-
Room No.	R002	Extent	-
Room ID	Fuel Store	Notes:	Other - Un-insulated metal pipe.

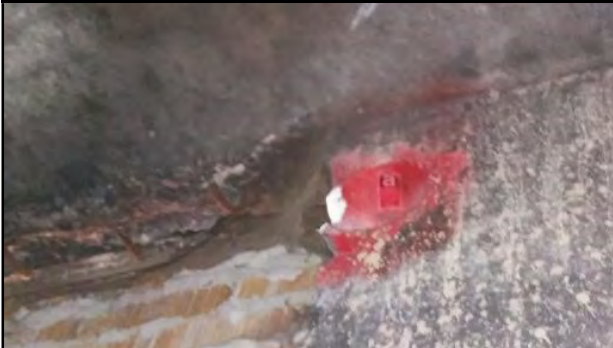
Building ID	Pinkie St Peters Primary School	Item Description	Cement flue pipes remains in Wall 1
Sample No.	PSG13-01632 - 0001	Material	Cement Product
Floor	First Basement Level	Asbestos Type	Crocidolite
Room No.	R003	Extent	2no
Room ID	Fuel Store	Notes:	The cement pipes are marked with red paint on the wall. There are two pipes remain in the wall and each are 230cm long. Other - Un-insulated metal pipe. No access due to door being locked and no key available. Previous photo used for reference. Presume condition of ACM remains the same - 11.07.2023.

HSG 264 Material Assessment Scores				Priority Assessment Scores				Risk Priority Rating:
Product:	1	Condition:	0	Occupant Activity:	0	Likelihood of Disturbance:	1	3
Surface Treatment:	1	Asbestos Type:	3	Potential of Human Exposure:	0	Maintenance Activity:	1	
Material Score:	5	Material Category:	C	Priority Score:	2	Total Score (Overall):	7

Surveyor:	Reece Feenie
		Recommendation:	Manage and Monitor through annual re-inspection

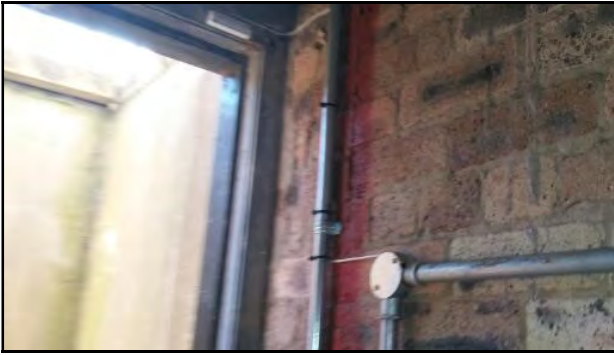
Building ID	Pinkie St Peters Primary School	Item Description	Insulation Residues Insulation residue on Wall 1
Sample No.	SP001	Material	Insulation Residues
Floor	First Basement Level	Asbestos Type	Presumed Asbestos
Room No.	R004	Extent	1.1lin m
Room ID	Circulation Area	Notes: Other - Un-insulated metal and plastic pipes, Metal conduits. The residues are marked with red paint where the wall couldn't be blasted without damaging fittings during previous removal works. The residues have to be referred back to previous survey G13-01632. The exact size of residues left on this wall is 110cm. No access due to door being locked and no key available. Previous photo used for reference. Presume condition of ACM remains the same - 11.07.2023

HSG 264 Material Assessment Scores				Priority Assessment Scores				Risk Priority Rating:
Product:	3	Condition:	1	Occupant Activity:	0	Likelihood of Disturbance:	1	3
Surface Treatment:	2	Asbestos Type:	3	Potential of Human Exposure:	0	Maintenance Activity:	0	
Material Score:	9	Material Category:	B	Priority Score:	1	Total Score (Overall):	10

Surveyor:	Reece Feenie
		Recommendation:	Manage and Monitor through annual re-inspection

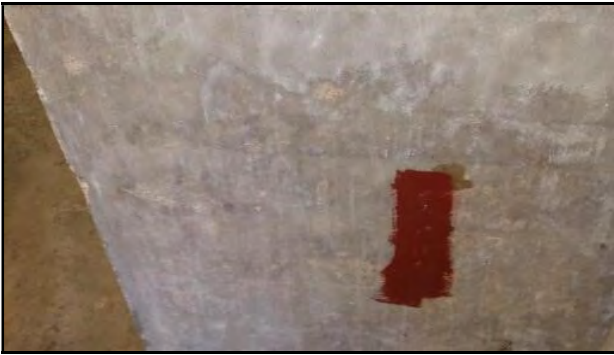
Building ID	Pinkie St Peters Primary School	Item Description	Insulation Residues Insulation residue on Wall 2
Sample No.	SP002	Material	Insulation Residues
Floor	First Basement Level	Asbestos Type	Presumed Asbestos
Room No.	R004	Extent	.43lin m
Room ID	Circulation Area	Notes: Other - Un-insulated metal and plastic pipes, Metal conduits. The residues are marked with red paint where the wall couldn't be blasted without damaging fittings during previous removal works. The residues have to be referred back to previous survey G13-01632. The exact size of residues left on this wall is 43cm. No access due to door being locked and no key available. Previous photo used for reference. Presume condition of ACM remains the same - 11.07.2023

HSG 264 Material Assessment Scores				Priority Assessment Scores				Risk Priority Rating:
Product:	3	Condition:	1	Occupant Activity:	0	Likelihood of Disturbance:	1	3
Surface Treatment:	2	Asbestos Type:	3	Potential of Human Exposure:	0	Maintenance Activity:	0	
Material Score:	9	Material Category:	B	Priority Score:	1	Total Score (Overall):	10

Surveyor:	Reece Feenie
		Recommendation:	Manage and Monitor through annual re-inspection

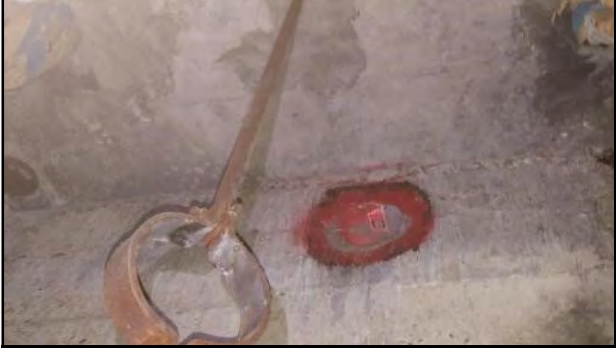
Building ID	Pinkie St Peters Primary School	Item Description	Cement flue pipes remains in Wall 1
Sample No.	PSG13-01632 - 0001	Material	Cement Product
Floor	First Basement Level	Asbestos Type	Crocidolite
Room No.	R005	Extent	1no
Room ID	Fuel Store	Notes: Other - Un-insulated metal pipes. The cement pipe is marked with red paint on the wall. There are two pipe is 230cm long. No access due to door being locked and no key available. Previous photo used for reference. Presume condition of ACM remains the same - 11.07.2023.

HSG 264 Material Assessment Scores				Priority Assessment Scores				Risk Priority Rating:
Product:	1	Condition:	0	Occupant Activity:	0	Likelihood of Disturbance:	1	3
Surface Treatment:	1	Asbestos Type:	3	Potential of Human Exposure:	0	Maintenance Activity:	1	
Material Score:	5	Material Category:	C	Priority Score:	2	Total Score (Overall):	7

Surveyor:	Reece Feenie
		Recommendation:	Manage and Monitor through annual re-inspection

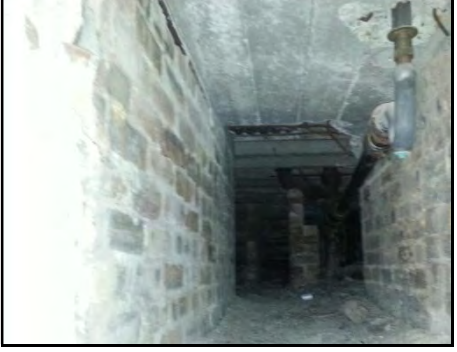
Building ID	Pinkie St Peters Primary School	Item Description	No Suspect Materials Seen
Sample No.		Material	-
Floor	First Basement Level	Asbestos Type	-
Room No.	R008	Extent	-
Room ID	Under Croft	Notes: Floor - Soil. Other - Metal waste pipes. Note that Bitumen damp proof course to walls has previously been sampled and did not contain asbestos. Only limited access could be gained to all of the solum area due to confined access space to different areas within the solum. Therefore asbestos should be presumed present until proven otherwise.

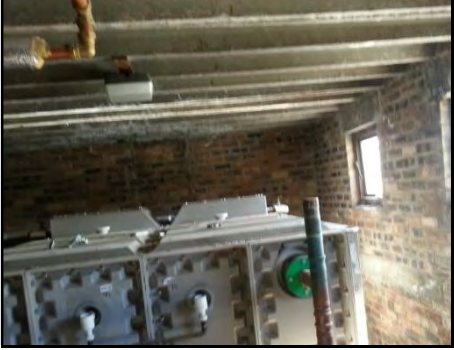
Building ID	Pinkie St Peters Primary School	Item Description	No Suspect Materials Seen
Sample No.		Material	-
Floor	Second Floor	Asbestos Type	-
Room No.	R001	Extent	-
Room ID	Tank Room	Notes: Other - Timber window frames, Large plastic water tank, MMMF insulated metal pipes, Metal and plastic downpipe.

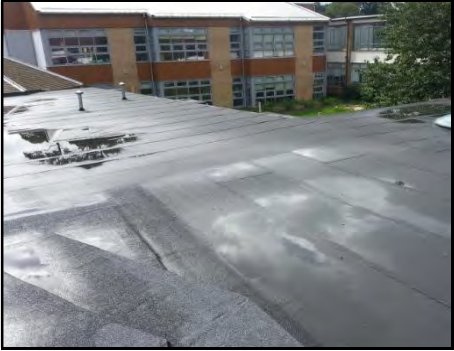
Building ID	Pinkie St Peters Primary School	Item Description	No Suspect Materials Seen
Sample No.		Material	-
Floor	External	Asbestos Type	-
Room No.	ER01	Extent	-
Room ID	Flat Roof	Notes: Roof covering - Bitumen felt on concrete. Core samples previously taken from this roof covering and did not contain asbestos. Other - Glass skylight, Metal flue pipes.

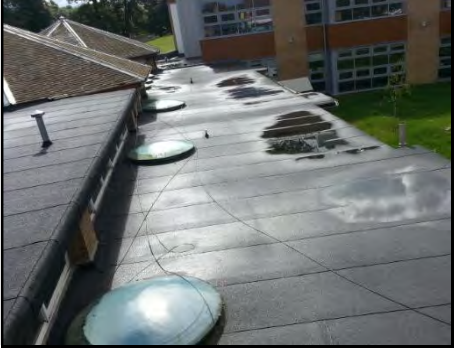
Building ID	Pinkie St Peters Primary School	Item Description	No Suspect Materials Seen
Sample No.		Material	-
Floor	External	Asbestos Type	-
Room No.	ER02	Extent	-
Room ID	Flat Roof	Notes: Roof covering - Bitumen felt on concrete. Core samples previously taken from this roof covering and did not contain asbestos. Other - Glass skylight, Metal flue pipes.

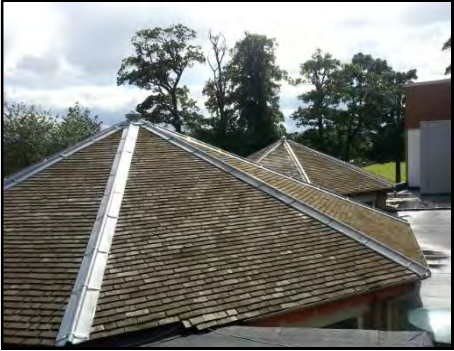
Building ID	Pinkie St Peters Primary School	Item Description	No Suspect Materials Seen
Sample No.		Material	-
Floor	External	Asbestos Type	-
Room No.	ER03	Extent	-
Room ID	Pitched Roofs	Notes: Roof covering - Timber tiles on timber batons, Metal flashings.

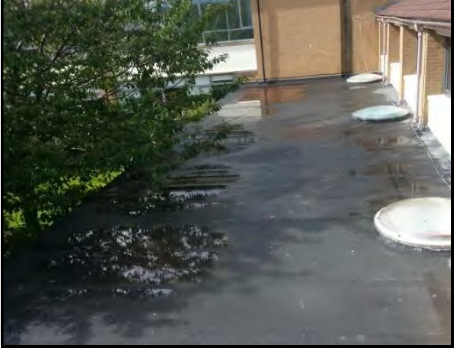
Building ID	Pinkie St Peters Primary School	Item Description	No Suspect Materials Seen
Sample No.		Material	-
Floor	External	Asbestos Type	-
Room No.	ER04	Extent	-
Room ID	Flat Roof	Notes: Roof covering - Bitumen felt on concrete. Core samples previously taken from this roof covering and did not contain asbestos. Other - Glass and Plastic skylights, Plastic flue pipes.

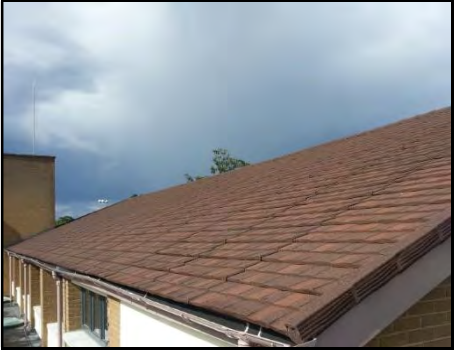
Building ID	Pinkie St Peters Primary School	Item Description	No Suspect Materials Seen
Sample No.		Material	-
Floor	External	Asbestos Type	-
Room No.	ER05	Extent	-
Room ID	Pitched Roof	Notes: Roof covering - Modern metal panels, Metal flashings.

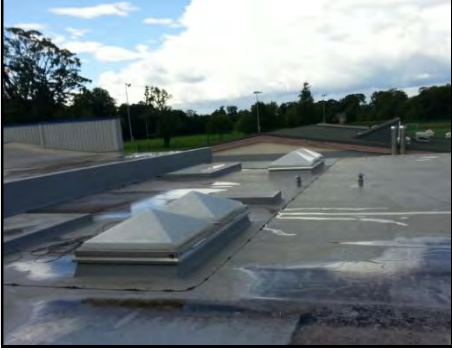
Building ID	Pinkie St Peters Primary School	Item Description	No Suspect Materials Seen
Sample No.		Material	-
Floor	External	Asbestos Type	-
Room No.	ER06	Extent	-
Room ID	Flat Roof	Notes: Roof covering - Modern plastic roof covering. Core samples previously taken from Bitumen felt to these roofs and did not contain asbestos. Other - Metal and plastic skylights, Metal flue pipes.

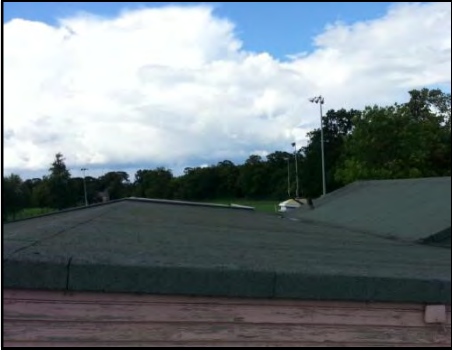
Building ID	Pinkie St Peters Primary School	Item Description	No Suspect Materials Seen
Sample No.		Material	-
Floor	External	Asbestos Type	-
Room No.	ER07	Extent	-
Room ID	Flat Roof	Notes: Roof covering - Bitumen felt on concrete. Core samples previously taken from this roof covering and did not contain asbestos. Other - Plastic skylight, Metal flue pipe, Timber fascias, Timber soffits. Note that Cement soffits previously present have been removed and replaced with timber.

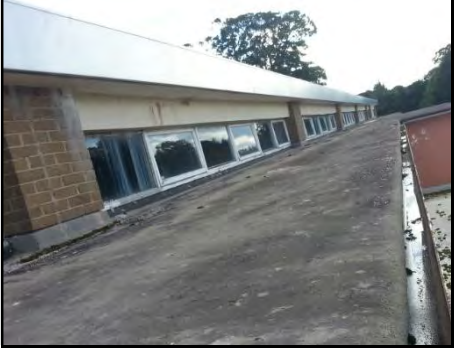
Building ID	Pinkie St Peters Primary School	Item Description	No Suspect Materials Seen
Sample No.		Material	-
Floor	External	Asbestos Type	-
Room No.	ER08	Extent	-
Room ID	Flat Roof	Notes: Roof covering - Black composite roof covering - Previously sampled and did not contain asbestos.

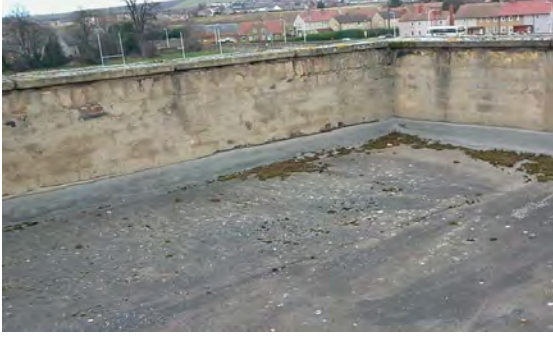
Building ID	Pinkie St Peters Primary School	Item Description	No Suspect Materials Seen
Sample No.		Material	-
Floor	External	Asbestos Type	-
Room No.	ER10	Extent	-
Room ID	Flat Roof	Notes: Roof covering - Black composite roof covering - Previously sampled and did not contain asbestos. Note that Bitumen damp proof course below coping stones to walls were previously sampled and did not contain asbestos.

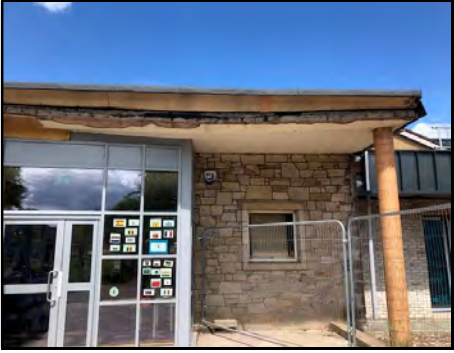
Building ID	Pinkie St Peters Primary School	Item Description	Bitumen within concrete canopy
Sample No.	PS139	Material	Bituminous Products
Floor	External	Asbestos Type	No Asbestos Detected
Room No.	EXT001	Extent	-
Room ID	Externals Elevations to ER01-ER04	Notes: Sampled by Jordan Goldfarb of Environmental Essentials

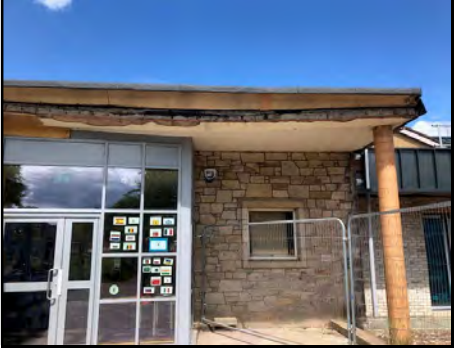
Building ID	Pinkie St Peters Primary School	Item Description	Layer of stramit board within concrete canopy
Sample No.	PS140	Material	Cement Product
Floor	External	Asbestos Type	No Asbestos Detected
Room No.	EXT001	Extent	-
Room ID	Externals Elevations to ER01-ER04	Notes: Sampled by Jordan Goldfarb of Environmental Essentials

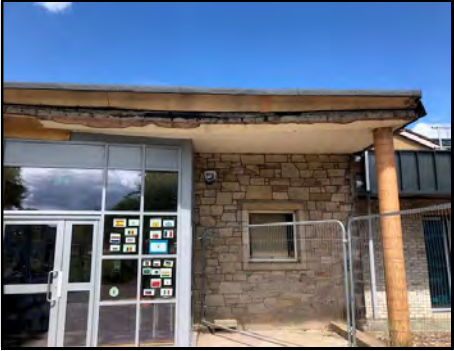
Building ID	Pinkie St Peters Primary School	Item Description	Second layer of dense stramit board within concrete canopy
Sample No.	PS141	Material	Cement Product
Floor	External	Asbestos Type	No Asbestos Detected
Room No.	EXT001	Extent	-
Room ID	Externals Elevations to ER01-ER04	Notes: Sampled by Jordan Goldfarb of Environmental Essentials

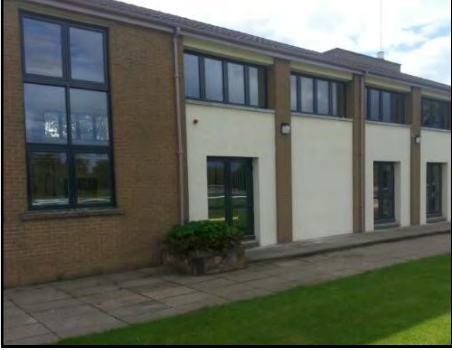
Building ID	Pinkie St Peters Primary School	Item Description	No Suspect Materials Seen
Sample No.		Material	-
Floor	External	Asbestos Type	-
Room No.	EXT002	Extent	-
Room ID	Externals Elevations to ER05	Notes: Other - Timber fascias, Concrete soffits, Metal rainwater goods, Metal doors, Metal window frames, Concrete sills. New window frames fitted since original survey and Asbestos containing mastic has been removed.

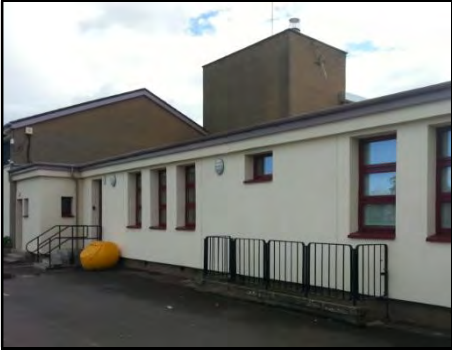
Building ID	Pinkie St Peters Primary School	Item Description	No Suspect Materials Seen
Sample No.		Material	-
Floor	External	Asbestos Type	-
Room No.	EXT003	Extent	-
Room ID	Externals Elevations to ER06	Notes: Other - Timber fascias, Concrete soffits, Metal rainwater goods, Metal doors, Metal window frames, Metal sills.

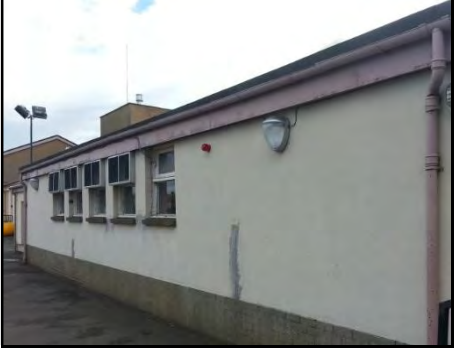
Building ID	Pinkie St Peters Primary School	Item Description	No Suspect Materials Seen
Sample No.		Material	-
Floor	External	Asbestos Type	-
Room No.	EXT004	Extent	-
Room ID	Externals Elevations to ER07	Notes: Other - Timber fascias and soffits, Metal rainwater goods, Timber window frames, Metal window frames, Timber doors, Metal doors and window frames. Note that previously identified cement soffits have been removed and replaced with timber.

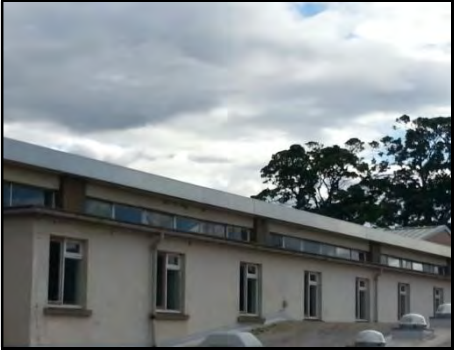
Building ID	Pinkie St Peters Primary School	Item Description	No Suspect Materials Seen
Sample No.		Material	-
Floor	External	Asbestos Type	-
Room No.	EXT005	Extent	-
Room ID	Externals Elevations to ER08 - ER10	Notes: Other - Timber fascias and soffits, Concrete soffits, Metal rainwater goods, Timber window frames. Note that samples from original timber window frames have been taken and did not contain asbestos.
