Lochend Hallhill site for housing Site 15a

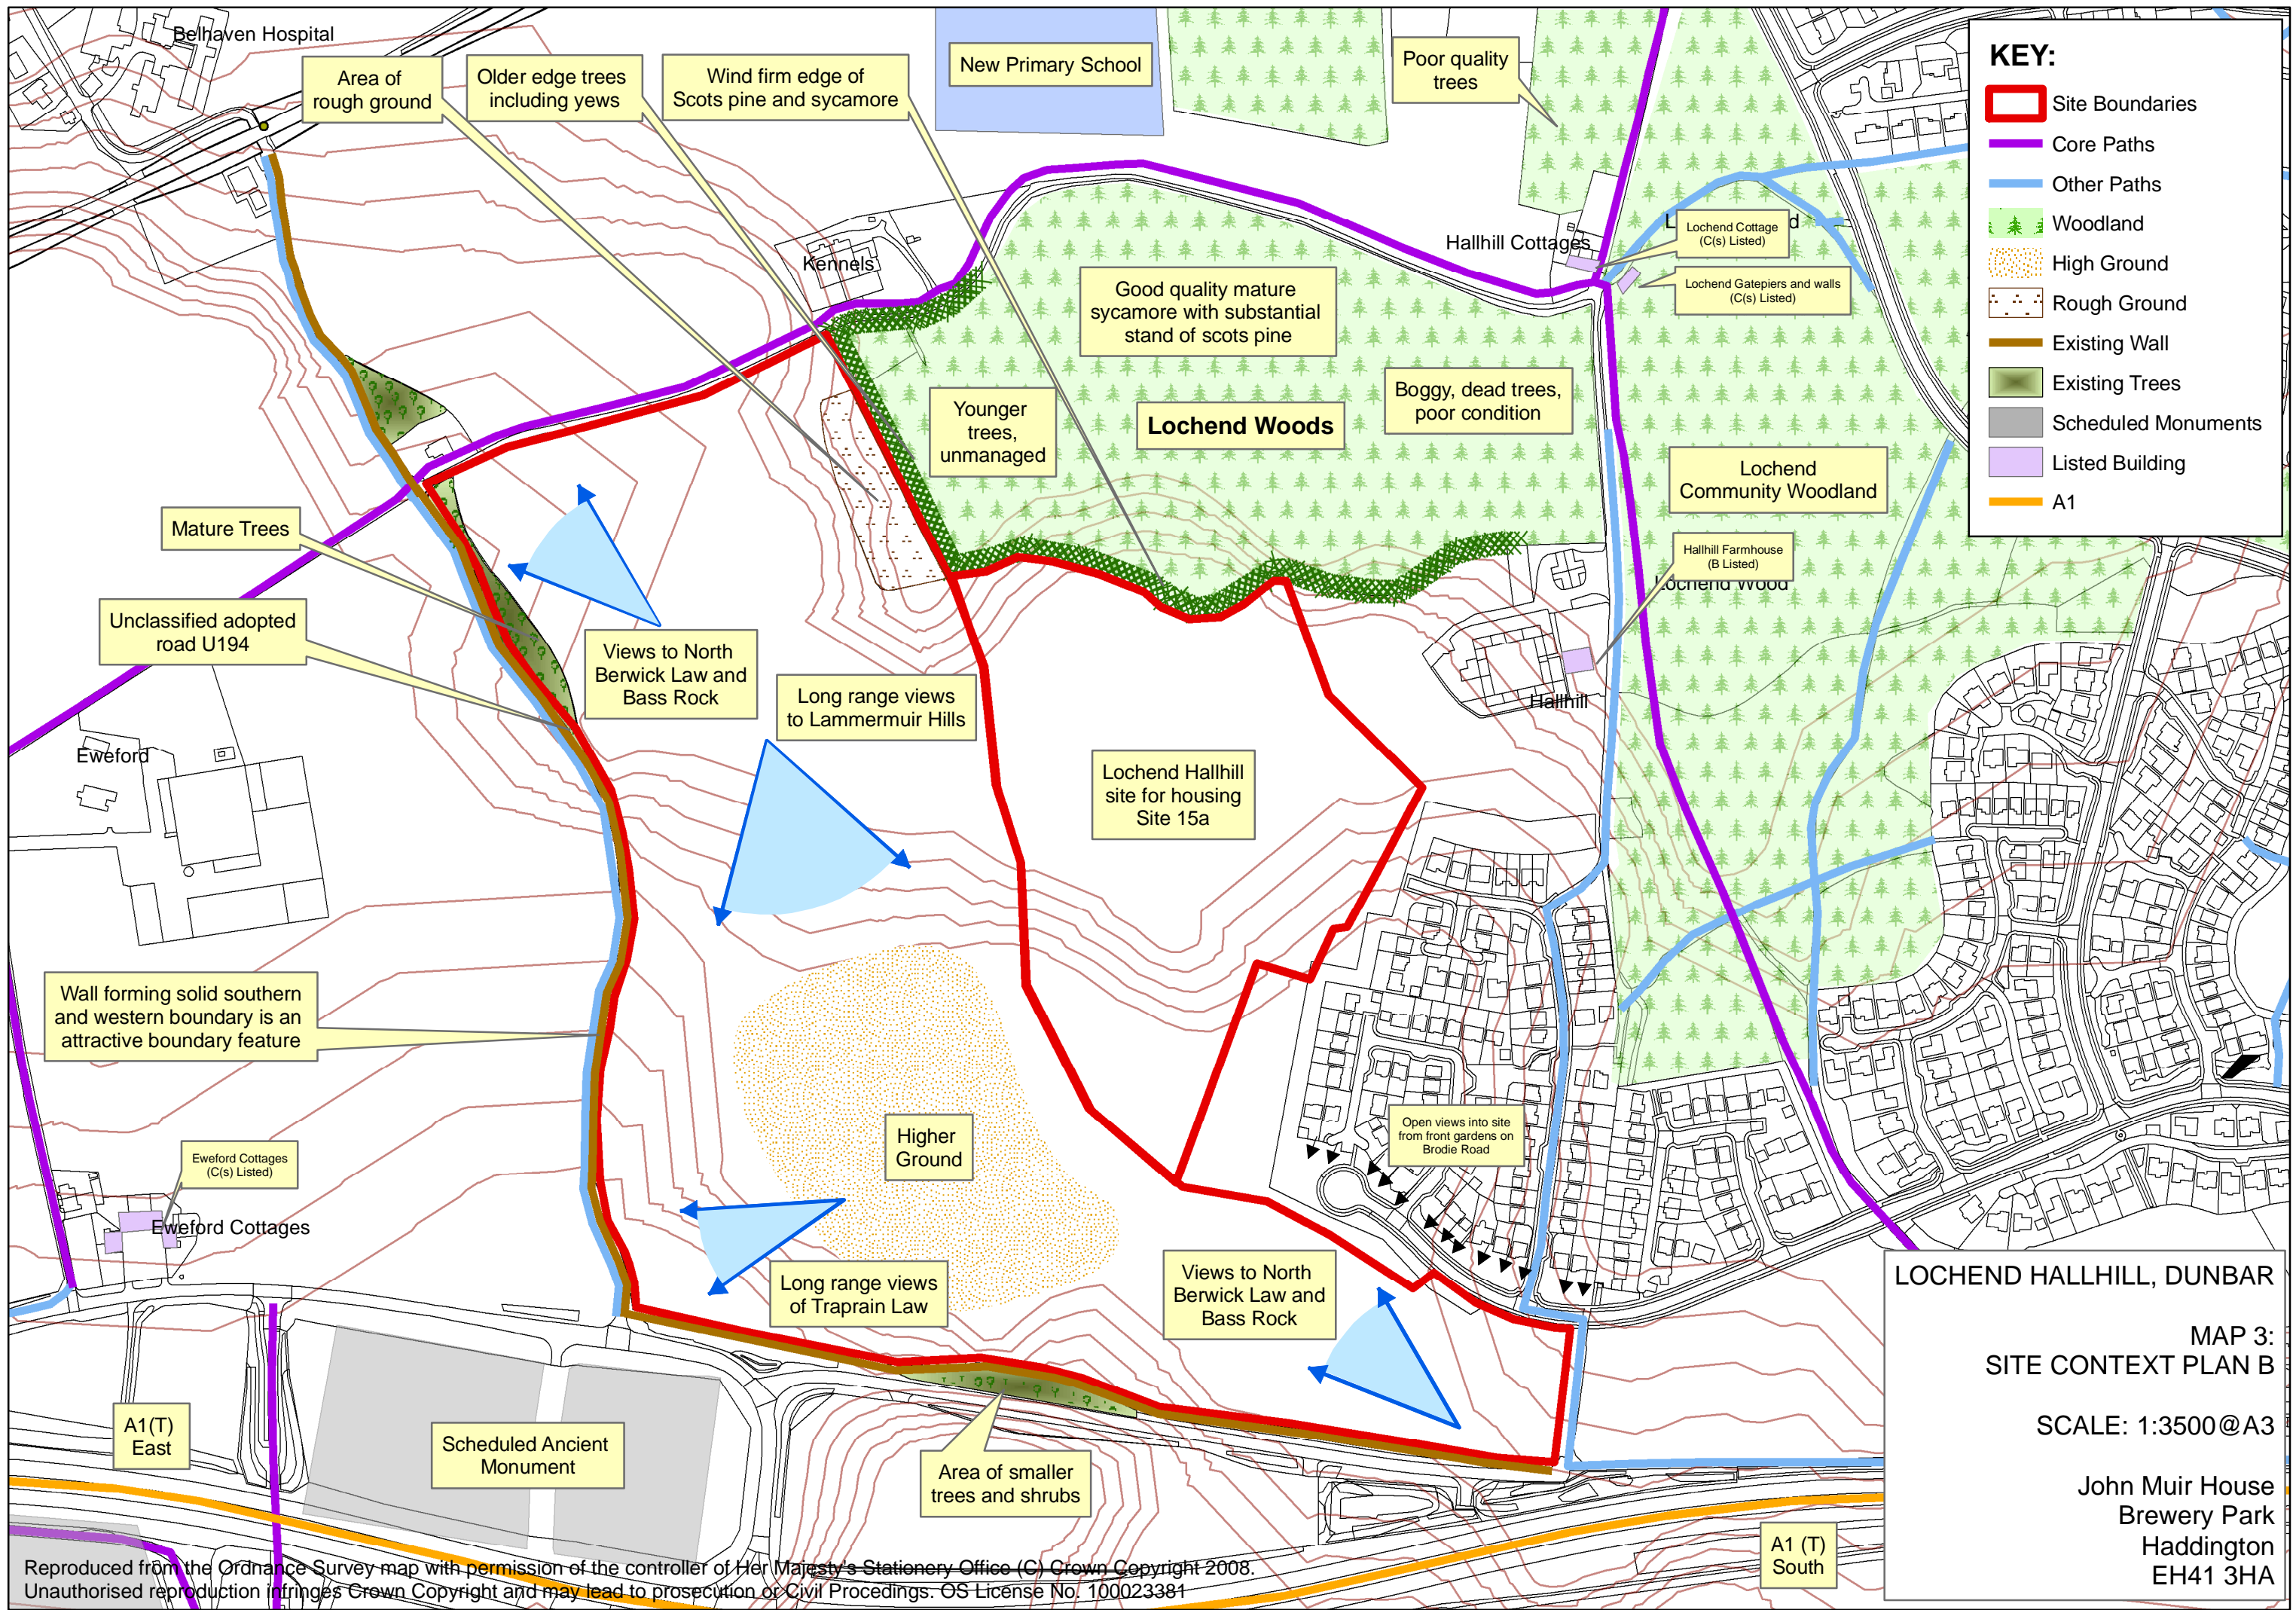
Good quality mature sycamore with substantial stand of scots pine

Boggy, dead trees, poor condition

Views to North Berwick Law and Bass Rock

Long range views to Lammermuir Hills

Wall forming solid southern and western boundary is an attractive boundary feature

Open views into site from front gardens on Brodie Road

Long range views of Traprain Law
